CATCHMENT INVESTIGATIONS GROUP ONE

Catchment Area of Outfall: OF_206

**Westford, Massachusetts
November 2023**

Tighe & Bond

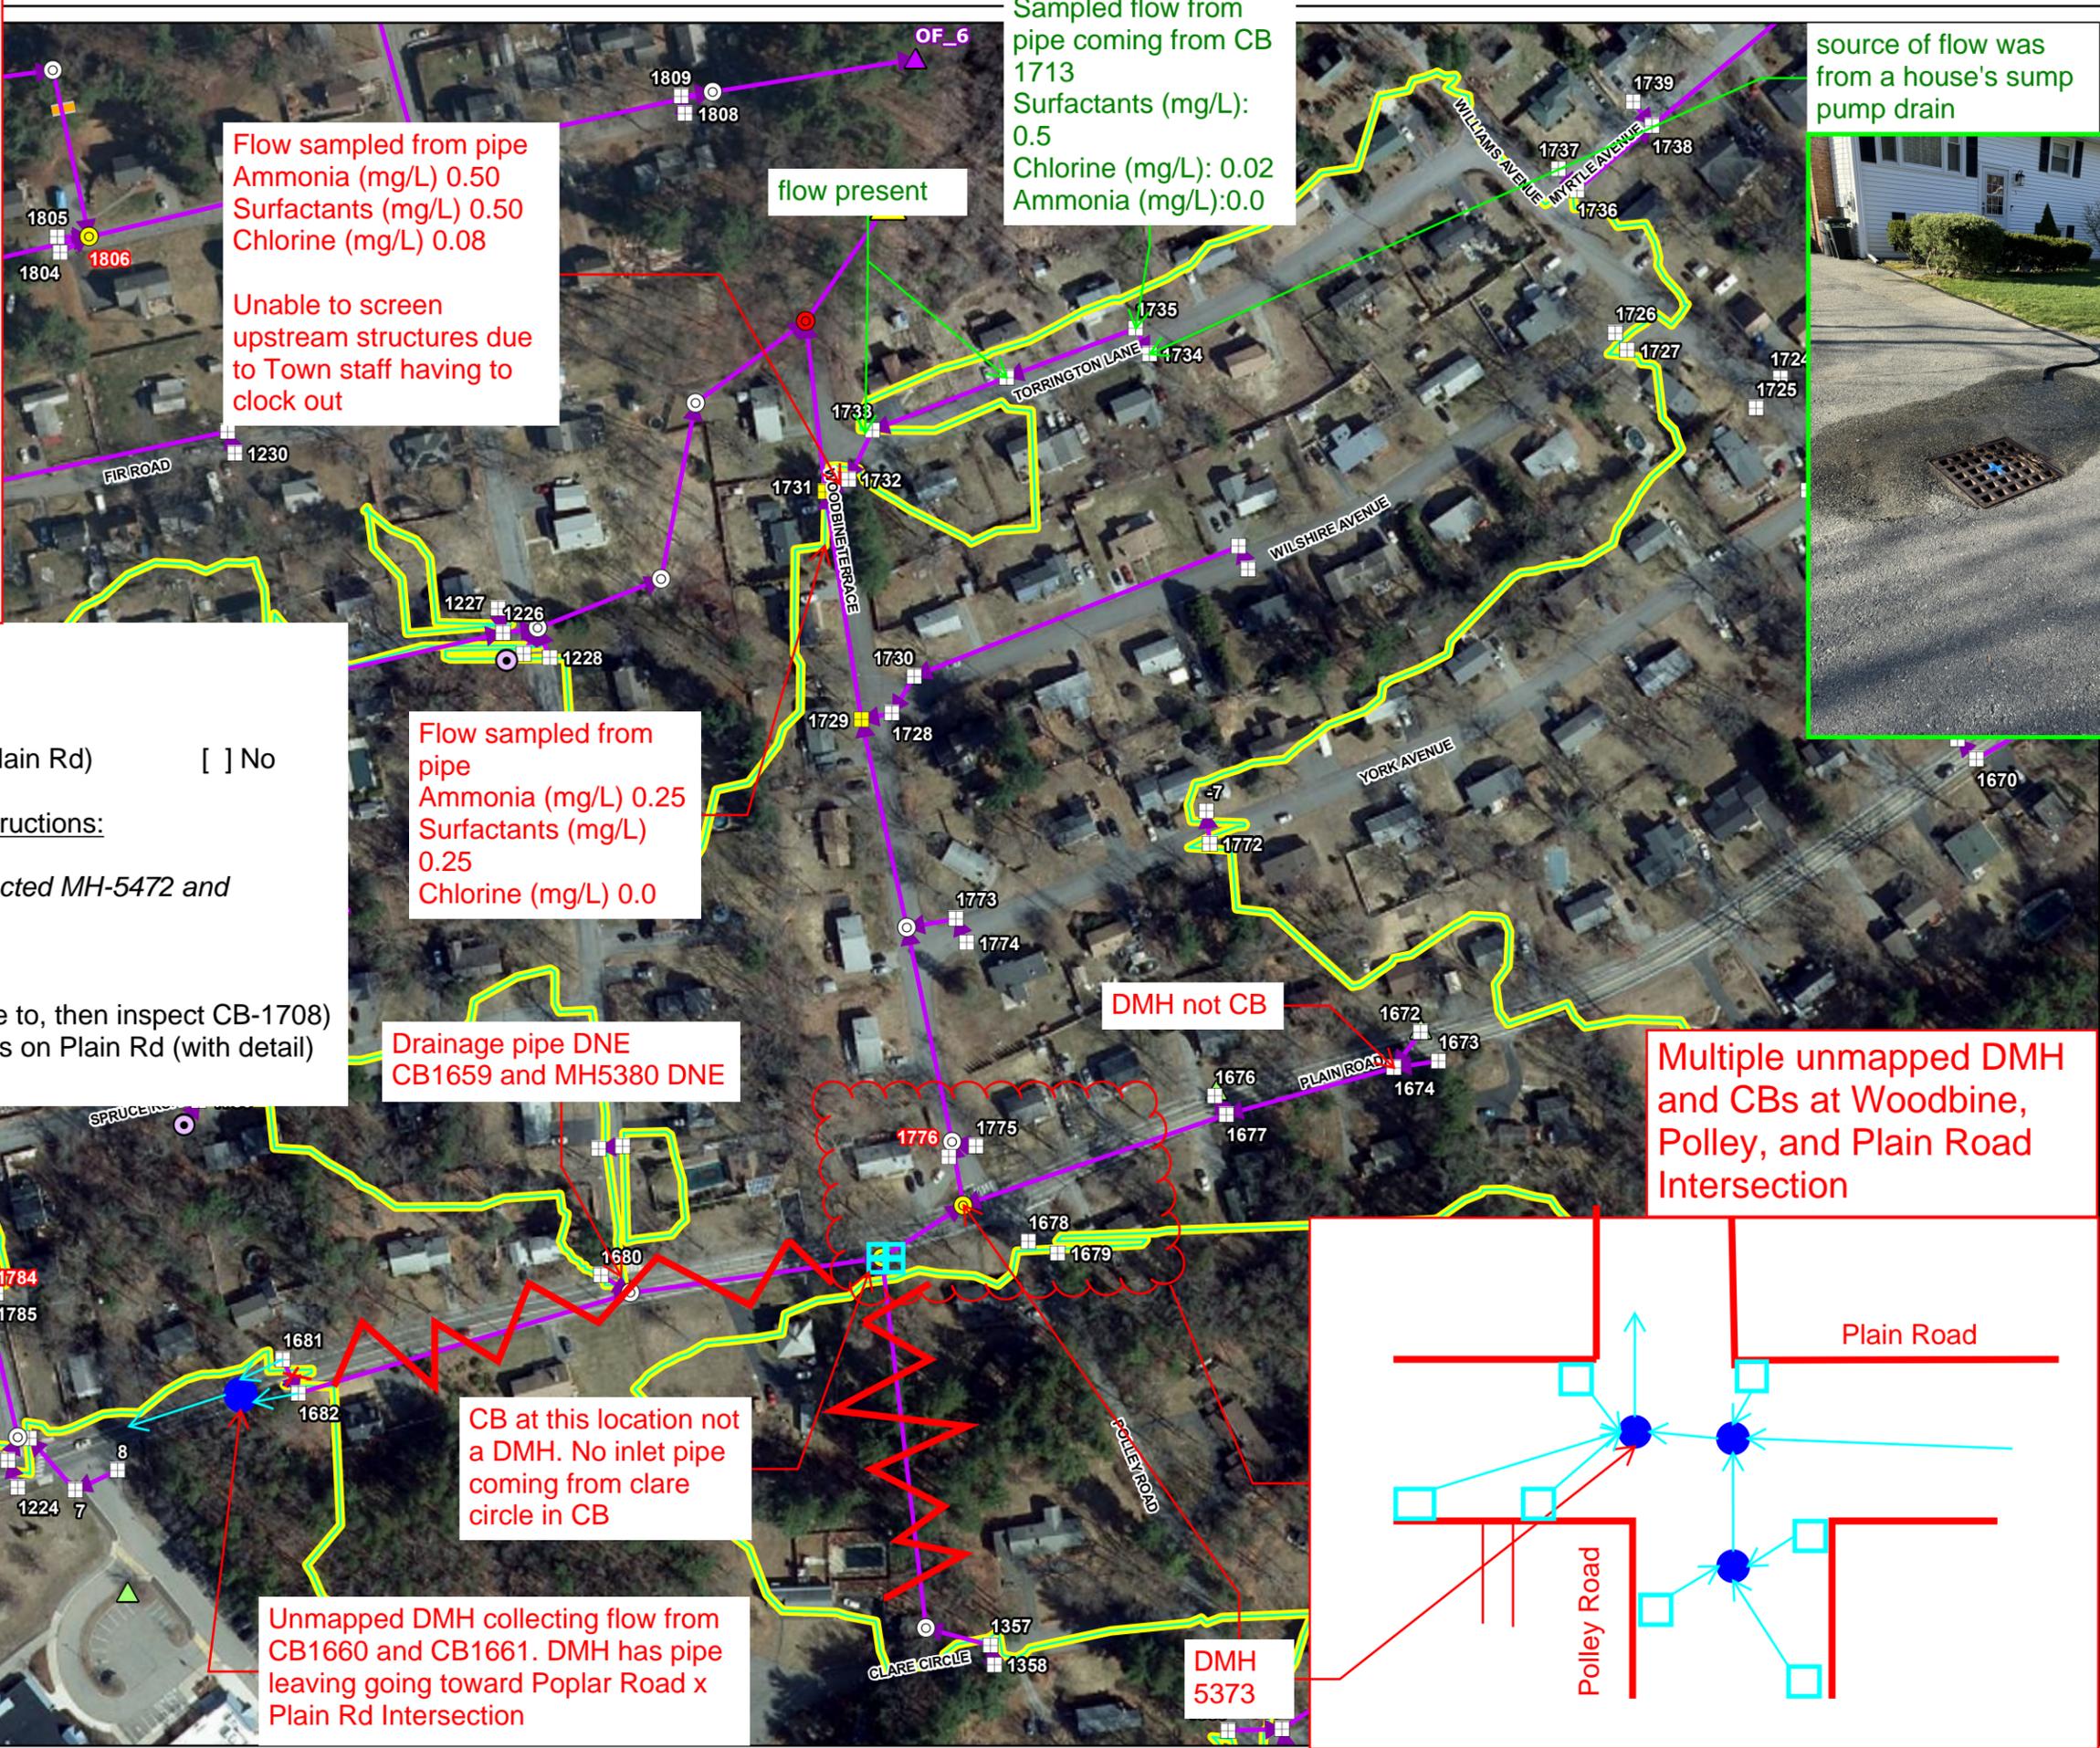
Flow sampled from pipe
 Ammonia (mg/L) 0.50
 Surfactants (mg/L) 0.50
 Chlorine (mg/L) 0.08

Unable to screen upstream structures due to Town staff having to clock out

Sampled flow from pipe coming from CB 1713
 Surfactants (mg/L): 0.5
 Chlorine (mg/L): 0.02
 Ammonia (mg/L): 0.0

source of flow was from a house's sump pump drain

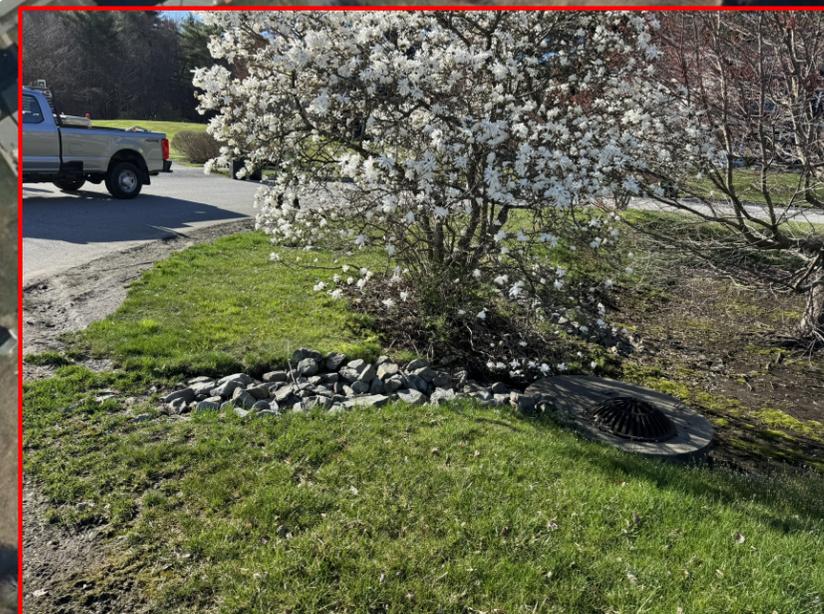
Orange figure is bmp outlet structure

riprap at this location, did not see any other drainage structure

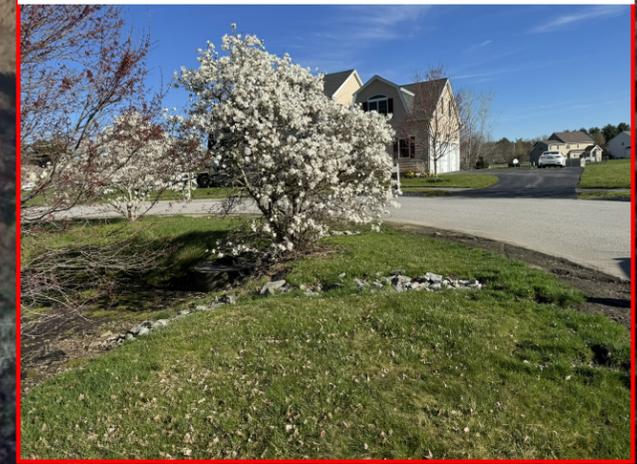
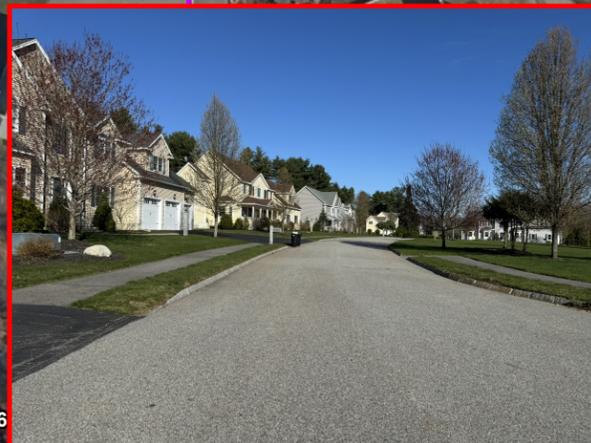
Photo of this area, did not see any drainage structure

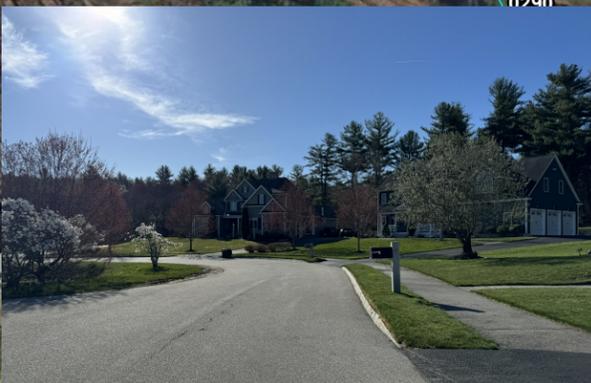
Photo of this area, did not see any drainage structure

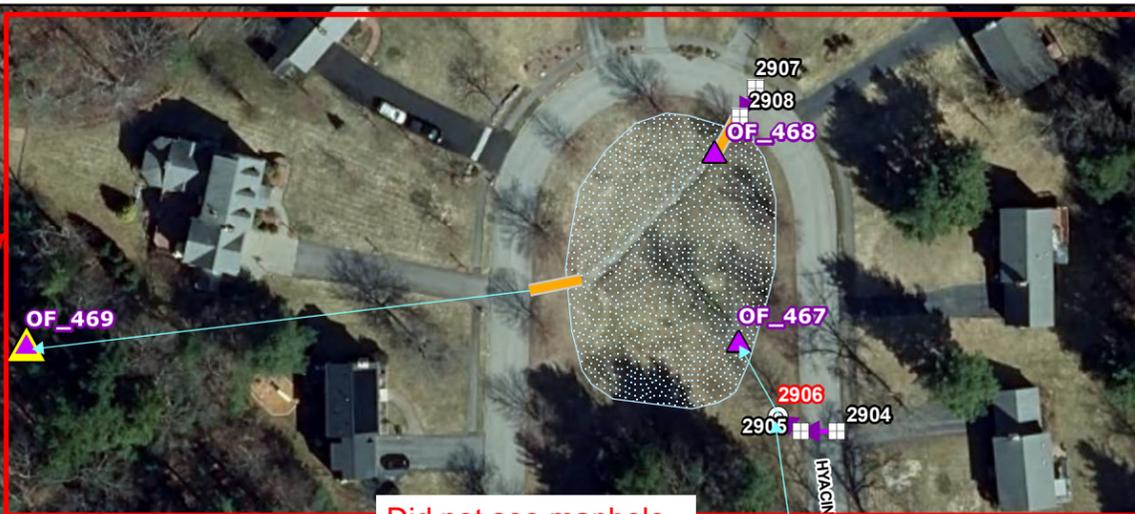
Did not see manhole mapped in record drawings otherwise mapping appeared accurate at CB 2903 and 2915. There were pipes directed toward mapped DMH location.

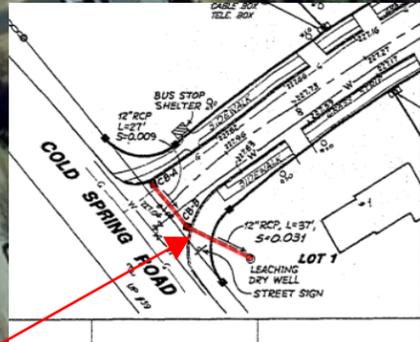
There was a pipe leaving CB2900 as mapped in record drawings, did not see outlet

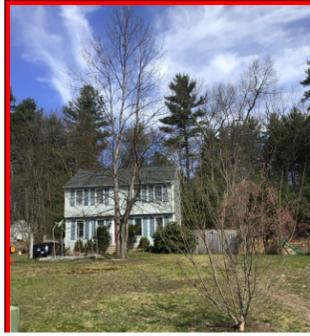
Area where pipe was directed coming from

Inlet 8" HDPE, could not locate where this was coming from

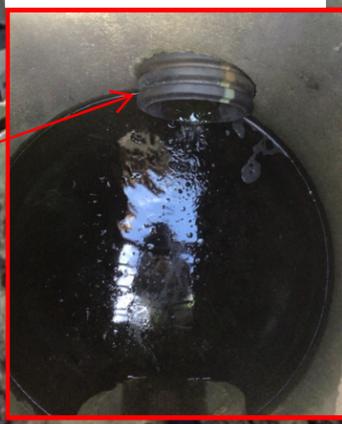
Unmapped pipe leaving CB2317 directed toward OF_386

Located outfall that appeared to be leaving CB2317 - unsure if this is OF_386 that was previously inspected

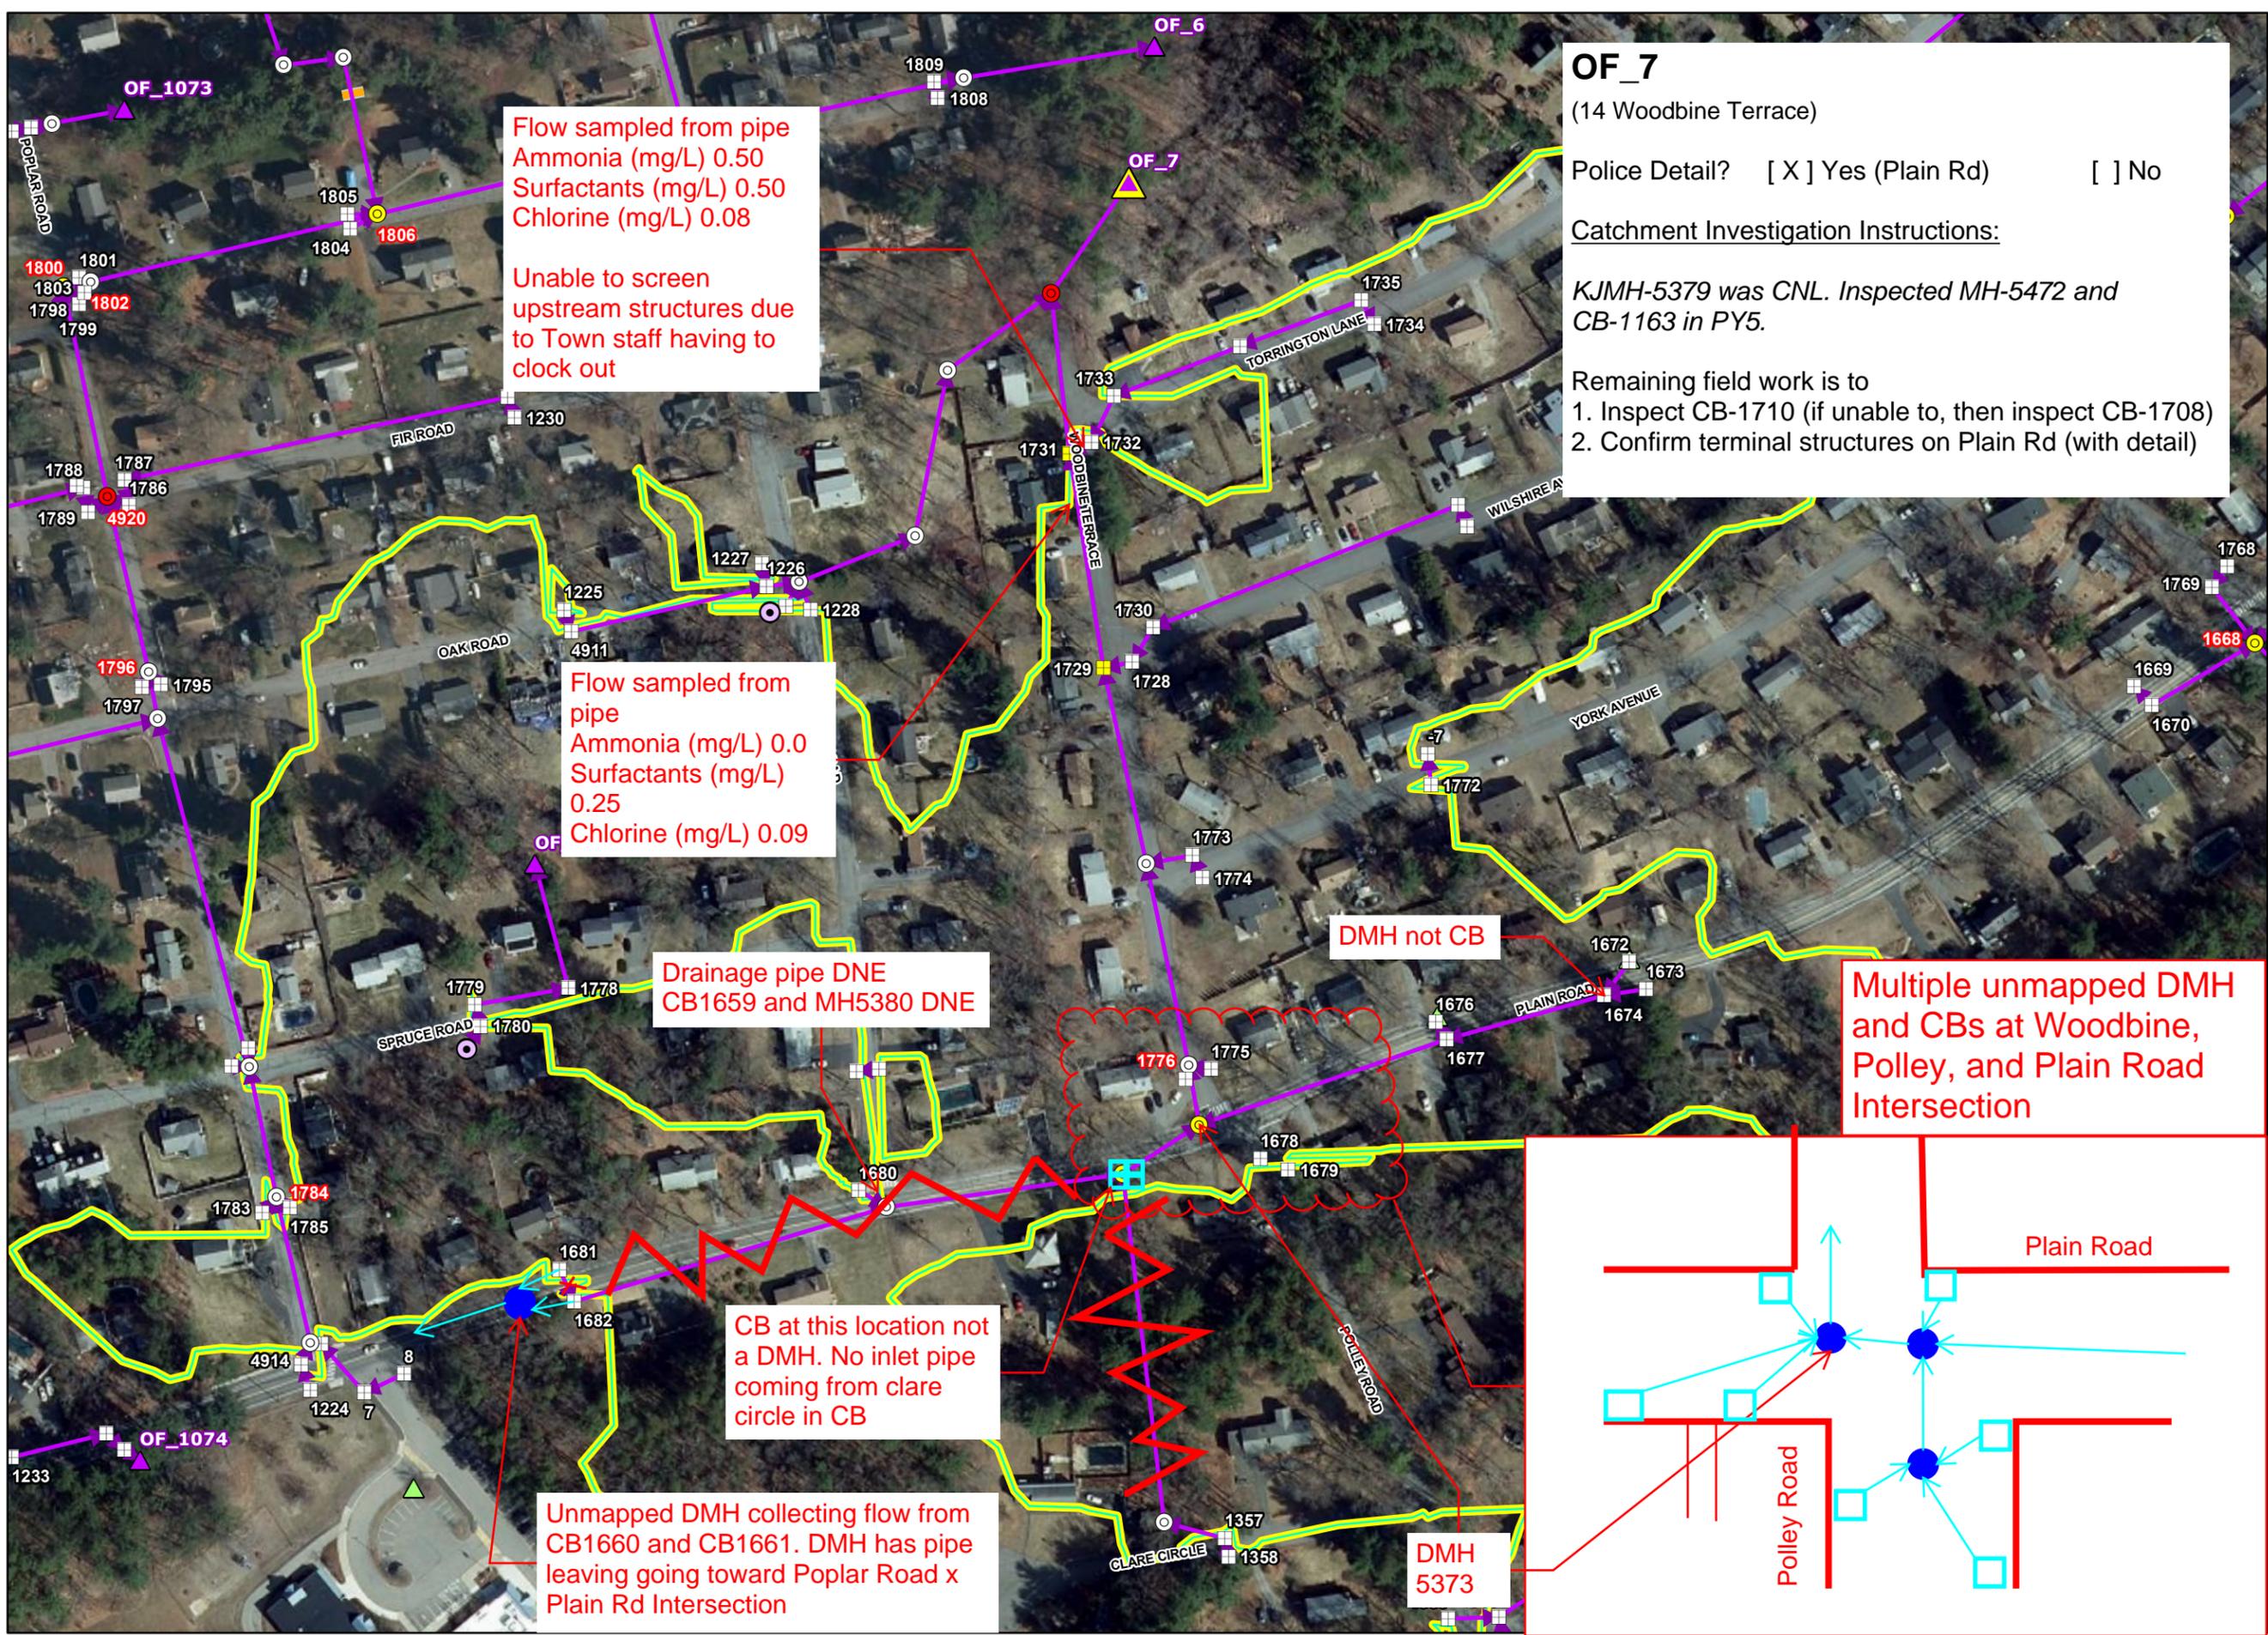
Flow sampled from pipe
 Ammonia (mg/L) 0.50
 Surfactants (mg/L) 0.50
 Chlorine (mg/L) 0.08

Unable to screen
 upstream structures due
 to Town staff having to
 clock out

DMH not CB

Multiple unmapped DMH
 and CBs at Woodbine,
 Polley, and Plain Road
 Intersection

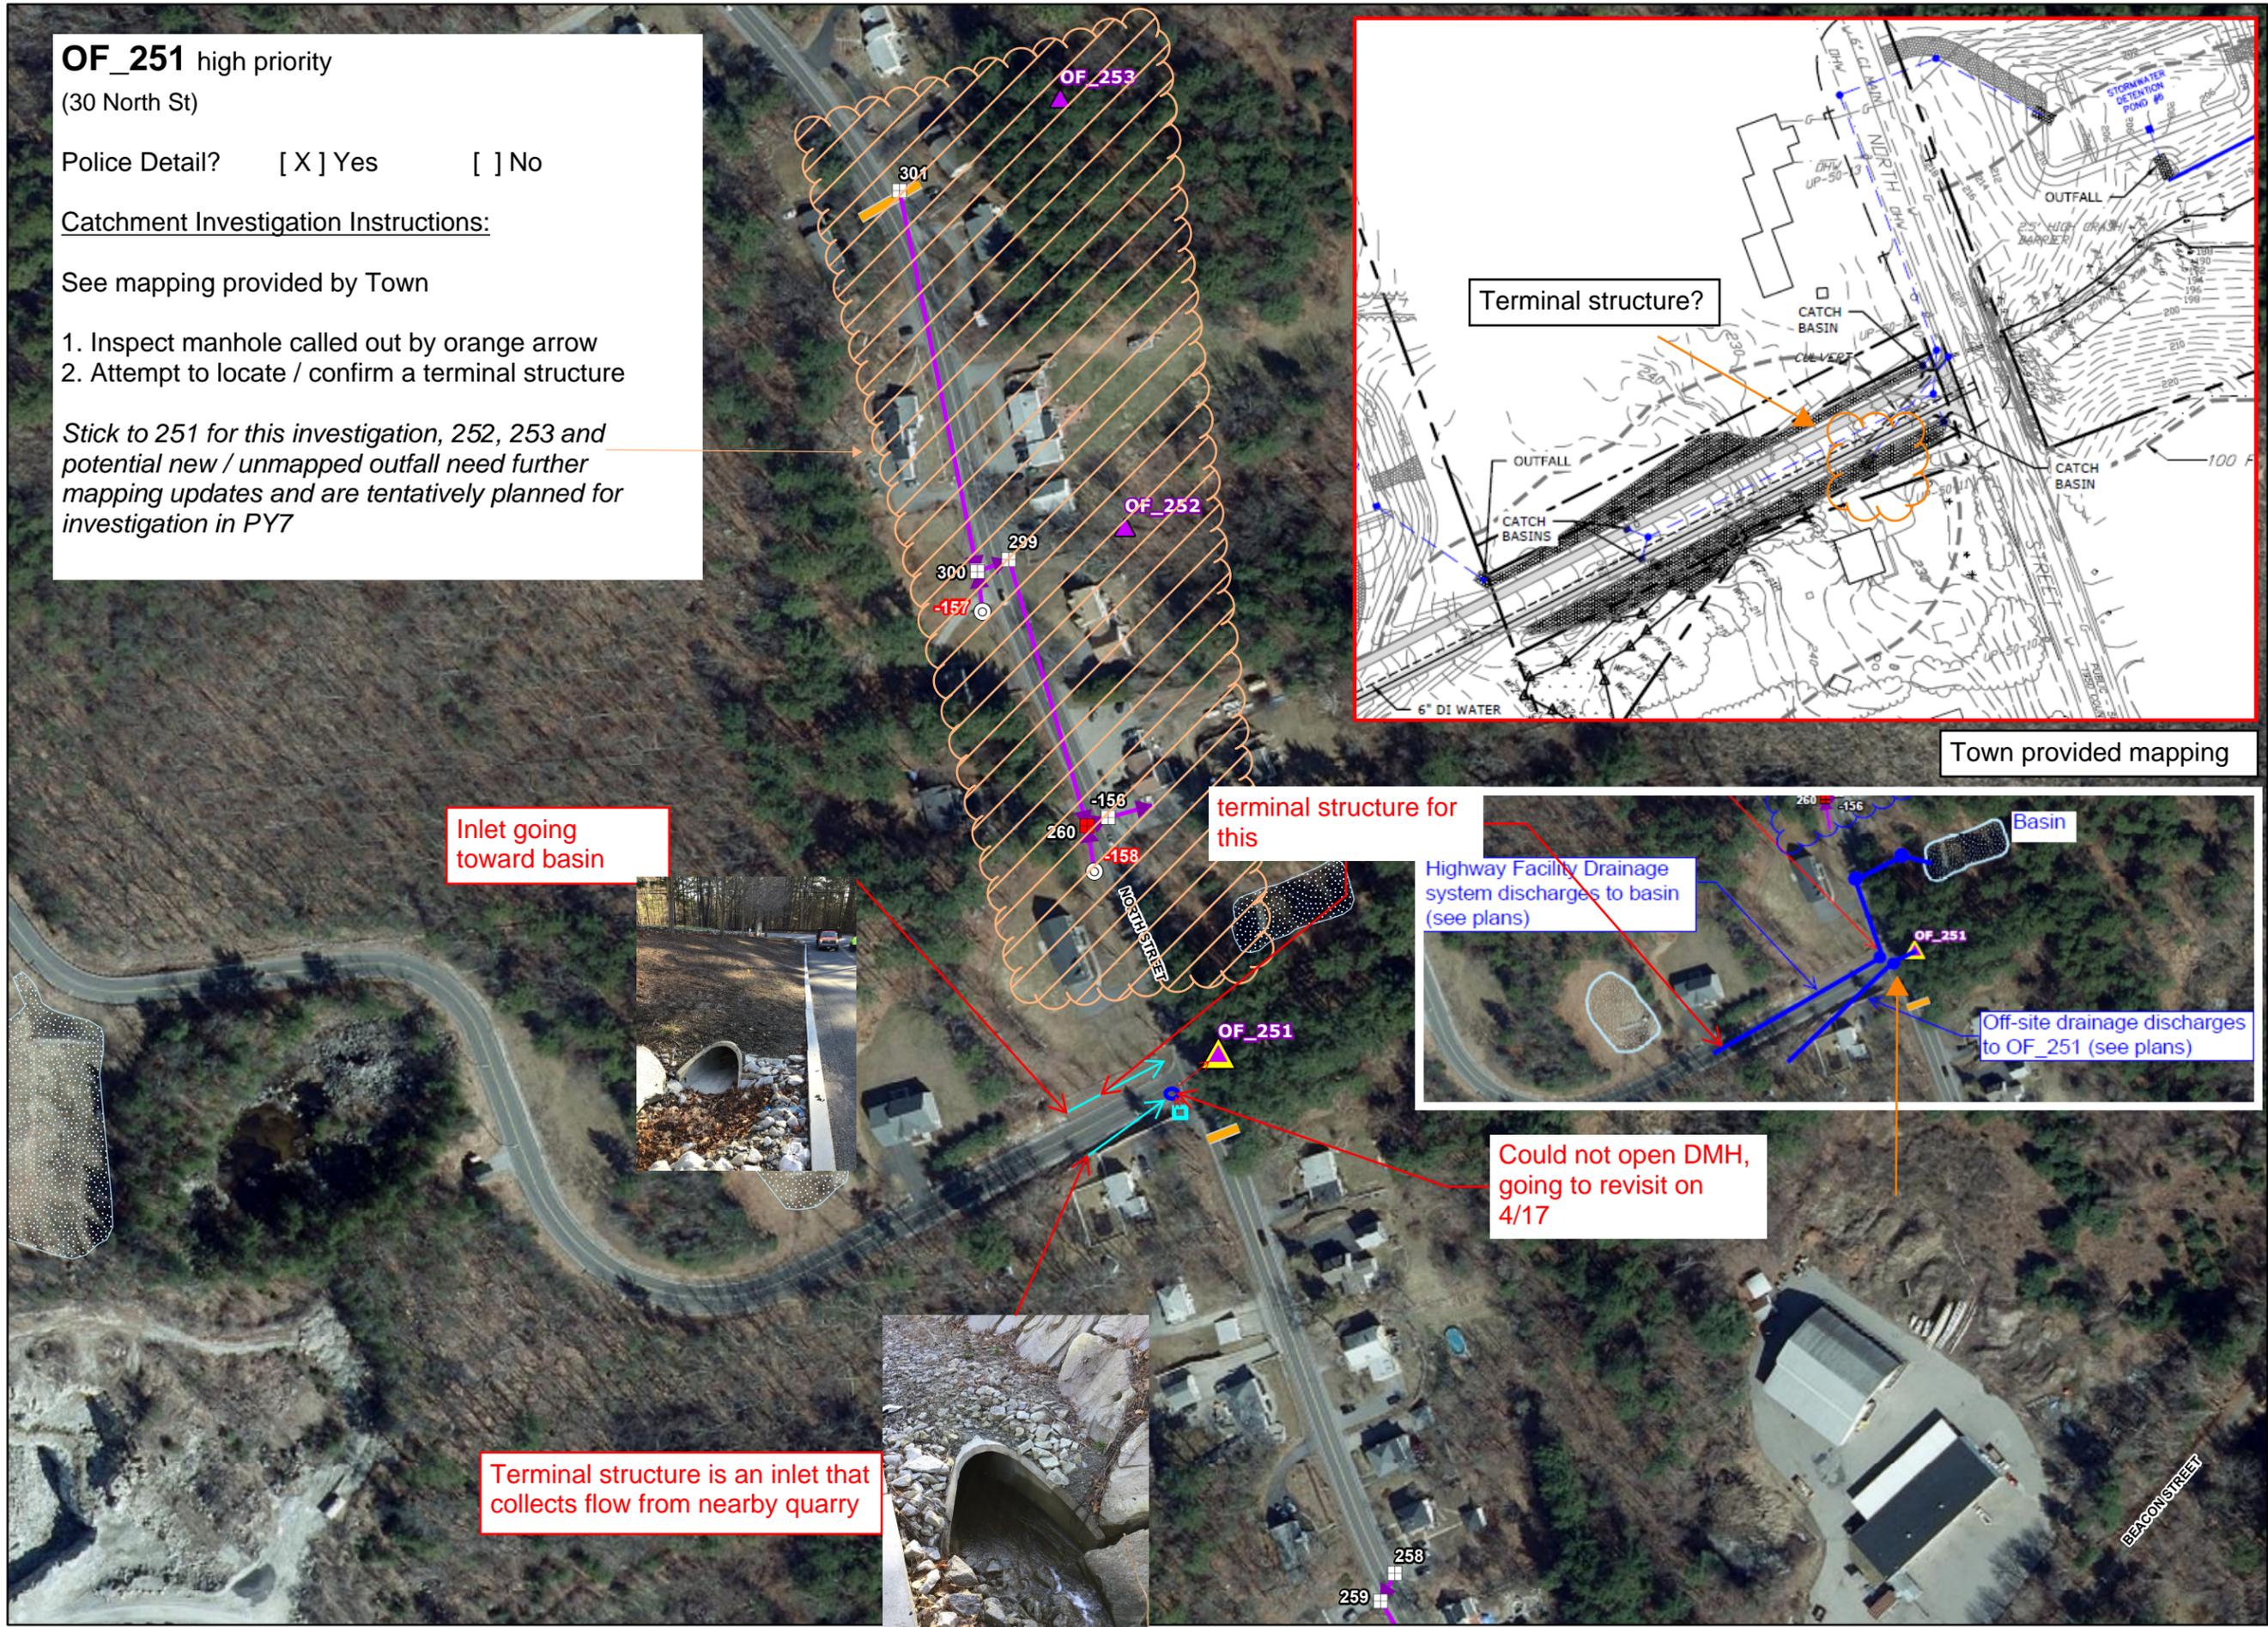
Inlet going toward basin

terminal structure for this

Could not open DMH, going to revisit on 4/17

Terminal structure is an inlet that collects flow from nearby quarry

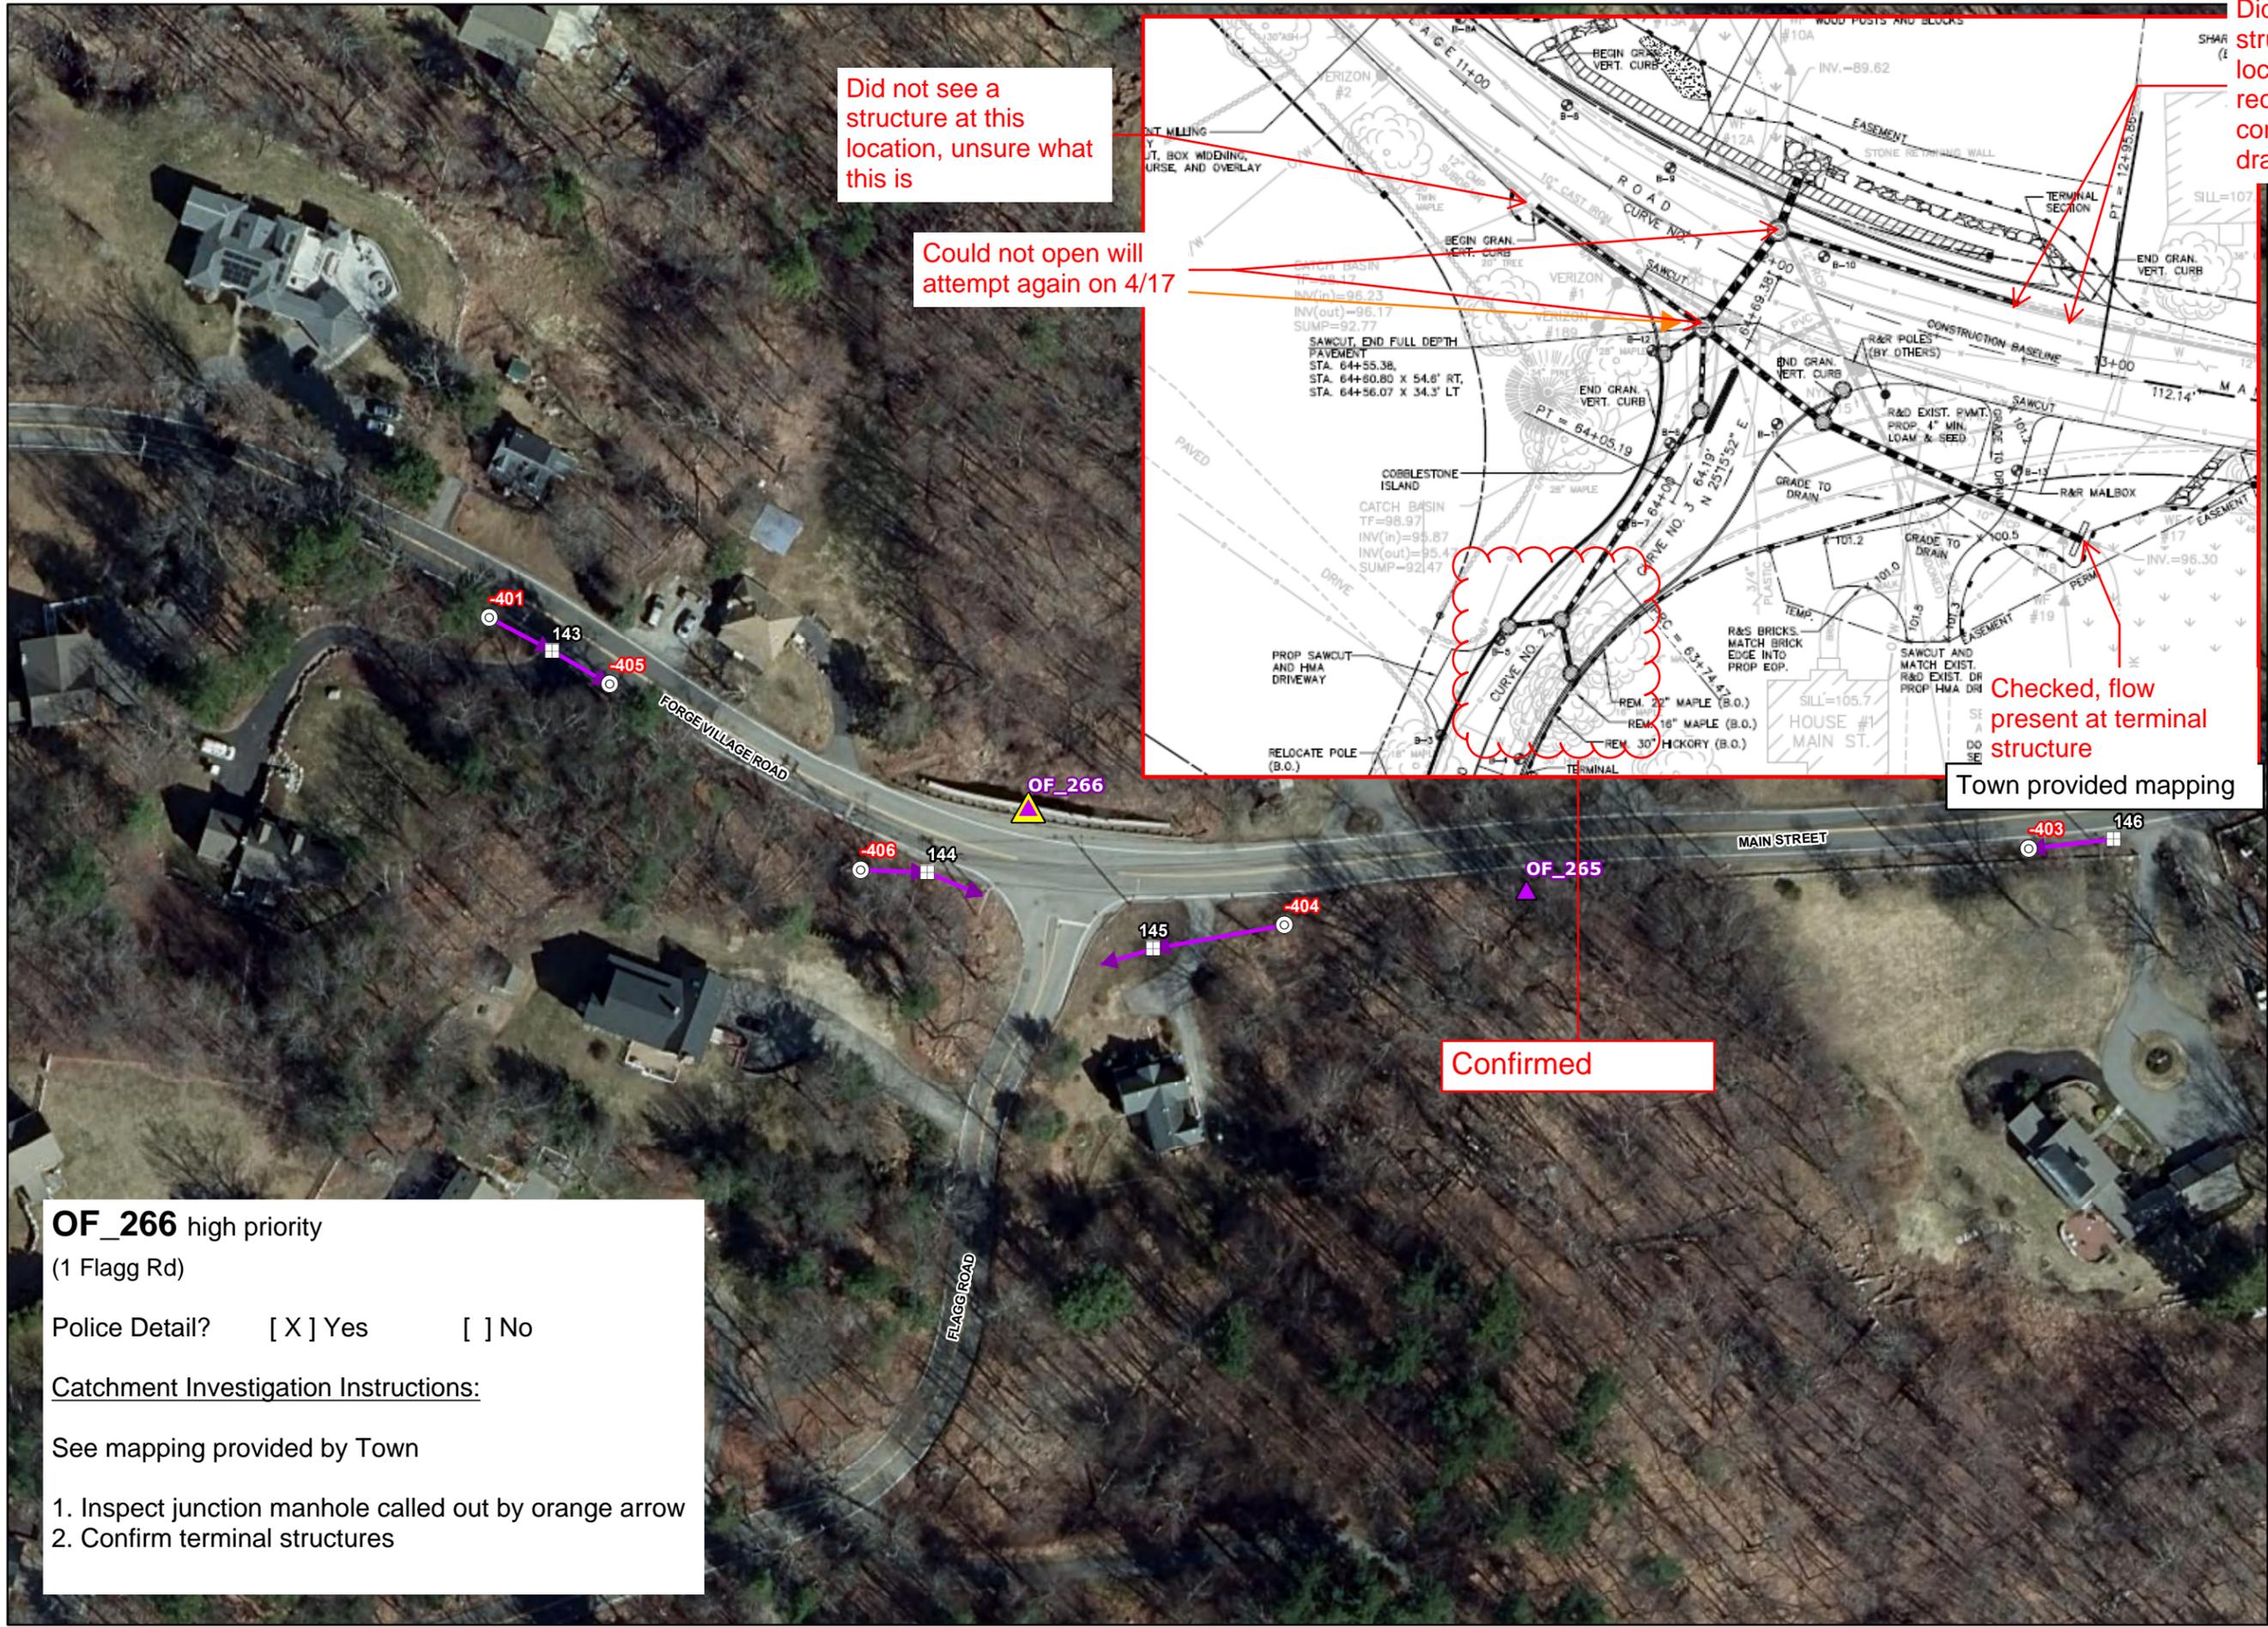
Did not see a structure at this location, unsure what this is

Could not open will attempt again on 4/17

Did not see a structure at this location. Based on record drawings connects to existing drainage

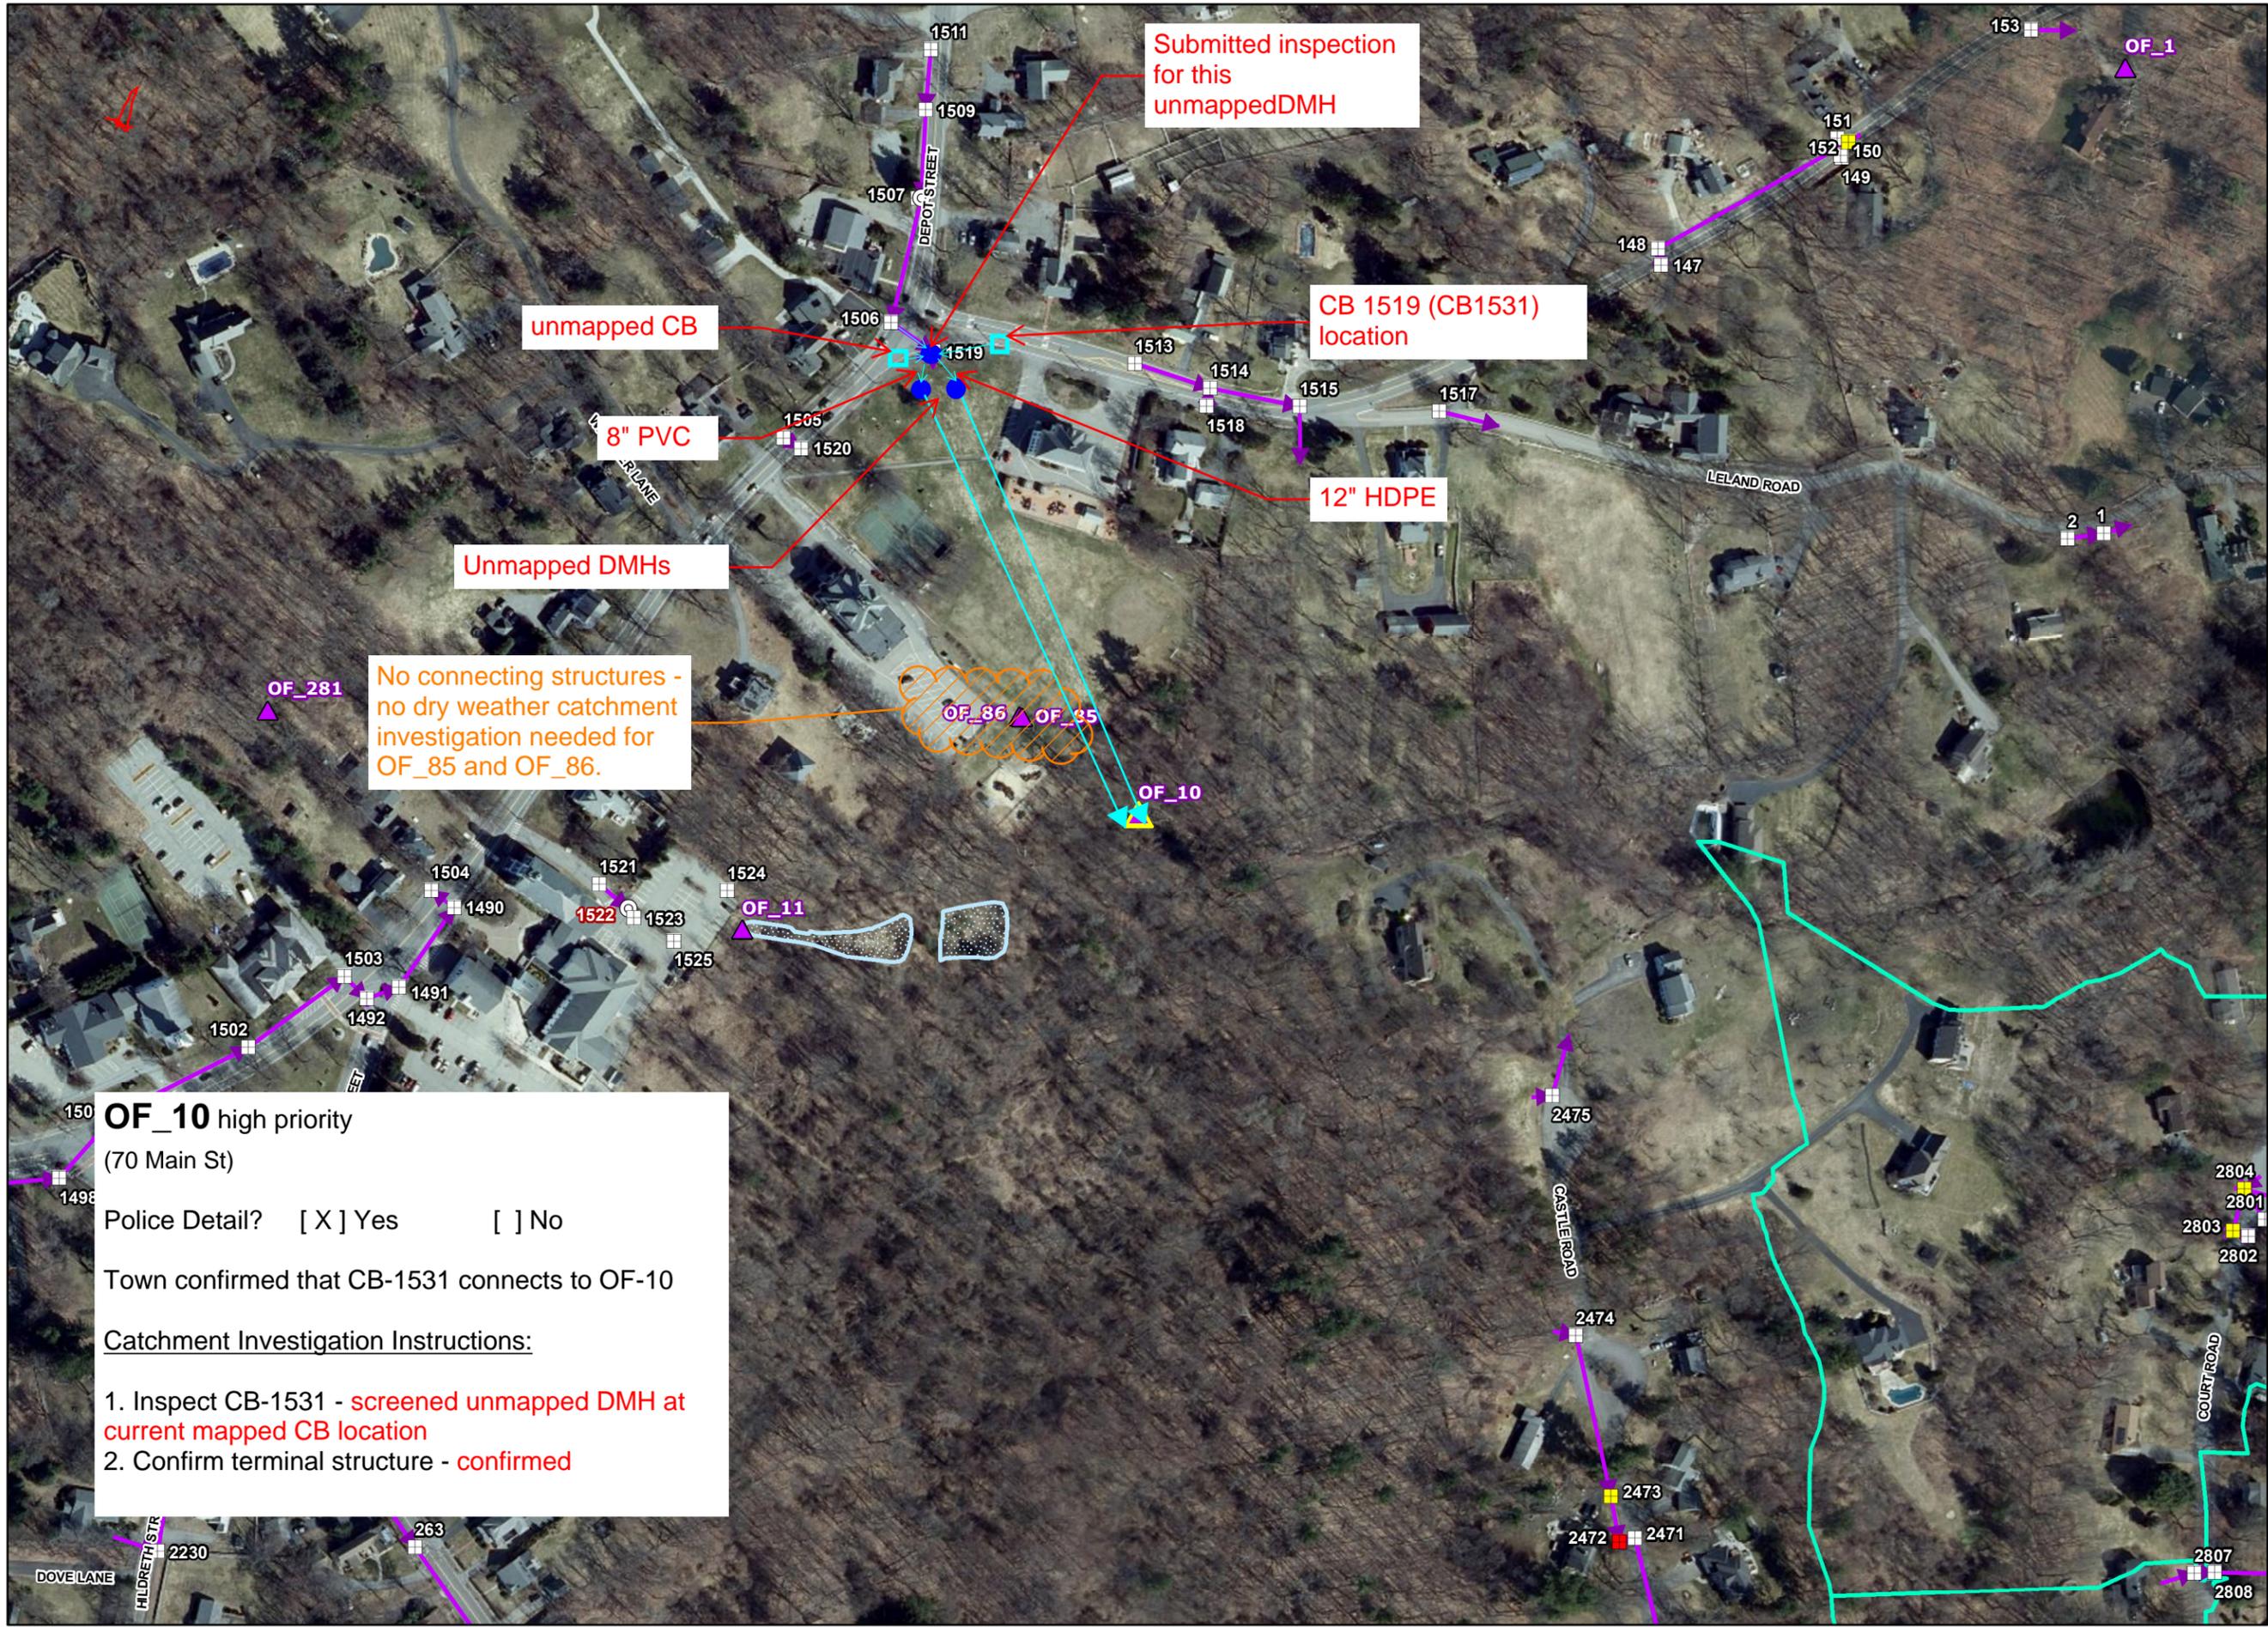
Submitted inspection for this unmapped DMH

unmapped CB
