CATCHMENT INVESTIGATIONS GROUP ONE

Catchment Area of Outfall: OF_206

**Westford, Massachusetts
November 2023**

Tighe & Bond

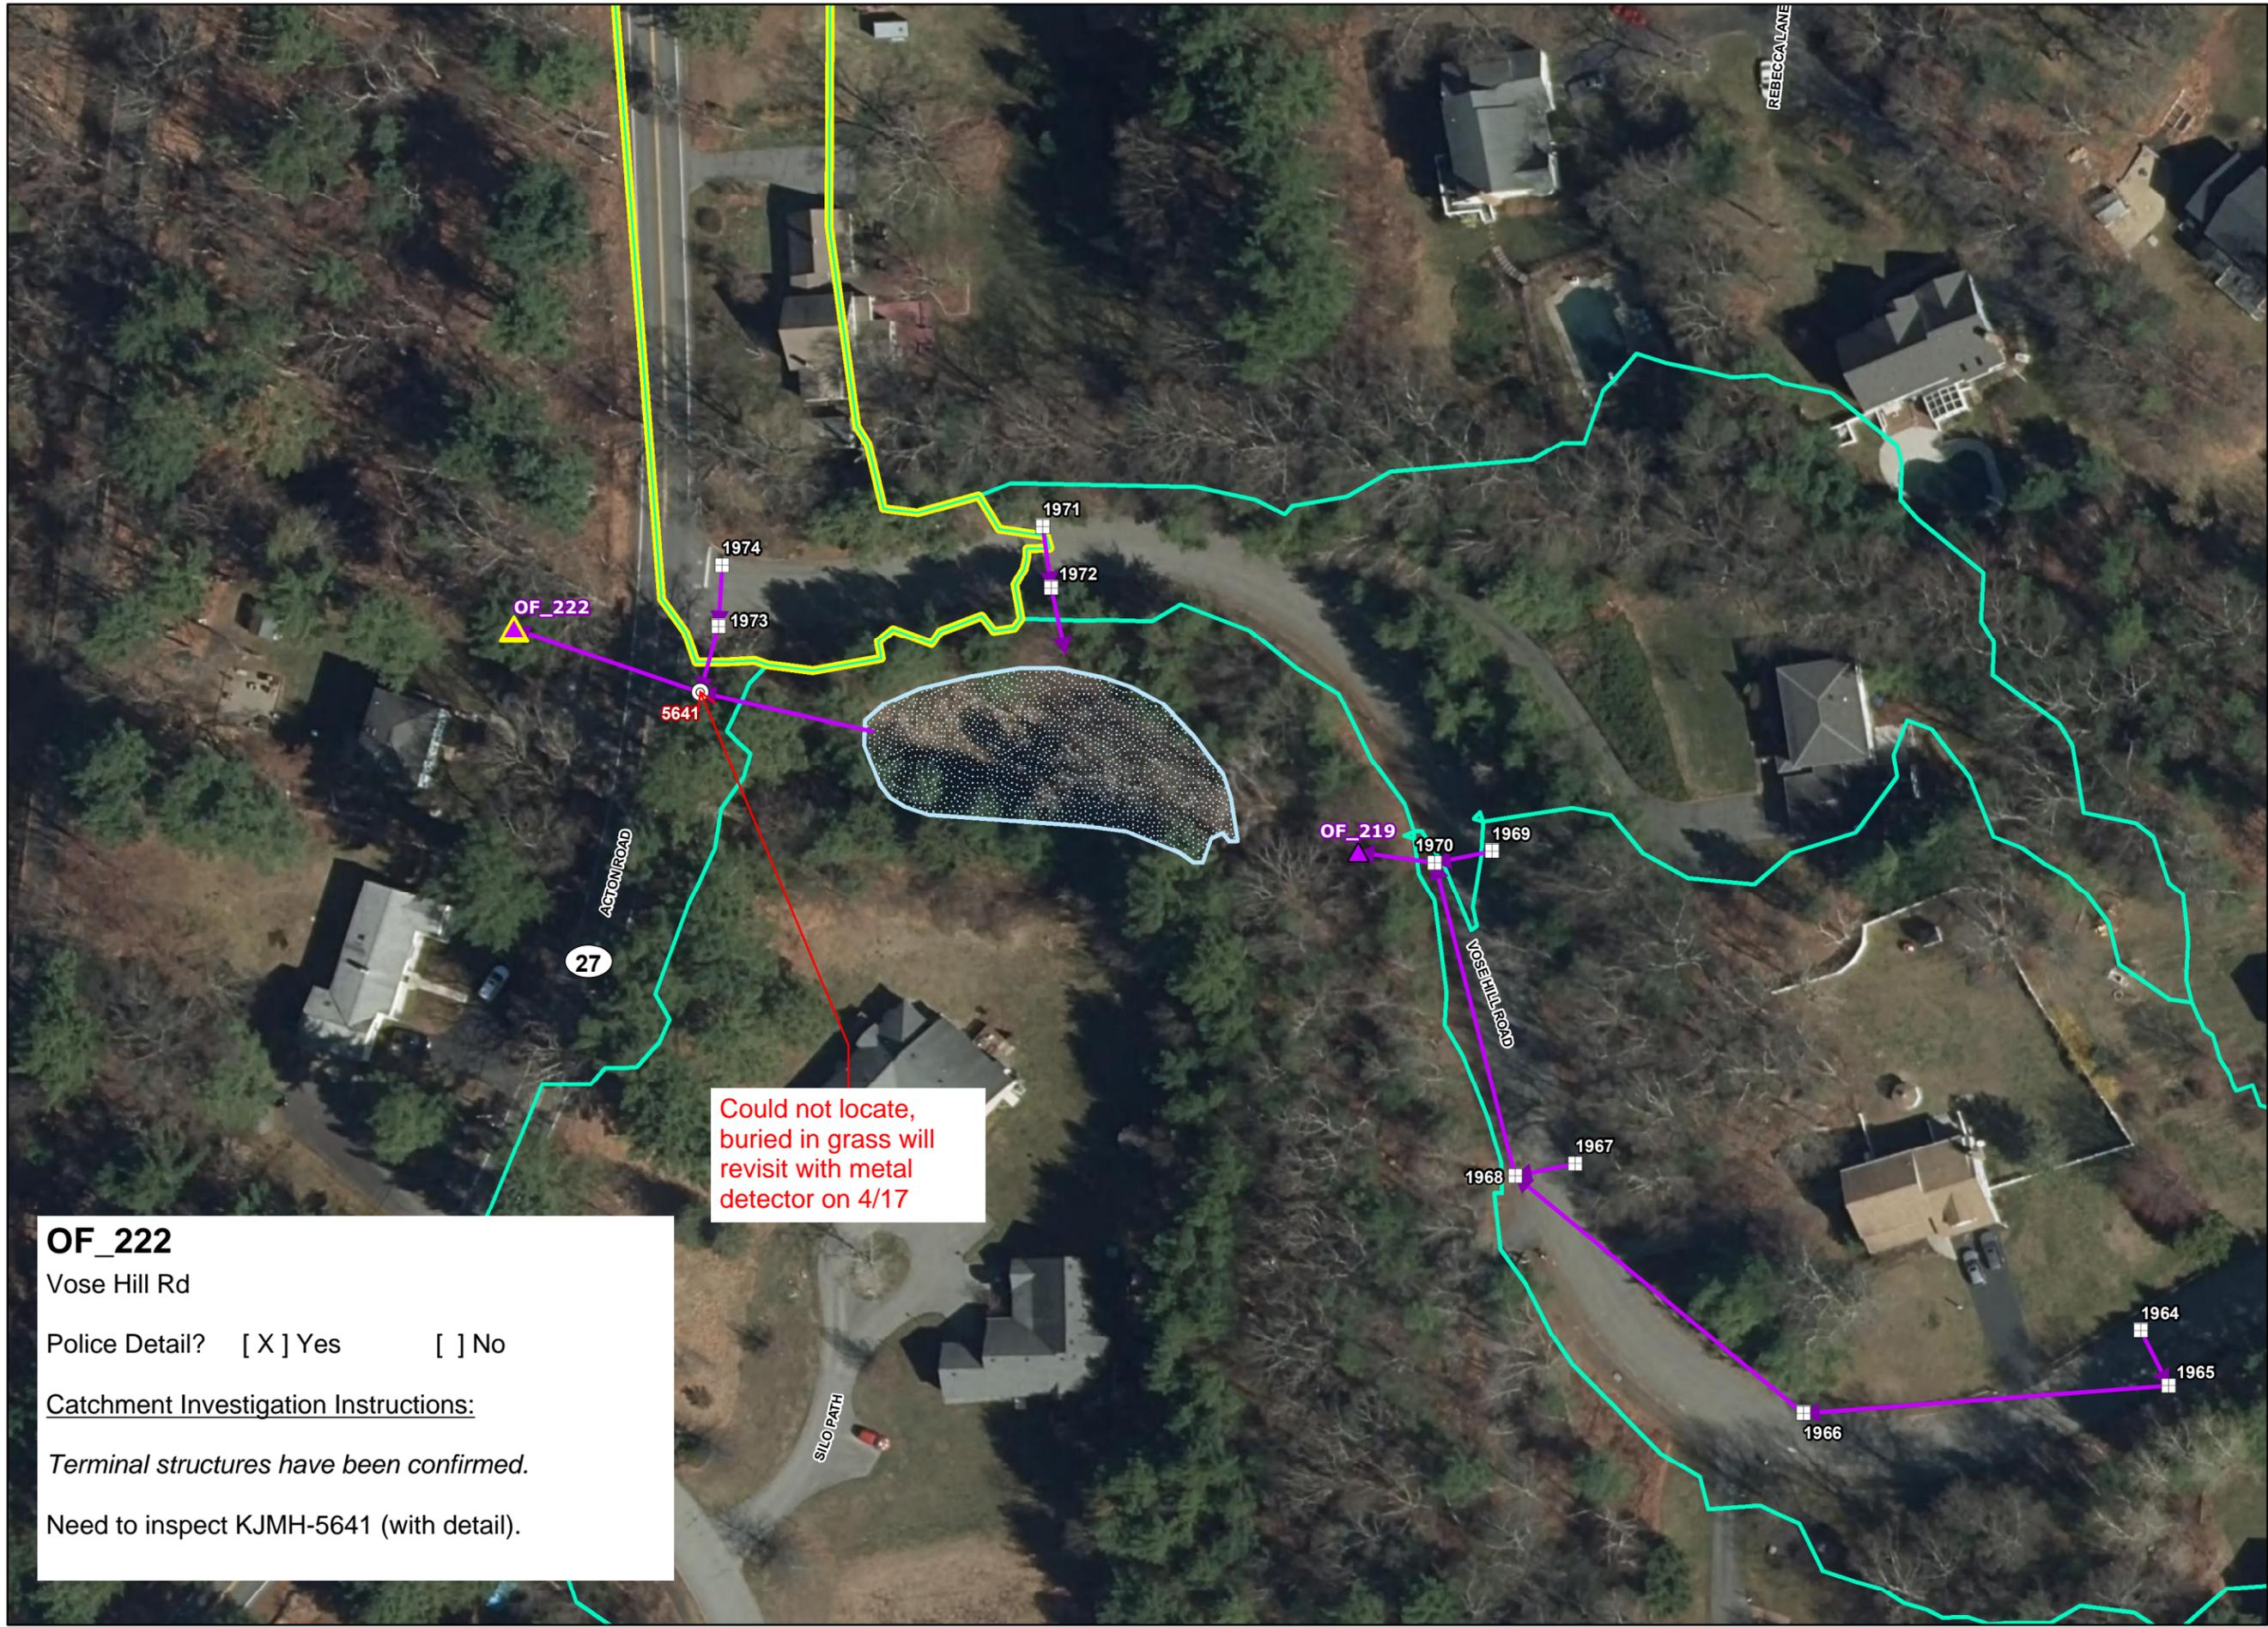
Could not locate, buried in grass will revisit with metal detector on 4/17

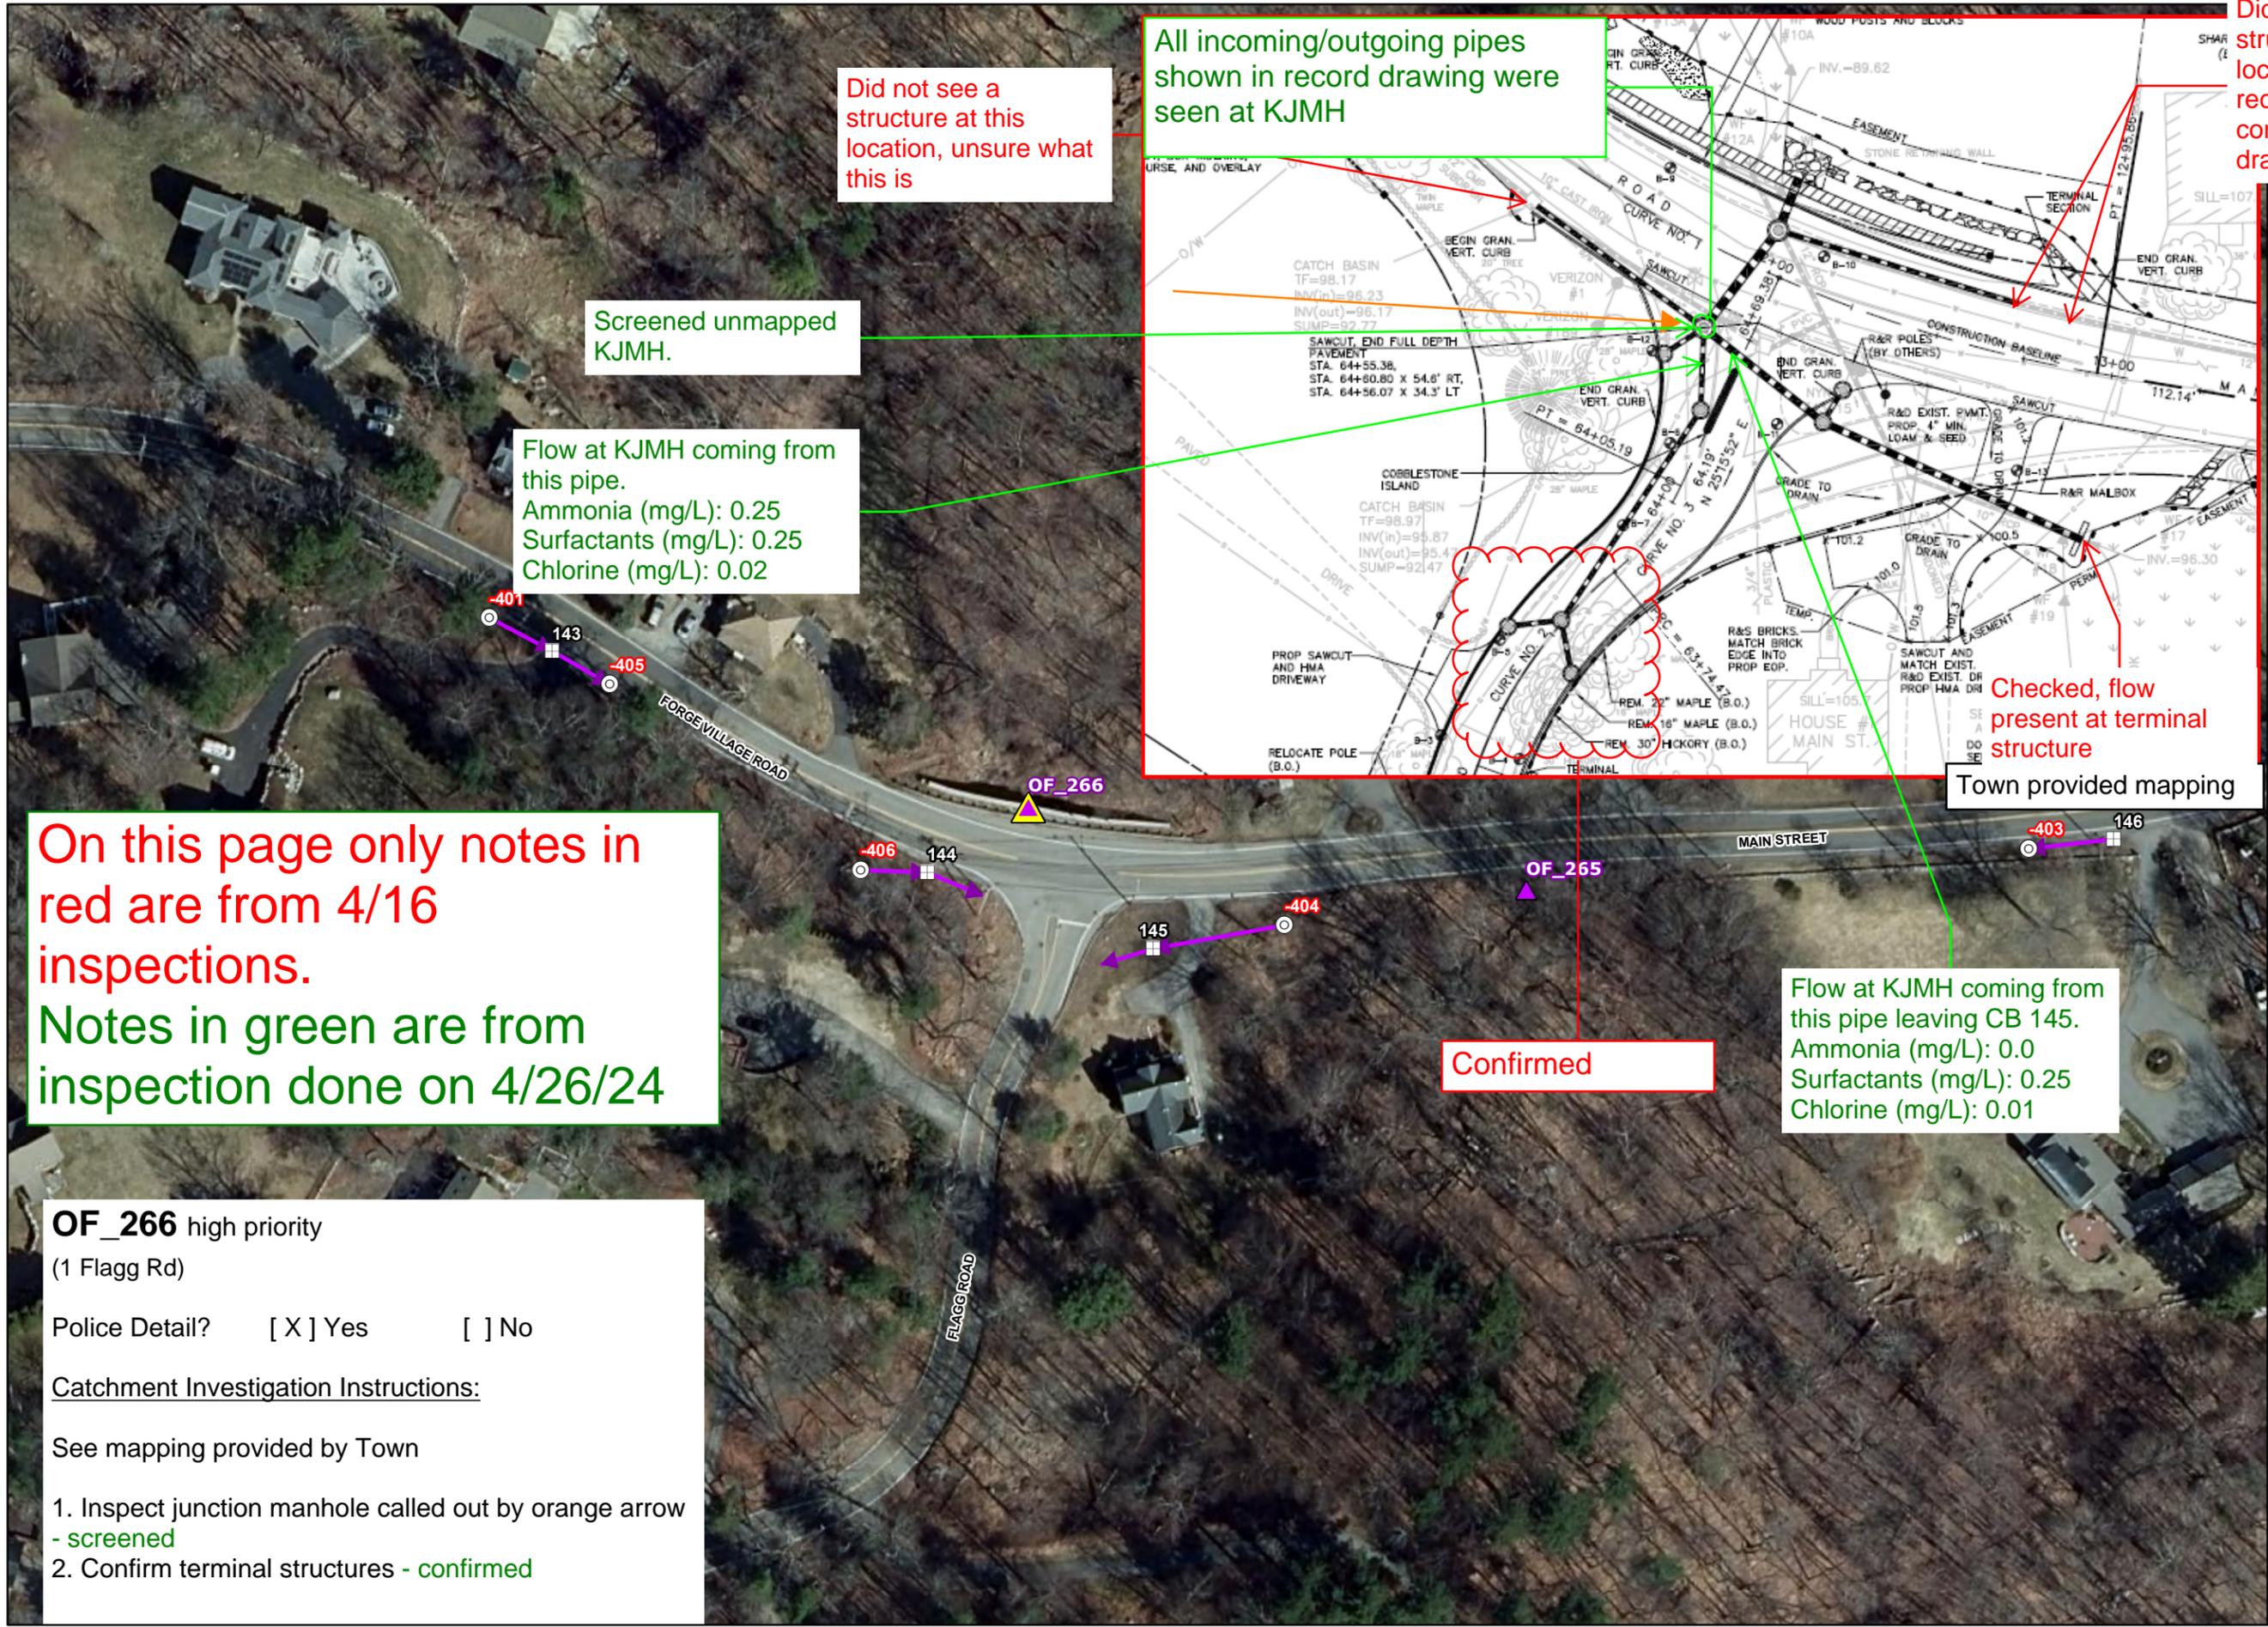
Did not see a structure at this location, unsure what this is

All incoming/outgoing pipes shown in record drawing were seen at KJMH

Did not see a structure at this location. Based on record drawings connects to existing drainage

Screened unmapped KJMH.

Flow at KJMH coming from this pipe.
 Ammonia (mg/L): 0.25
 Surfactants (mg/L): 0.25
 Chlorine (mg/L): 0.02

Checked, flow present at terminal structure
 Town provided mapping

Confirmed

Flow at KJMH coming from this pipe leaving CB 145.
 Ammonia (mg/L): 0.0
 Surfactants (mg/L): 0.25
 Chlorine (mg/L): 0.01

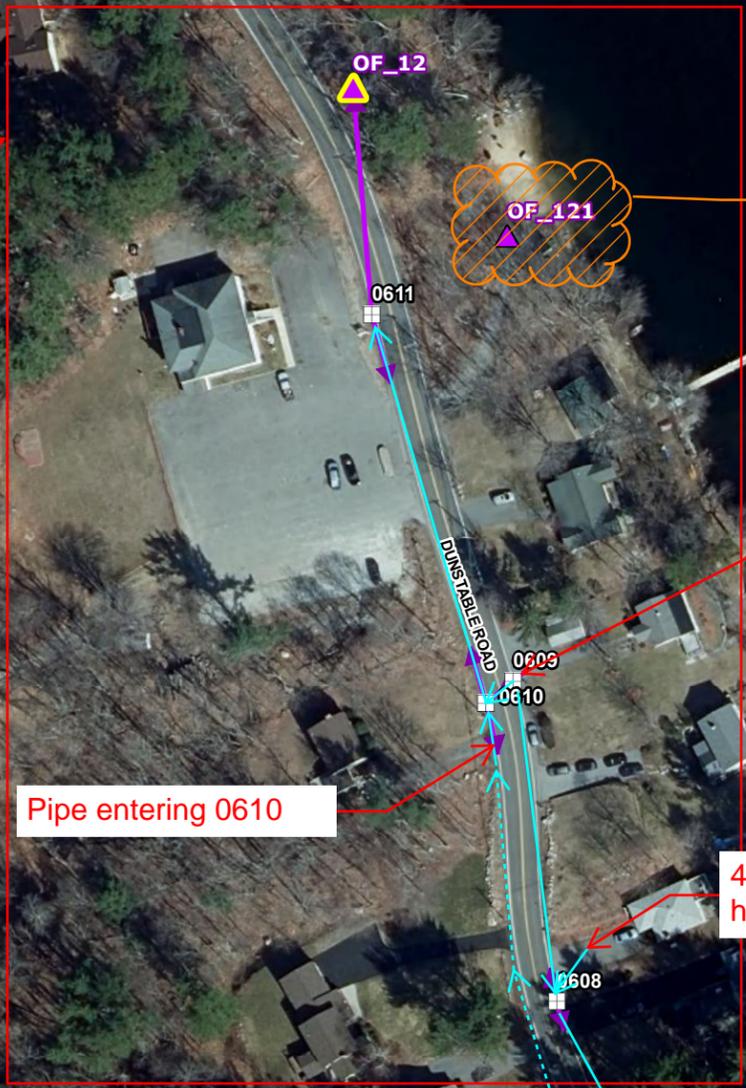
Dry weather catchment investigation not needed for OF_121.

No inlet pipe in this CB besides the outgoing pipe to 0610.

Pipe entering 0610

4" PVC coming from house

12" CMP leaving CB

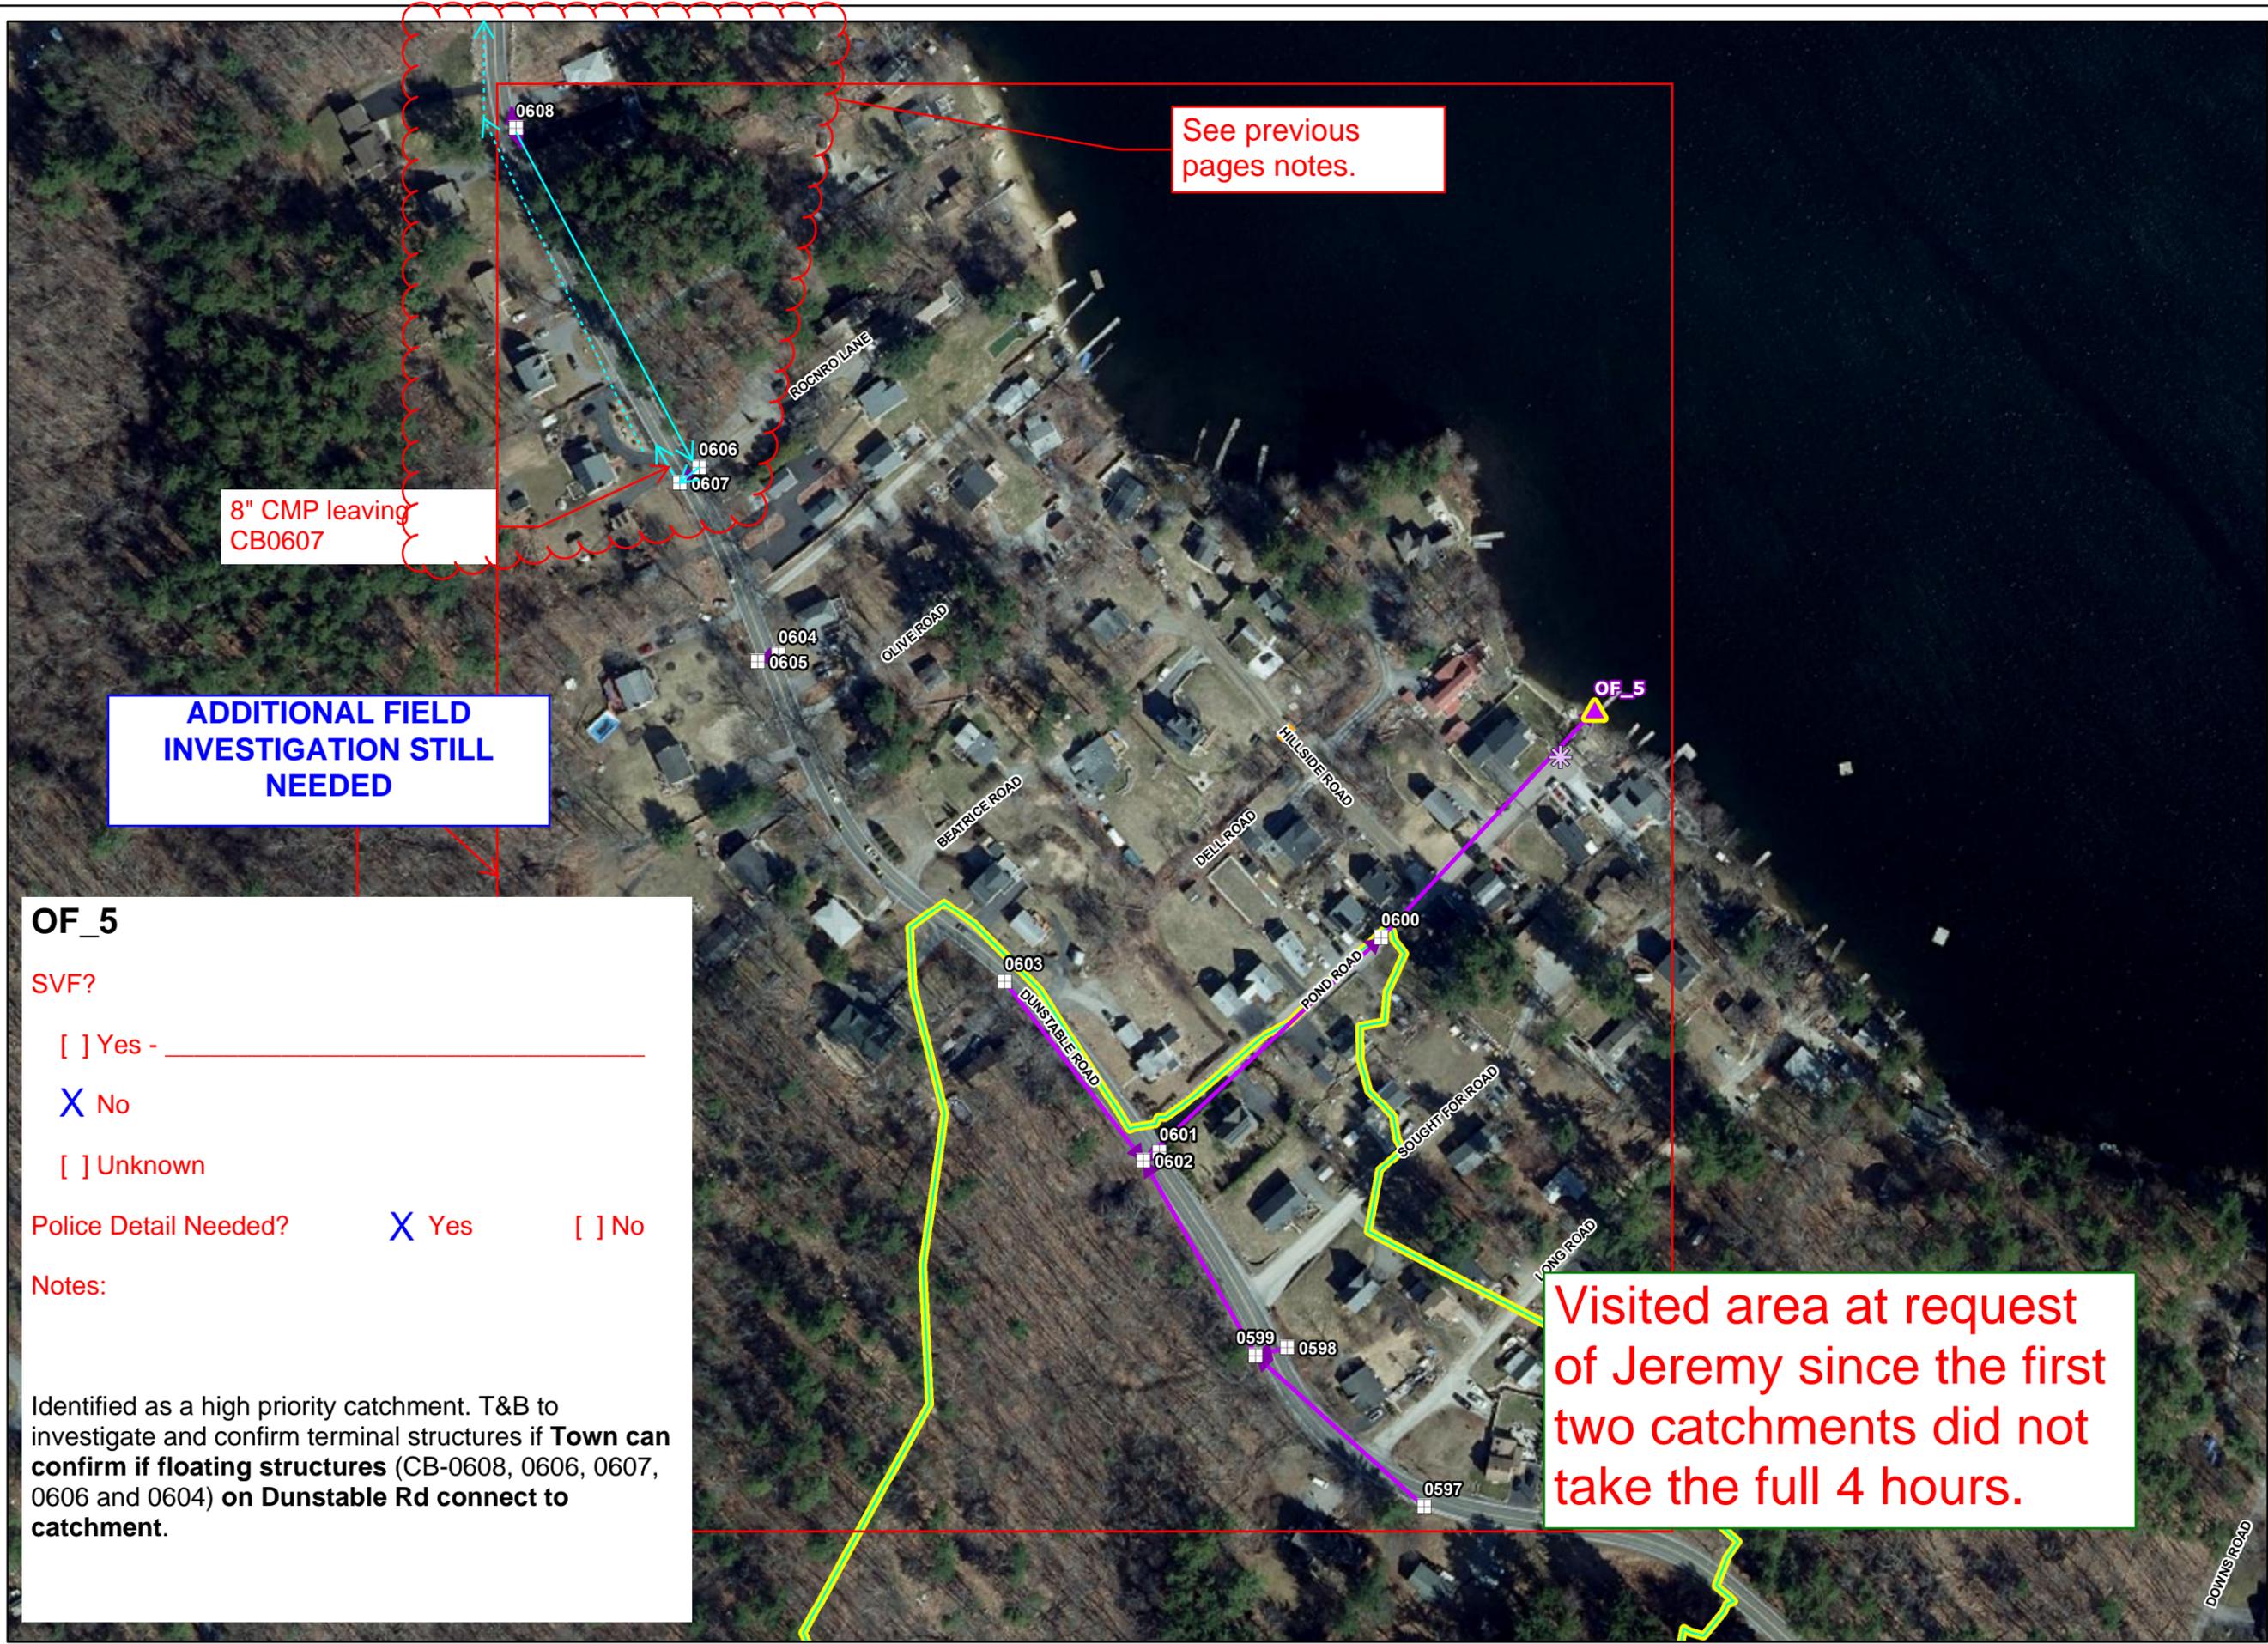
See previous pages notes.

8" CMP leaving CB0607

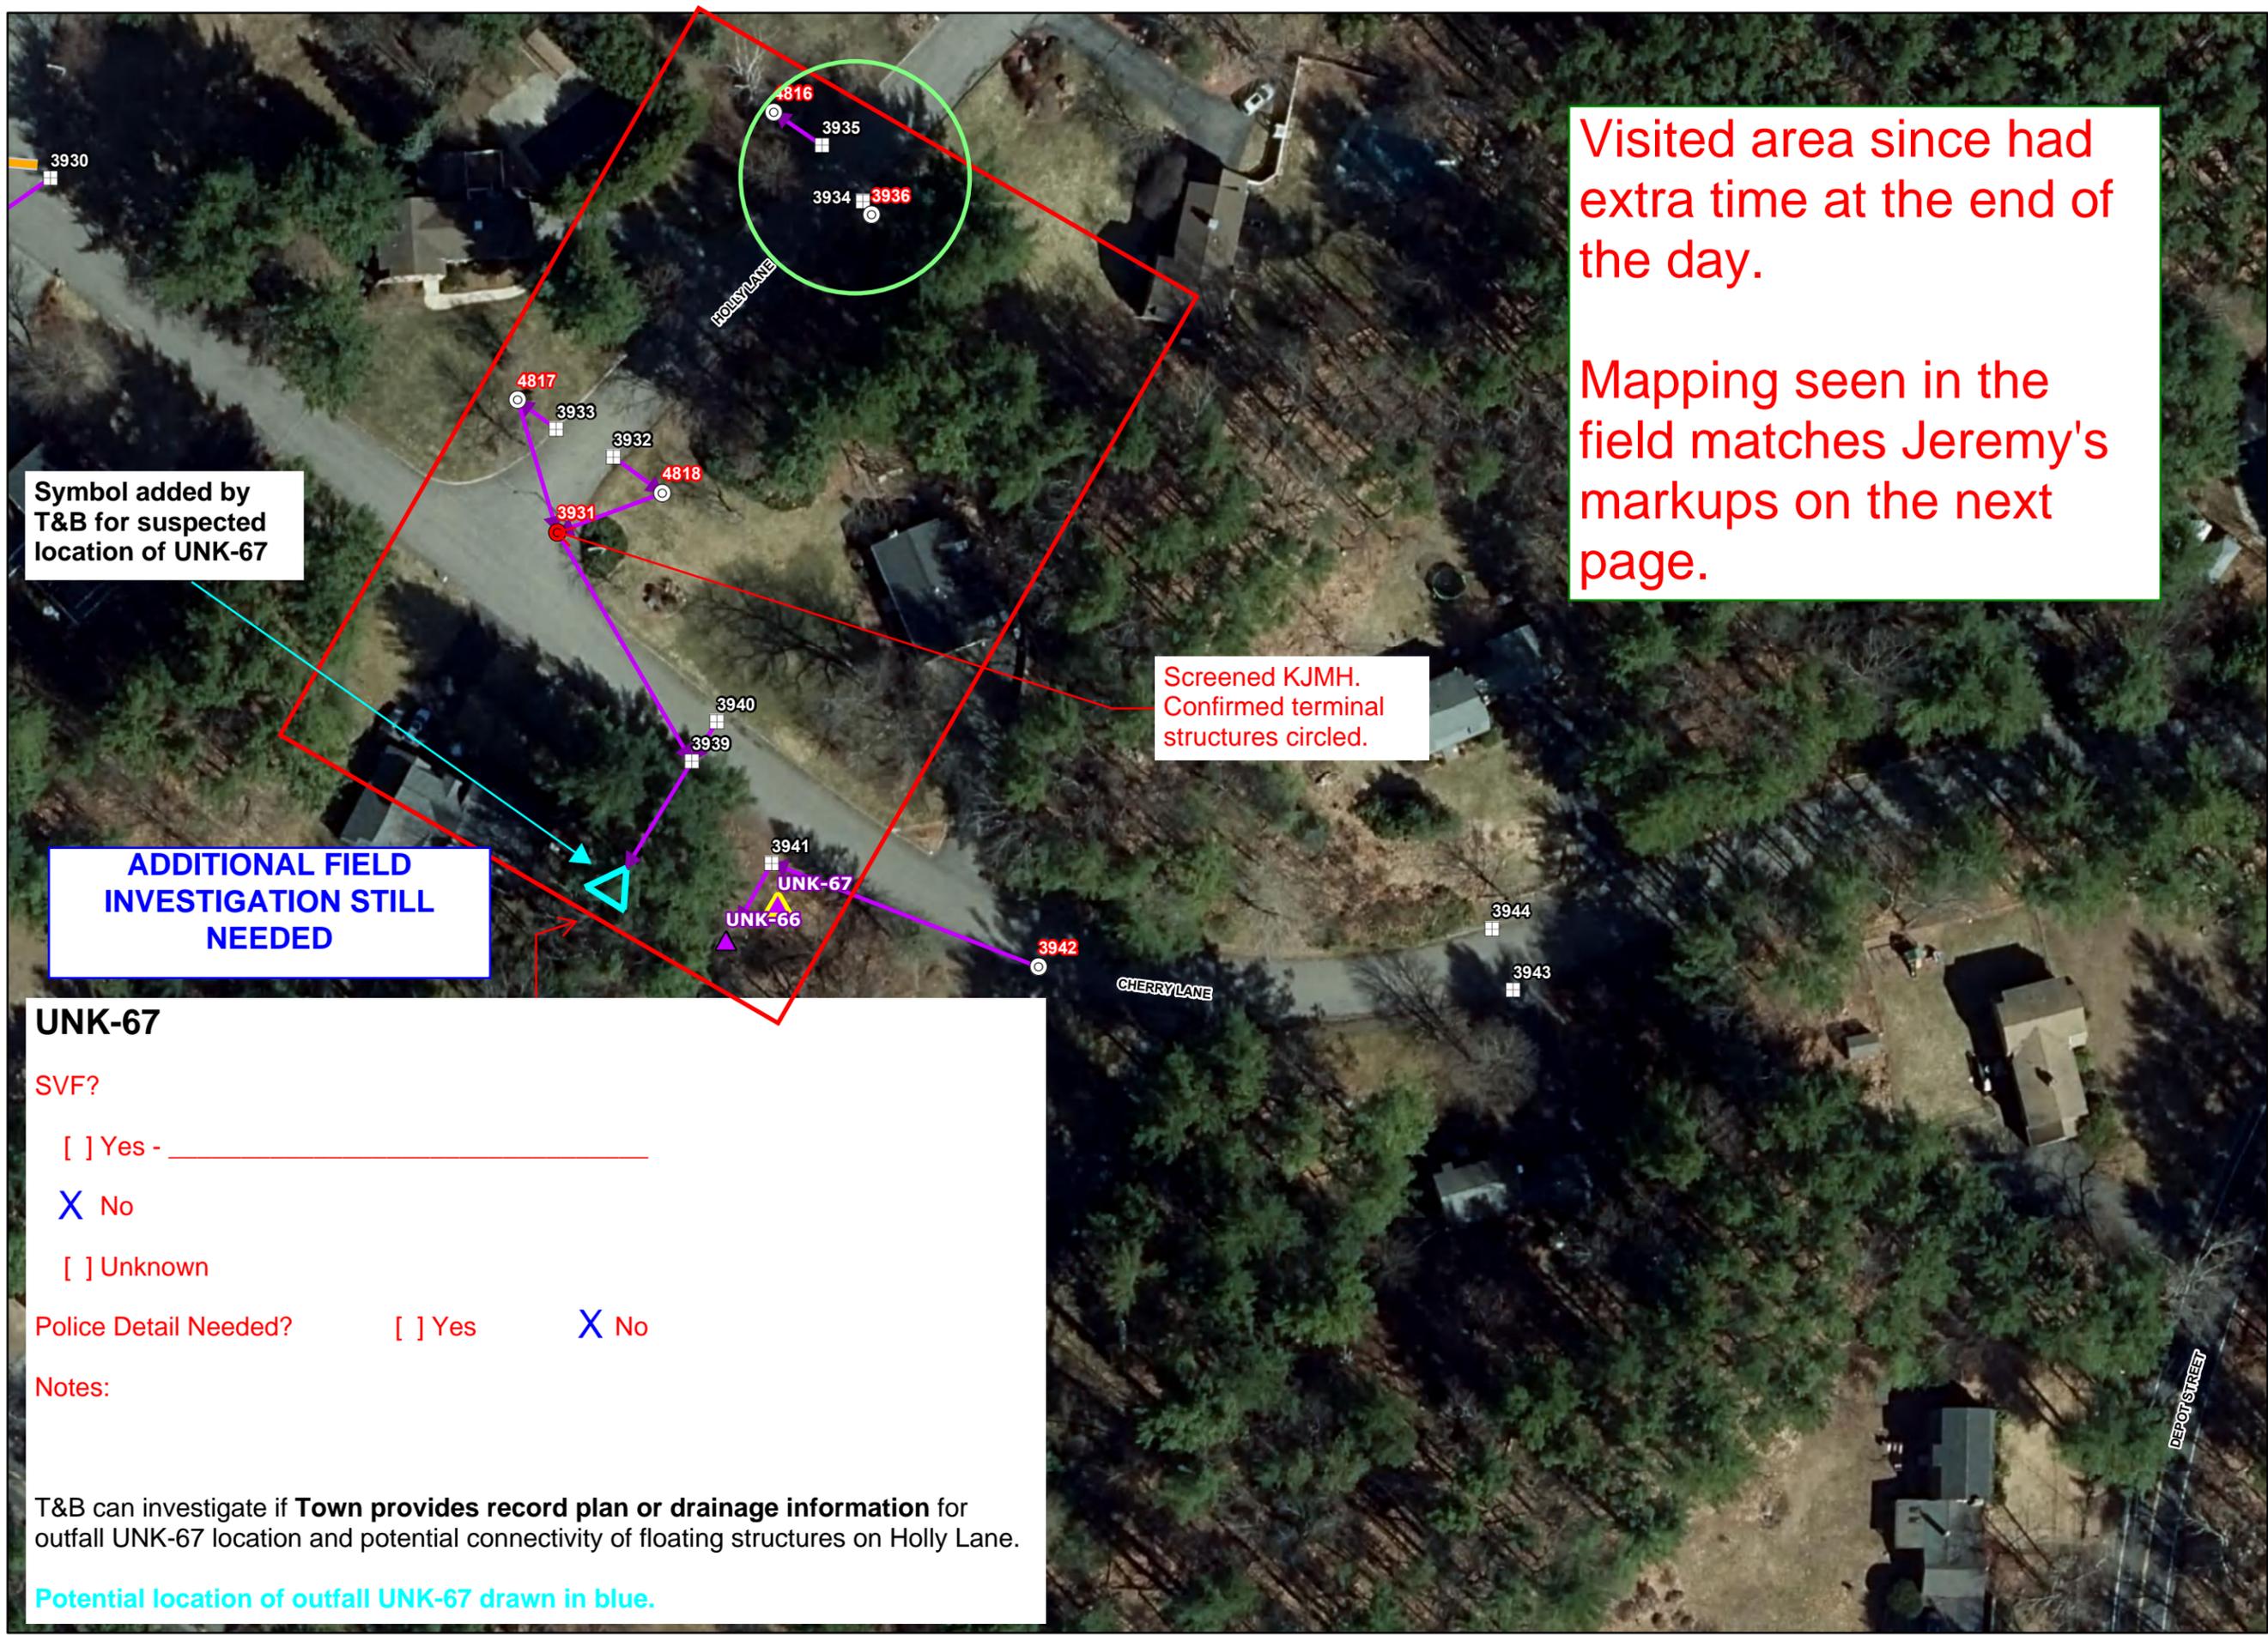
Symbol added by T&B for suspected location of UNK-67

Visited area since had extra time at the end of the day.

Mapping seen in the field matches Jeremy's markups on the next page.

Screened KJMH. Confirmed terminal structures circled.

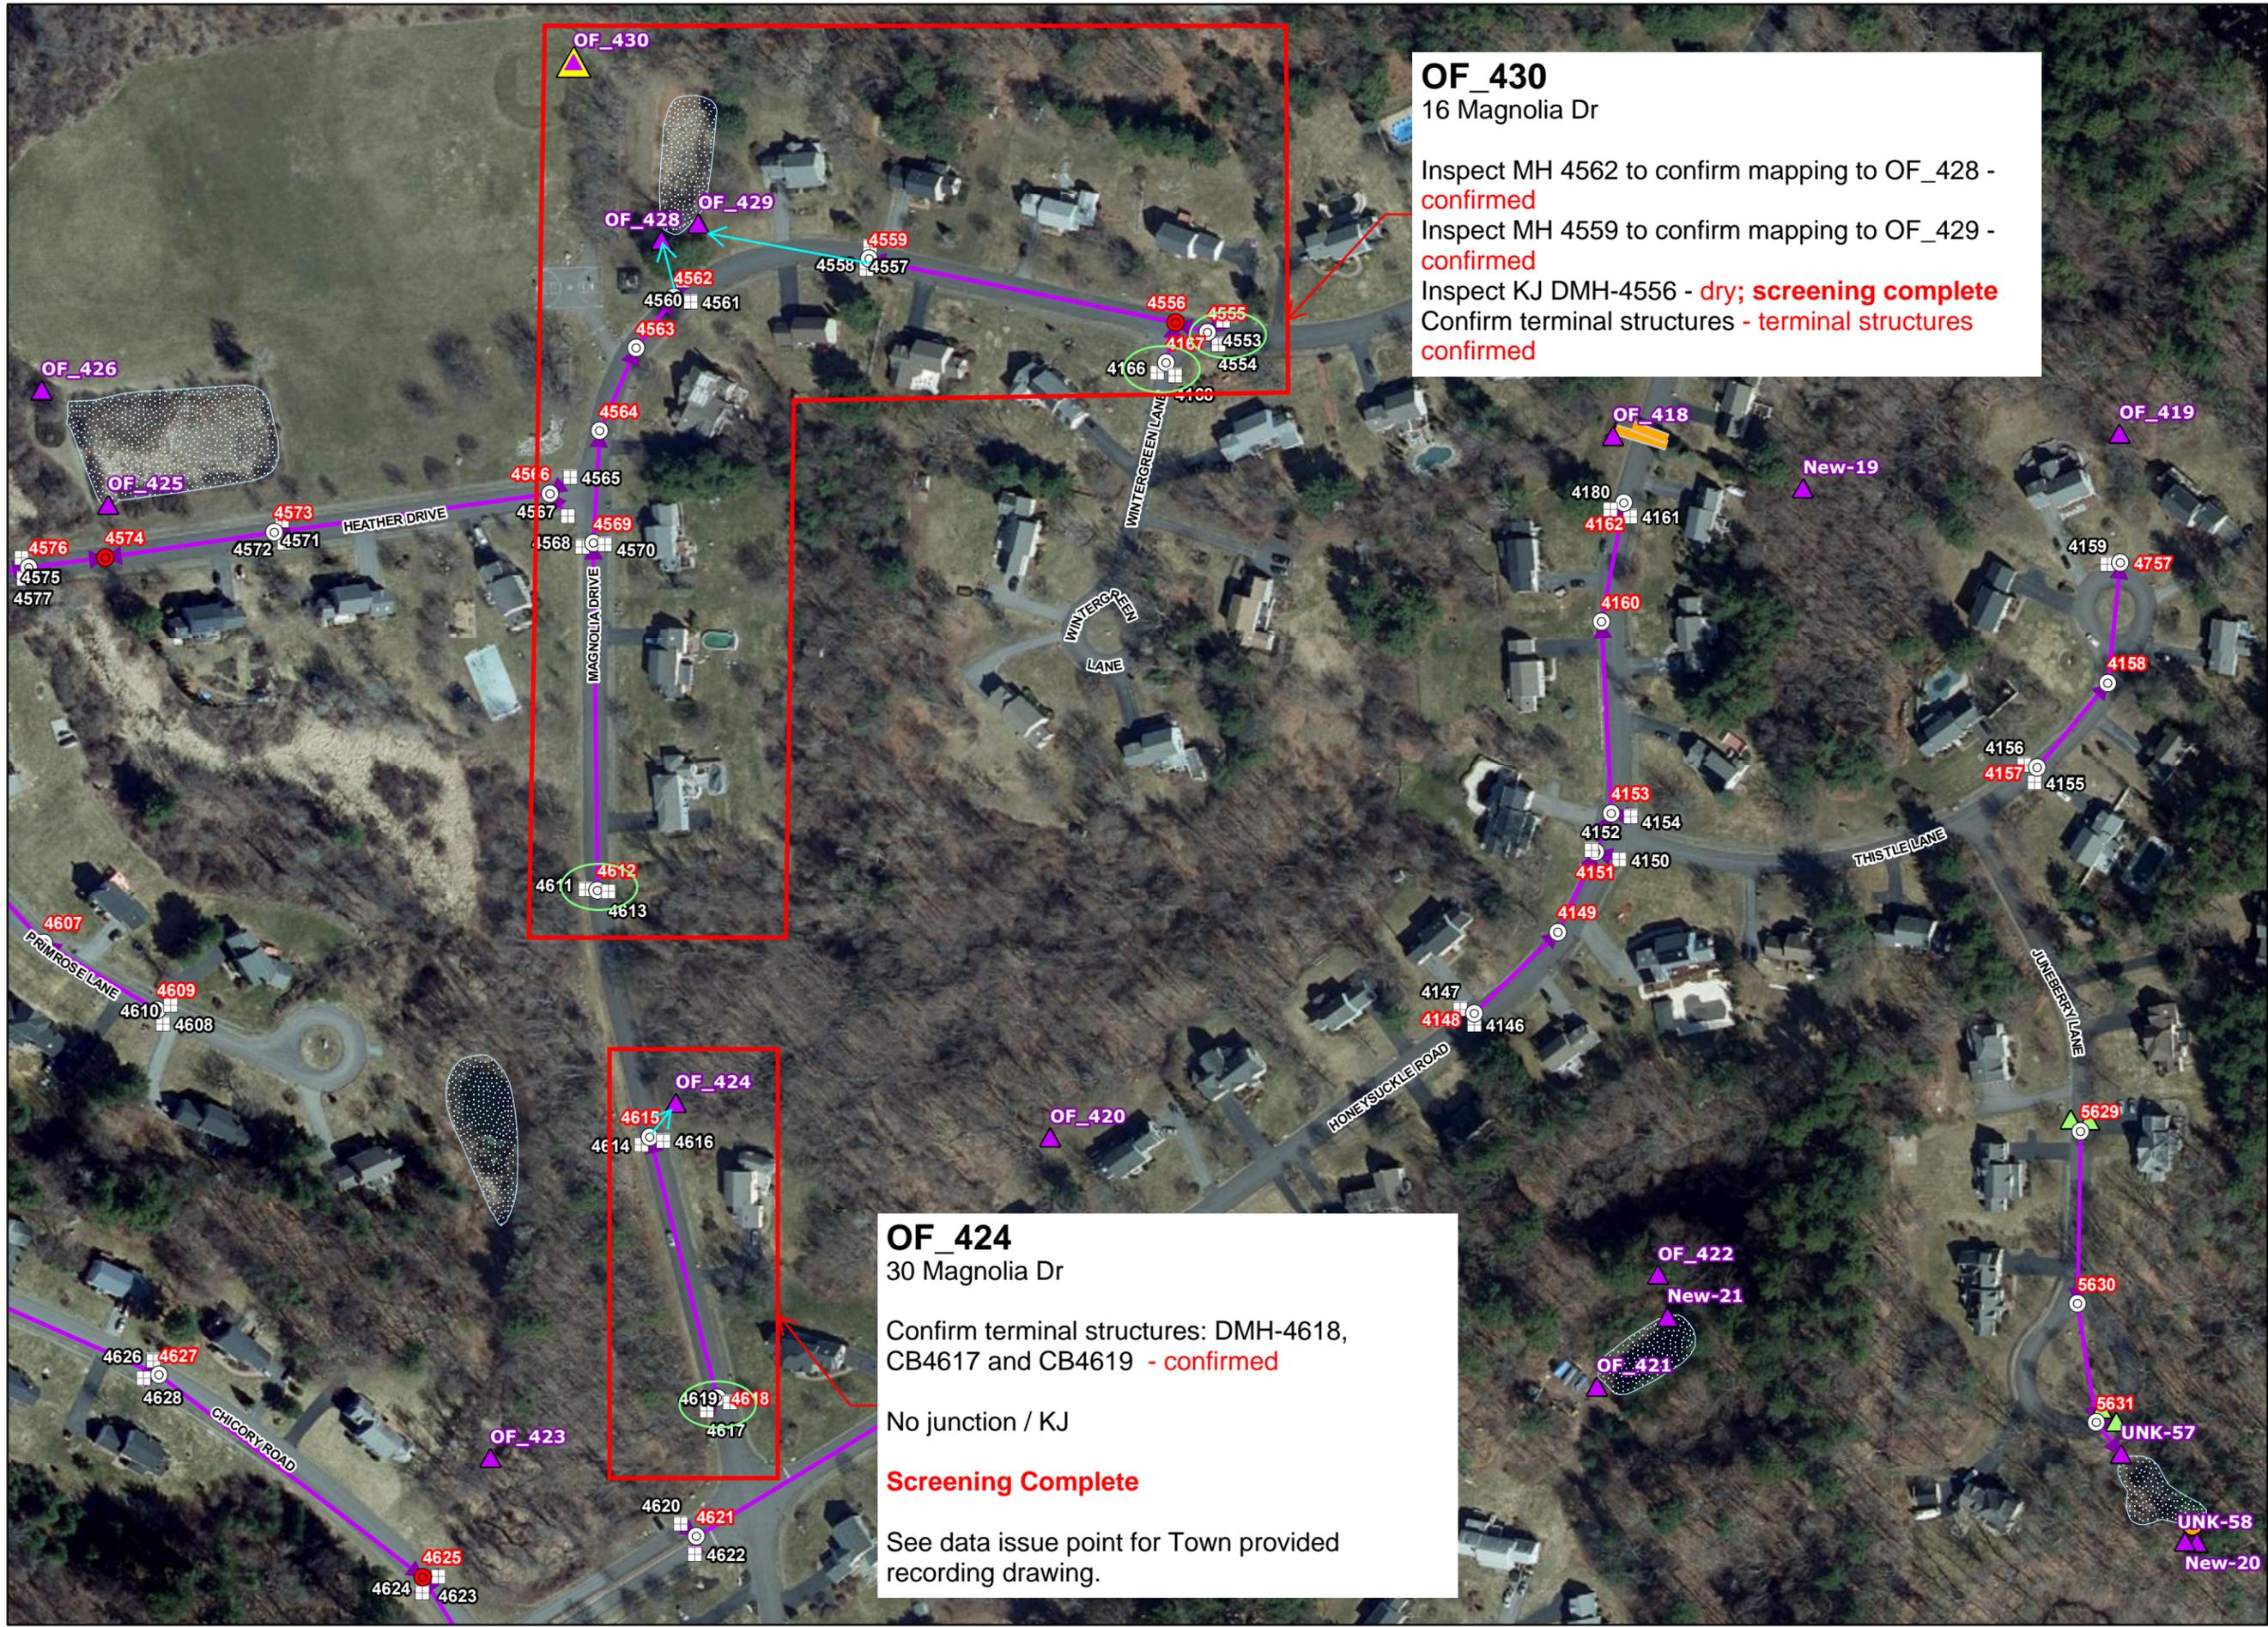
OF_430
 16 Magnolia Dr

Inspect MH 4562 to confirm mapping to OF_428 - **confirmed**
 Inspect MH 4559 to confirm mapping to OF_429 - **confirmed**
 Inspect KJ DMH-4556 - **dry; screening complete**
 Confirm terminal structures - **terminal structures confirmed**

OF_424
 30 Magnolia Dr

Confirm terminal structures: DMH-4618, CB4617 and CB4619 - **confirmed**

No junction / KJ

Screening Complete

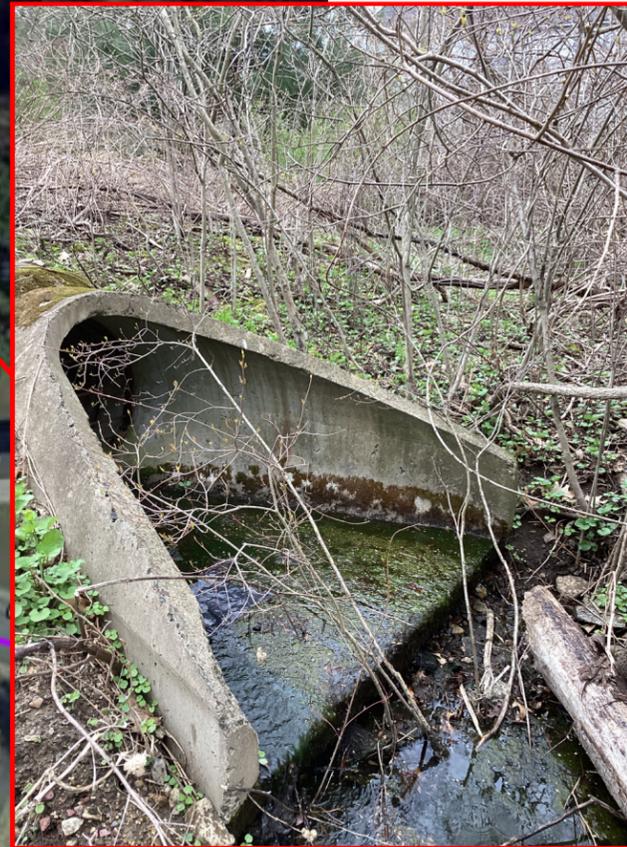
Unmapped outfall located and flow was present.

Flow present leaving DMH going to OF.

Unmapped Outfall - Located by LEP on 4/24/24 in the field
