CATCHMENT INVESTIGATIONS GROUP ONE

Catchment Area of Outfall: OF_206

**Westford, Massachusetts
November 2023**

Tighe & Bond

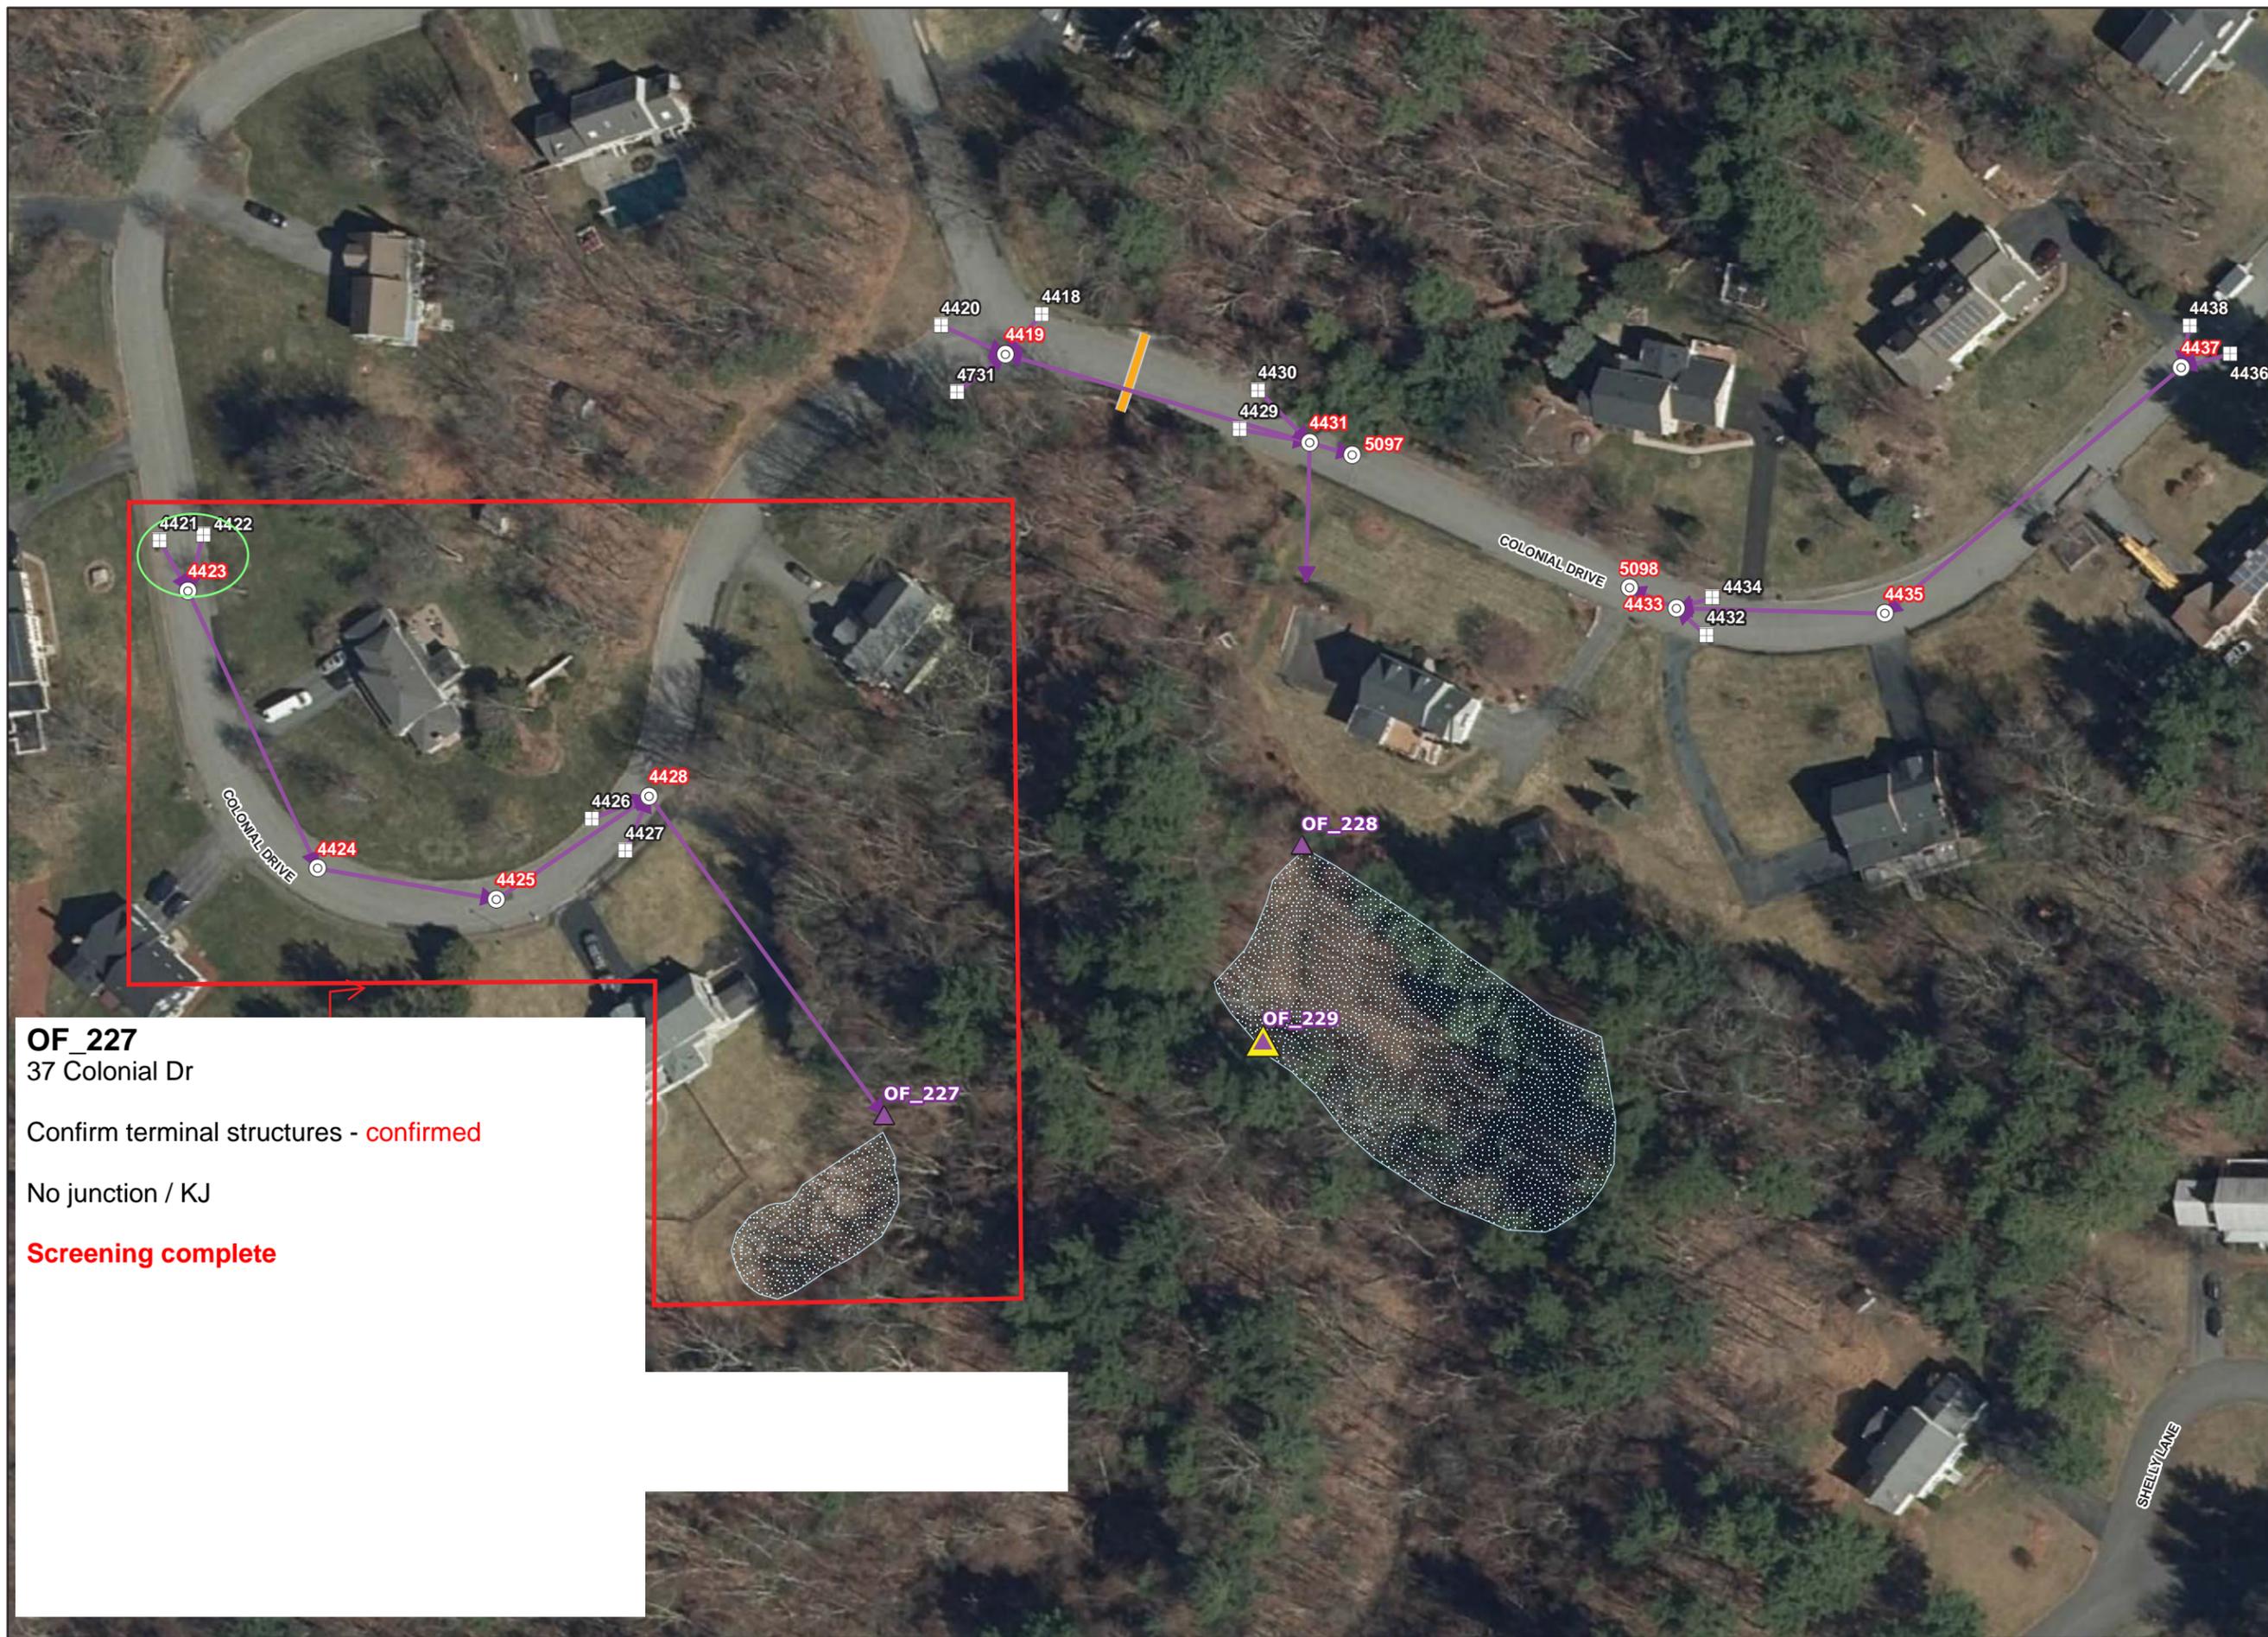
OF_227
37 Colonial Dr

Confirm terminal structures - **confirmed**

No junction / KJ

Screening complete

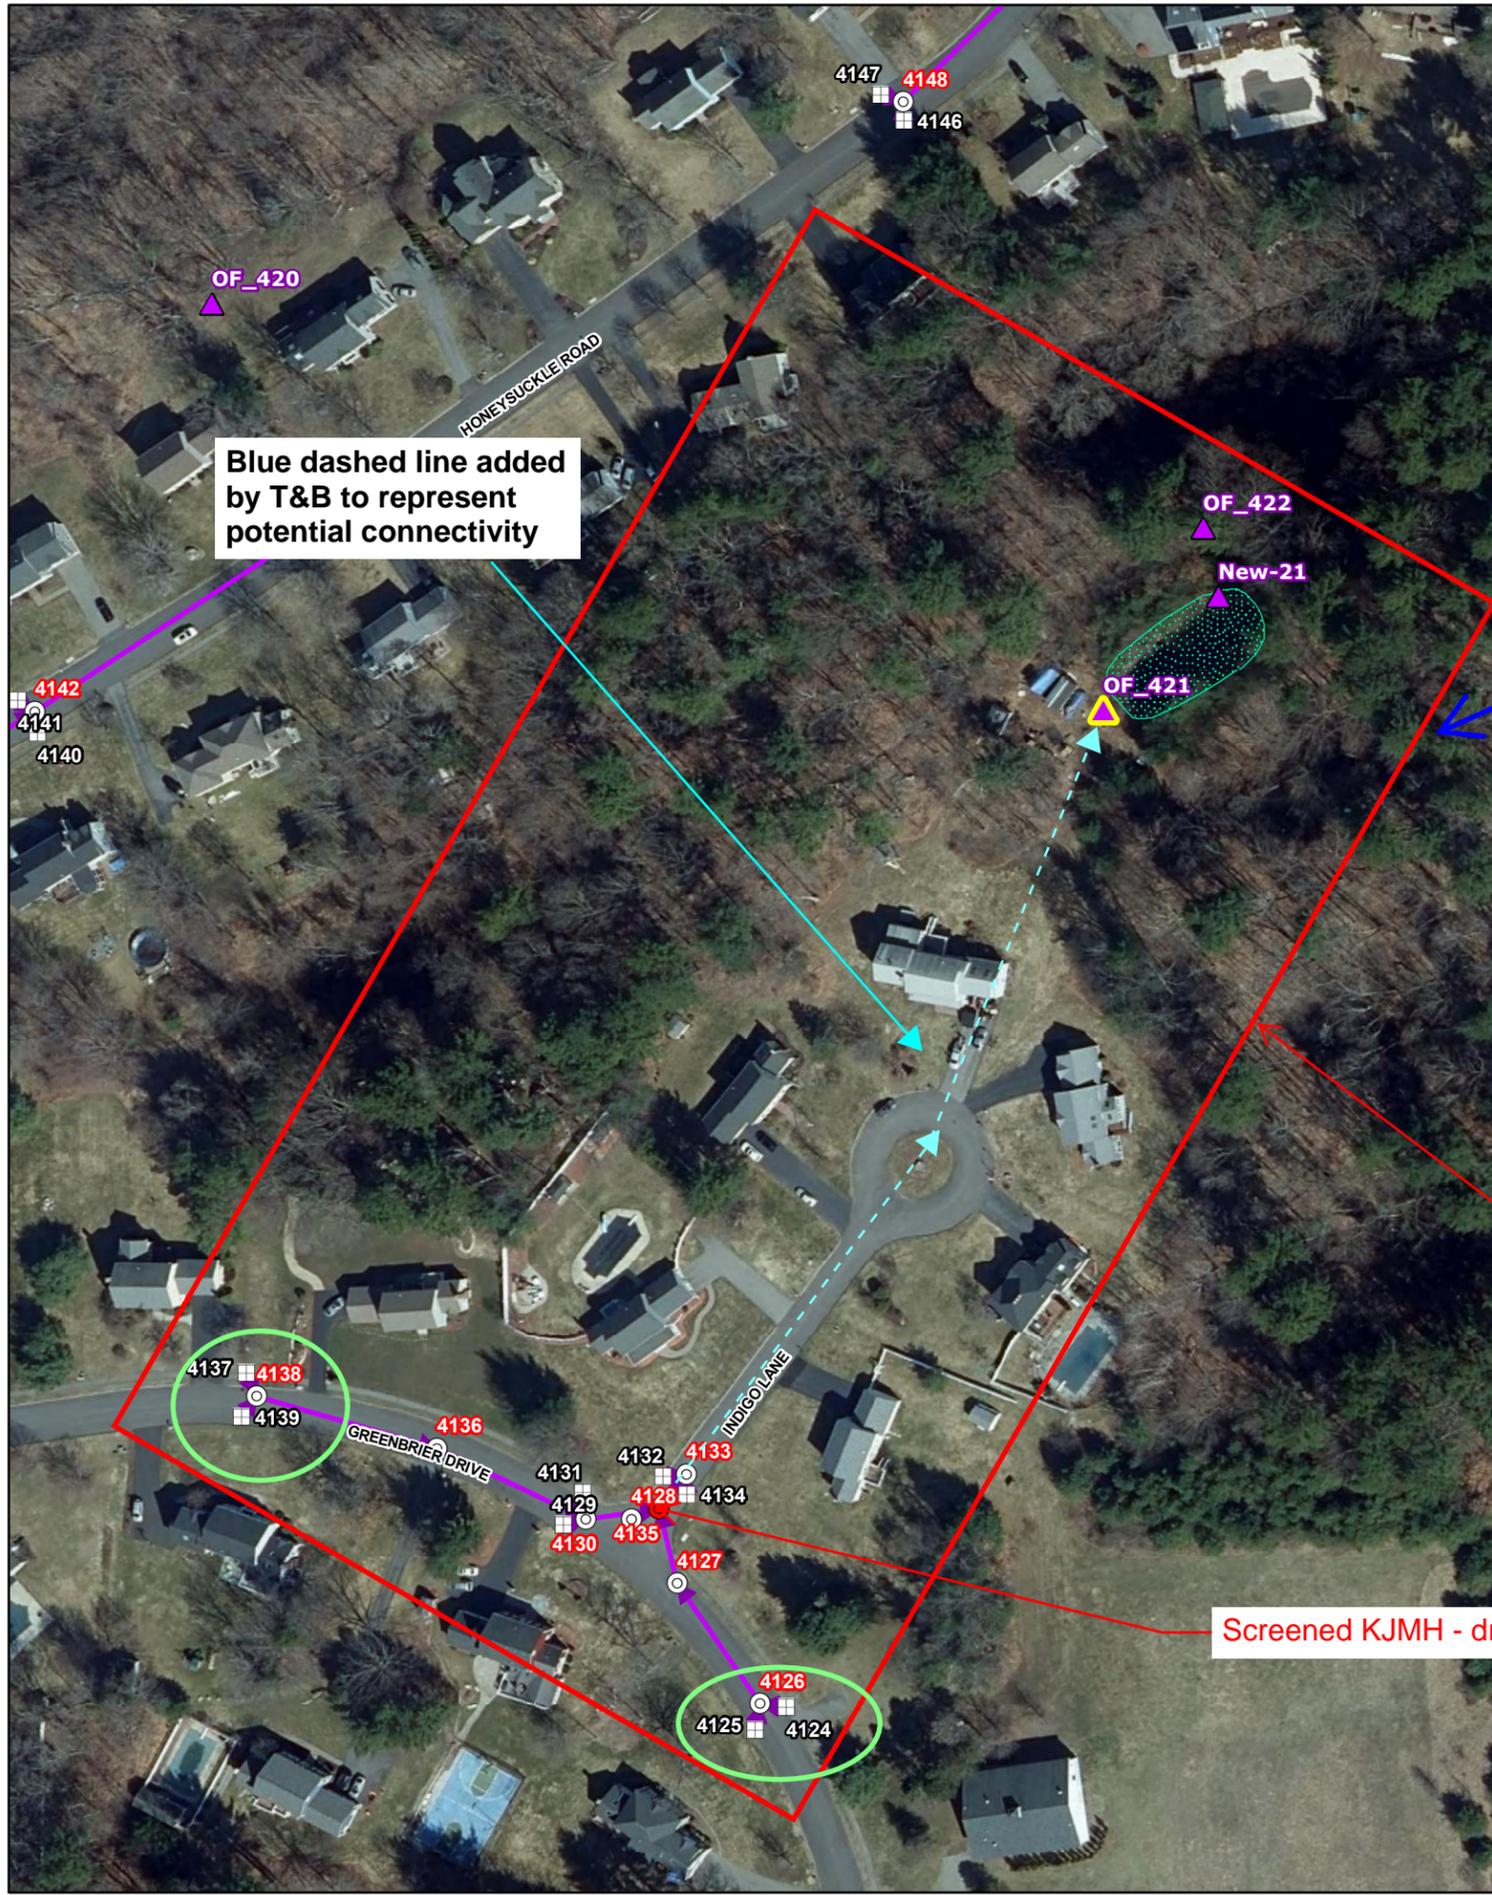
Blue dashed line added by T&B to represent potential connectivity

Screened KJMH - dry

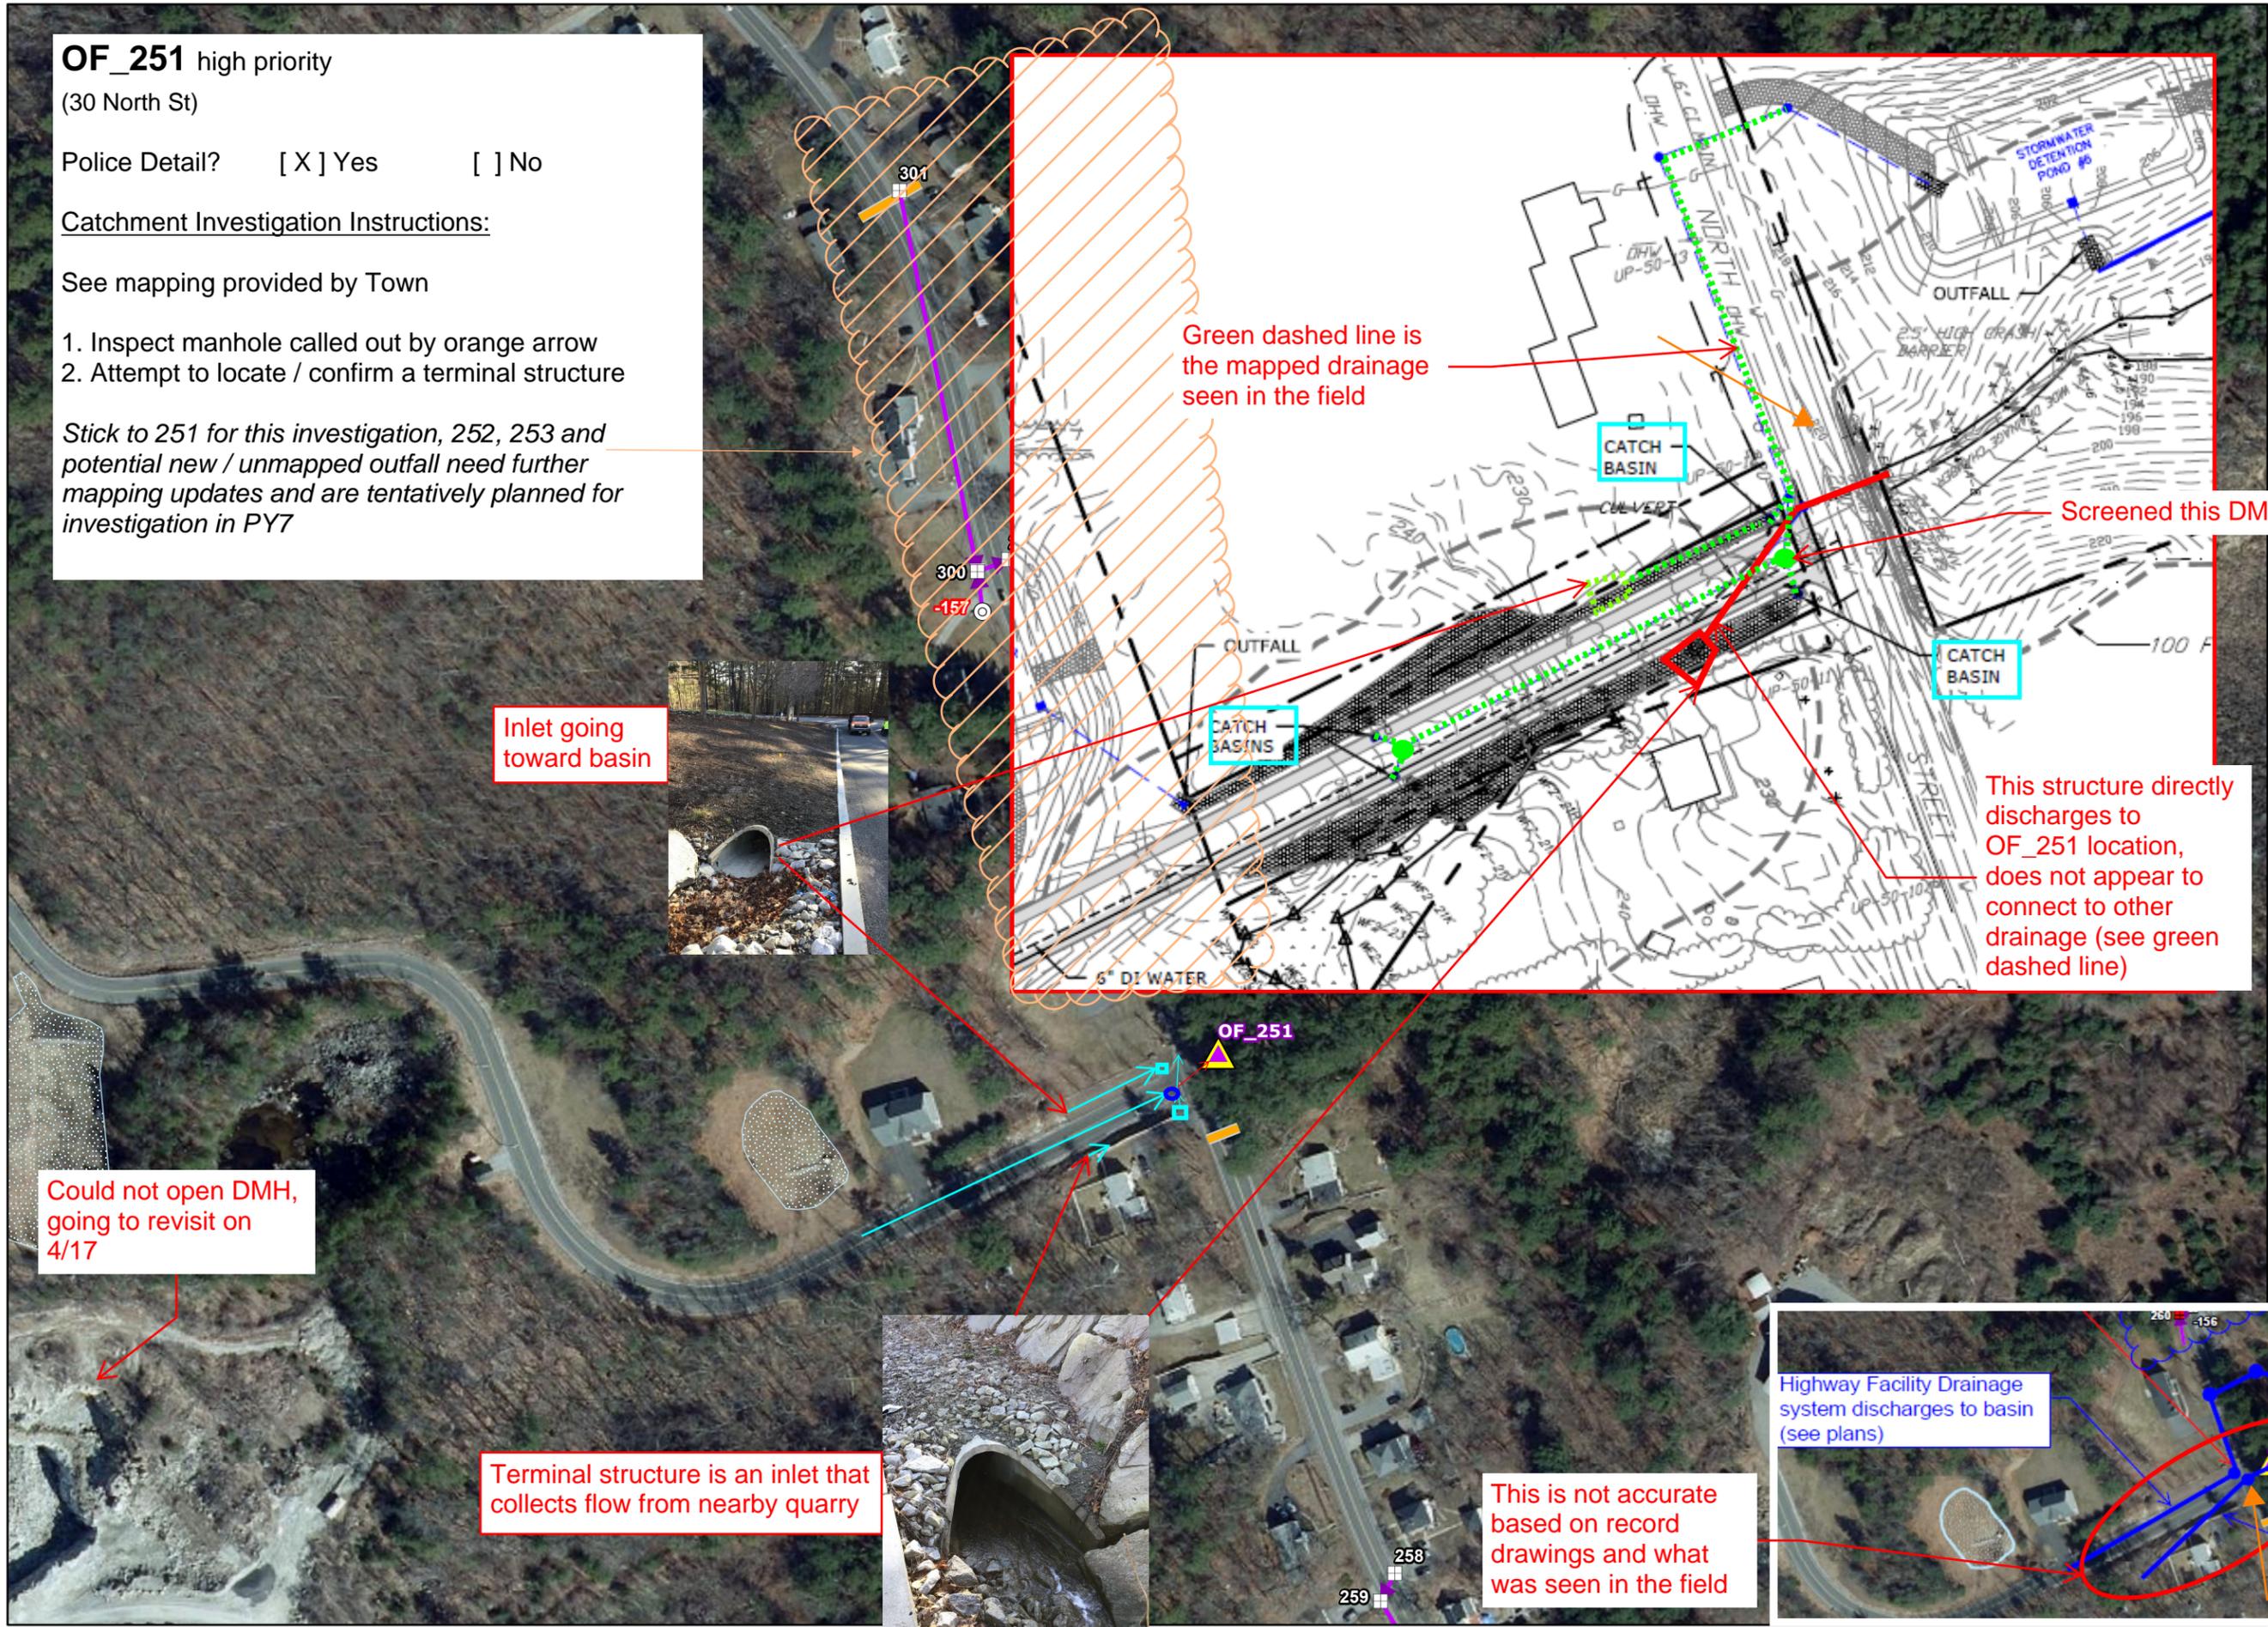
Inlet going toward basin

Could not open DMH, going to revisit on 4/17

Terminal structure is an inlet that collects flow from nearby quarry

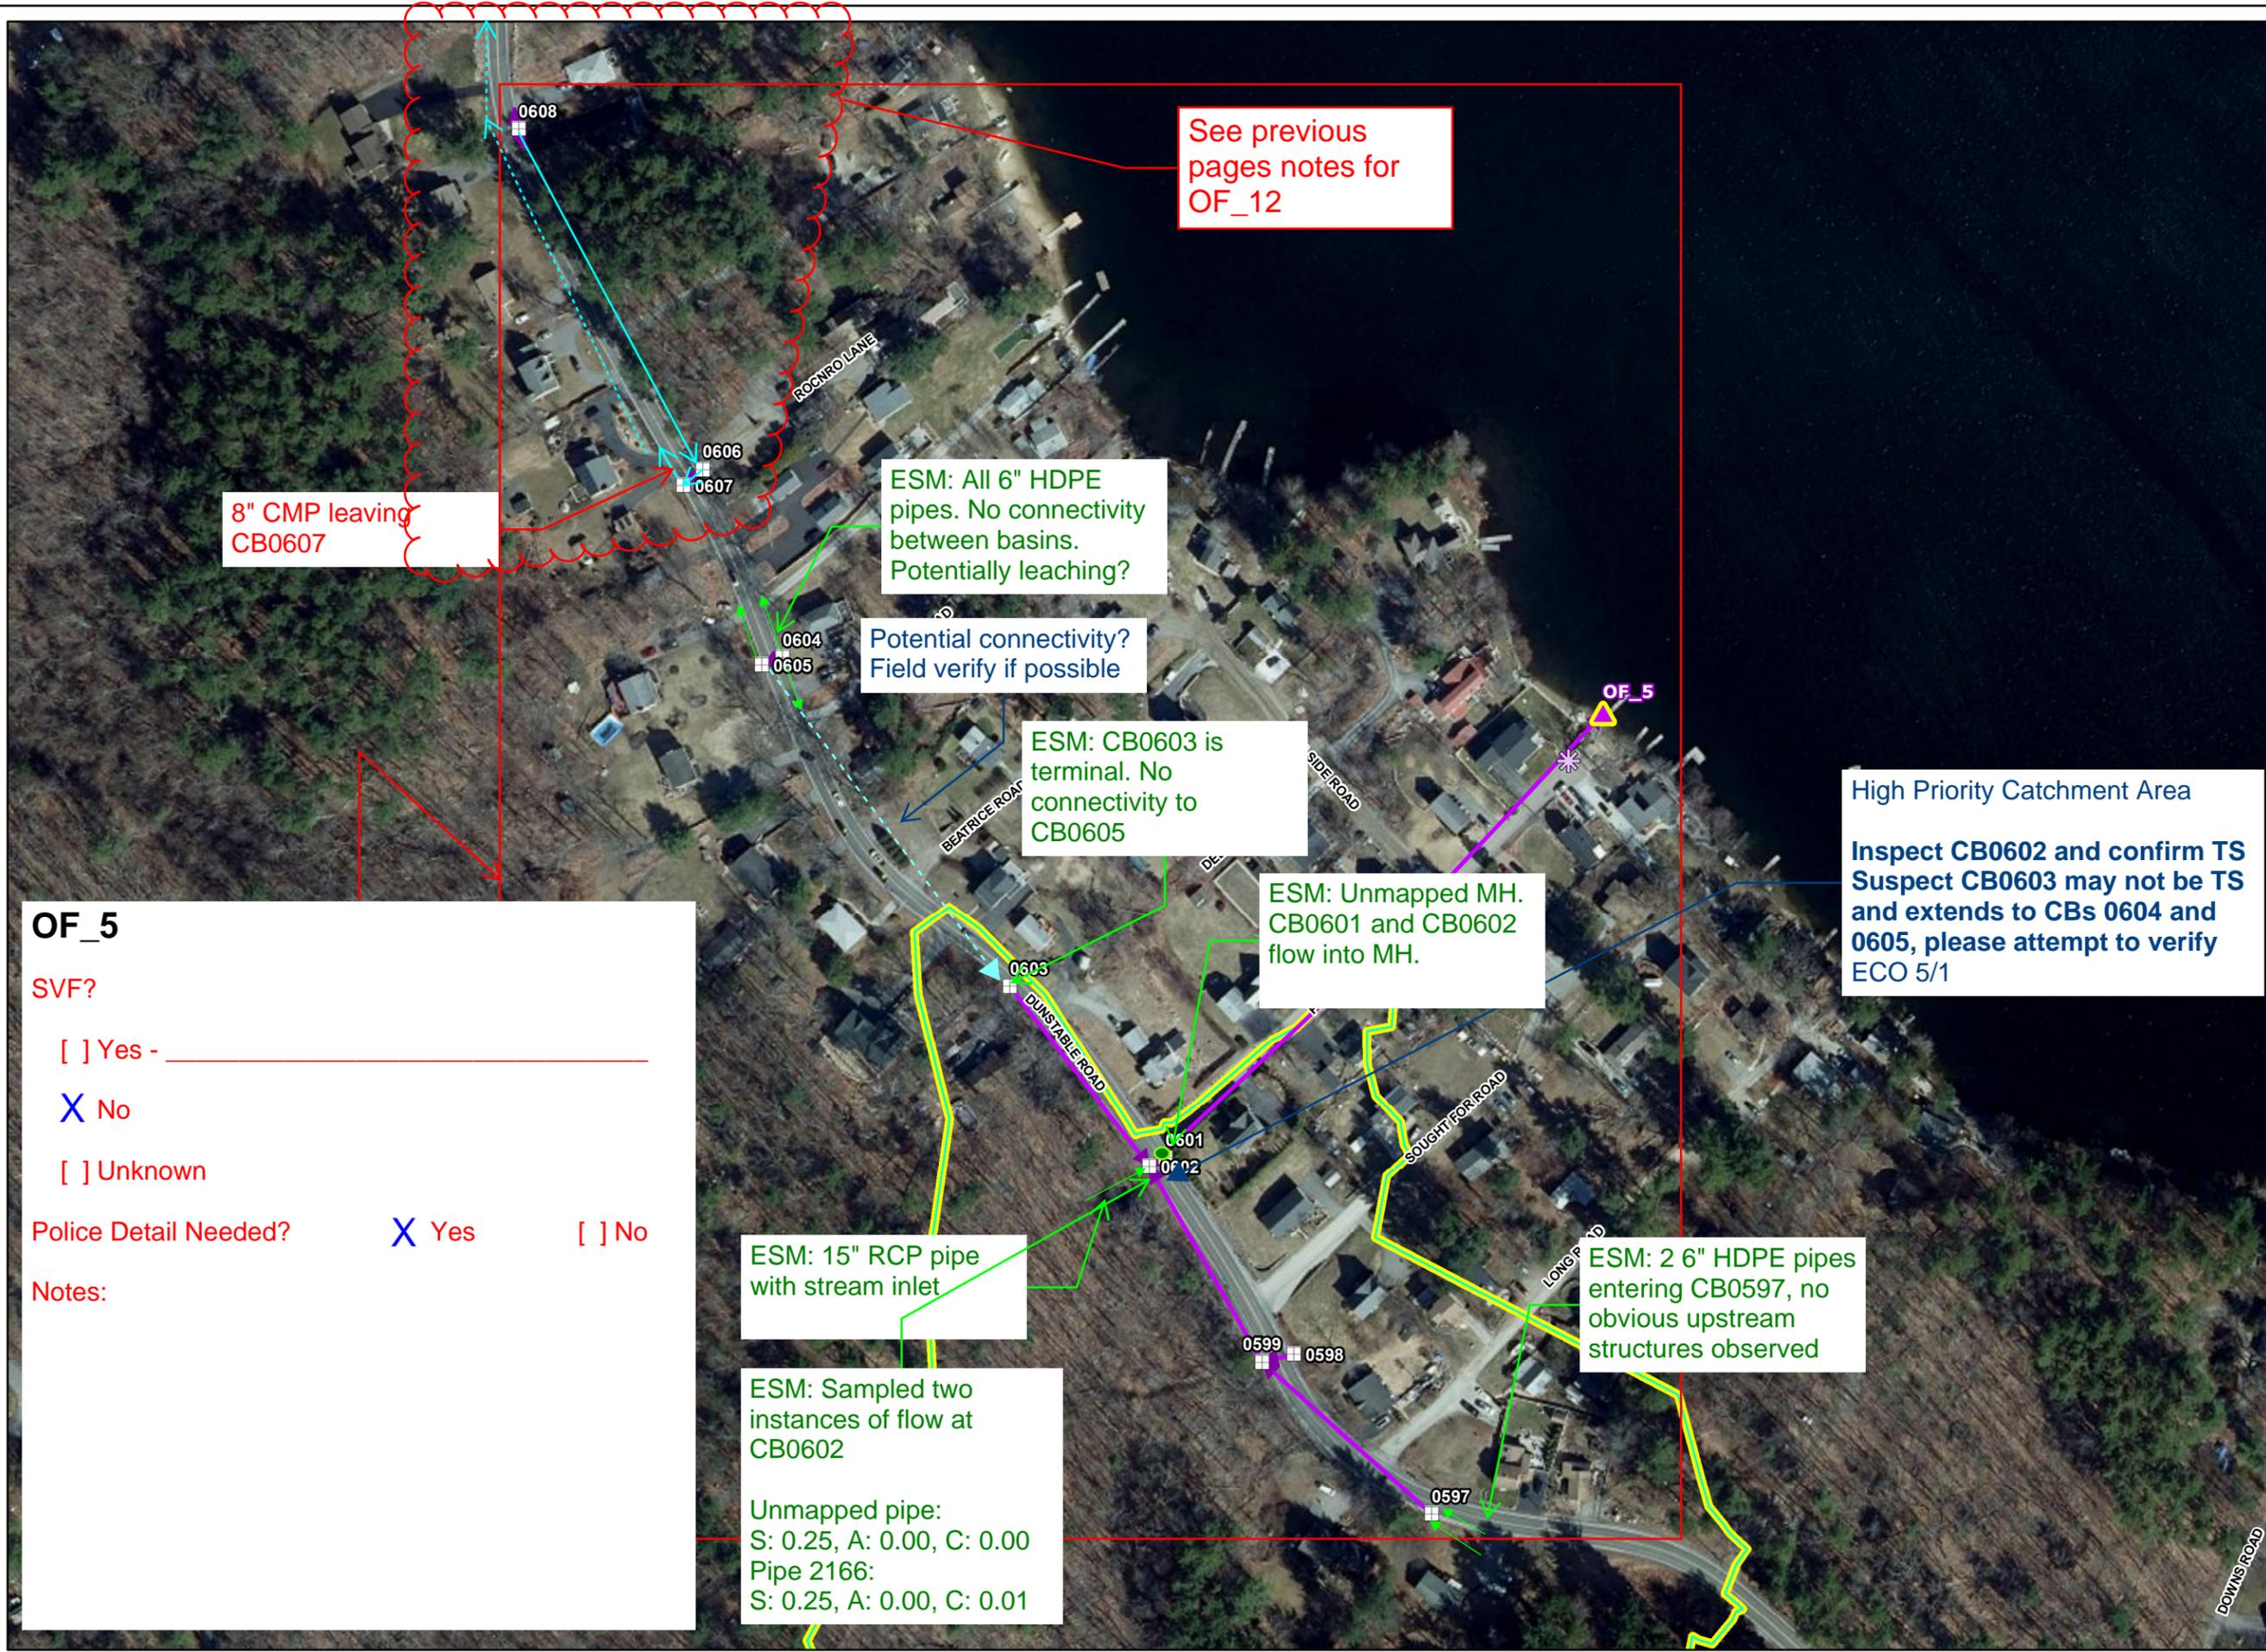
See previous pages notes for OF_12

8" CMP leaving CB0607

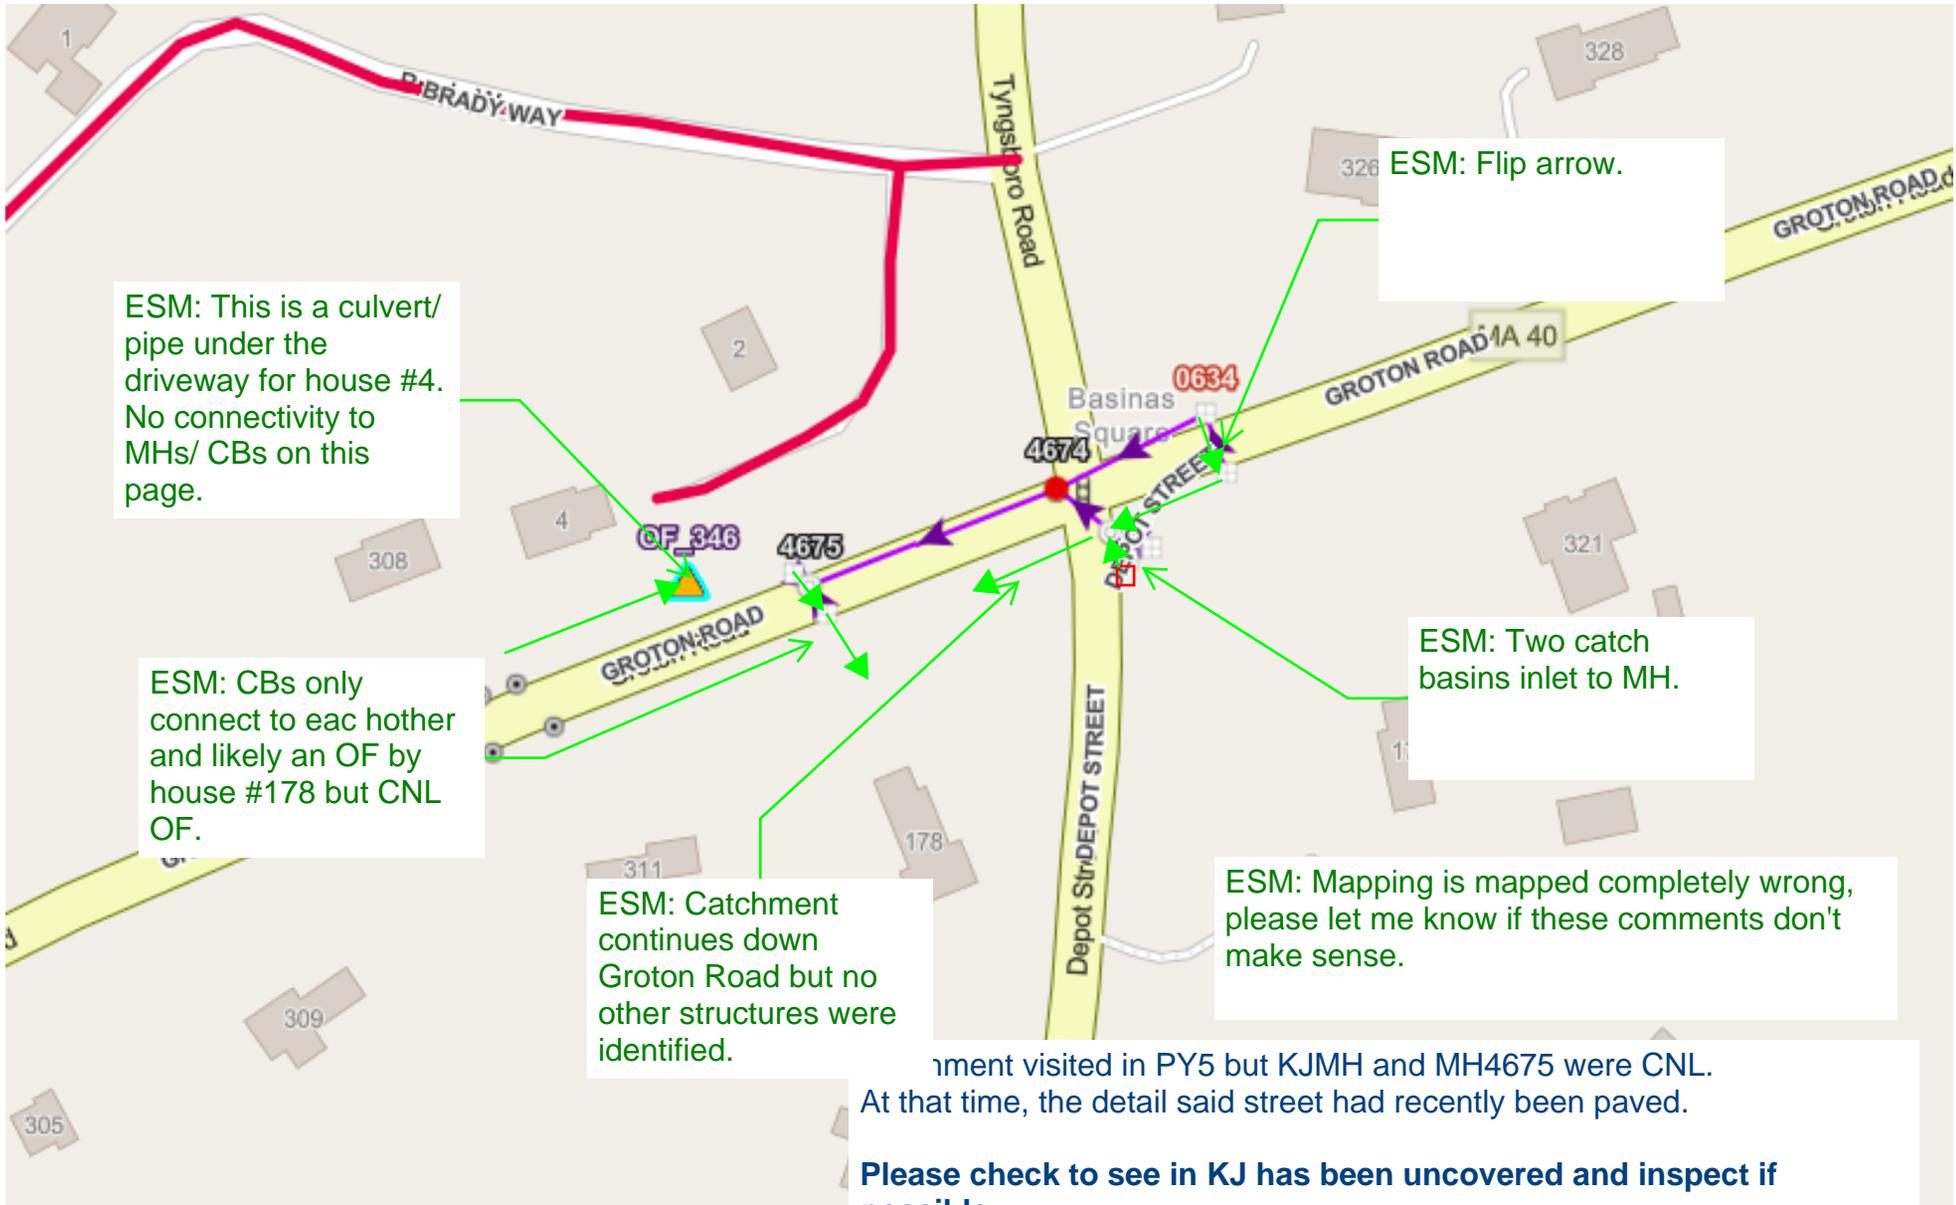
OF_346 - Revisit from PY5
Detail needed

ment visited in PY5 but KJMH and MH4675 were CNL.
At that time, the detail said street had recently been paved.

Please check to see in KJ has been uncovered and inspect if possible
Also check for MH4675 to verify connection to outfall
Confirm TS CB0635
Other TS and MH0638 already inspected in PY5
ECO 5/1

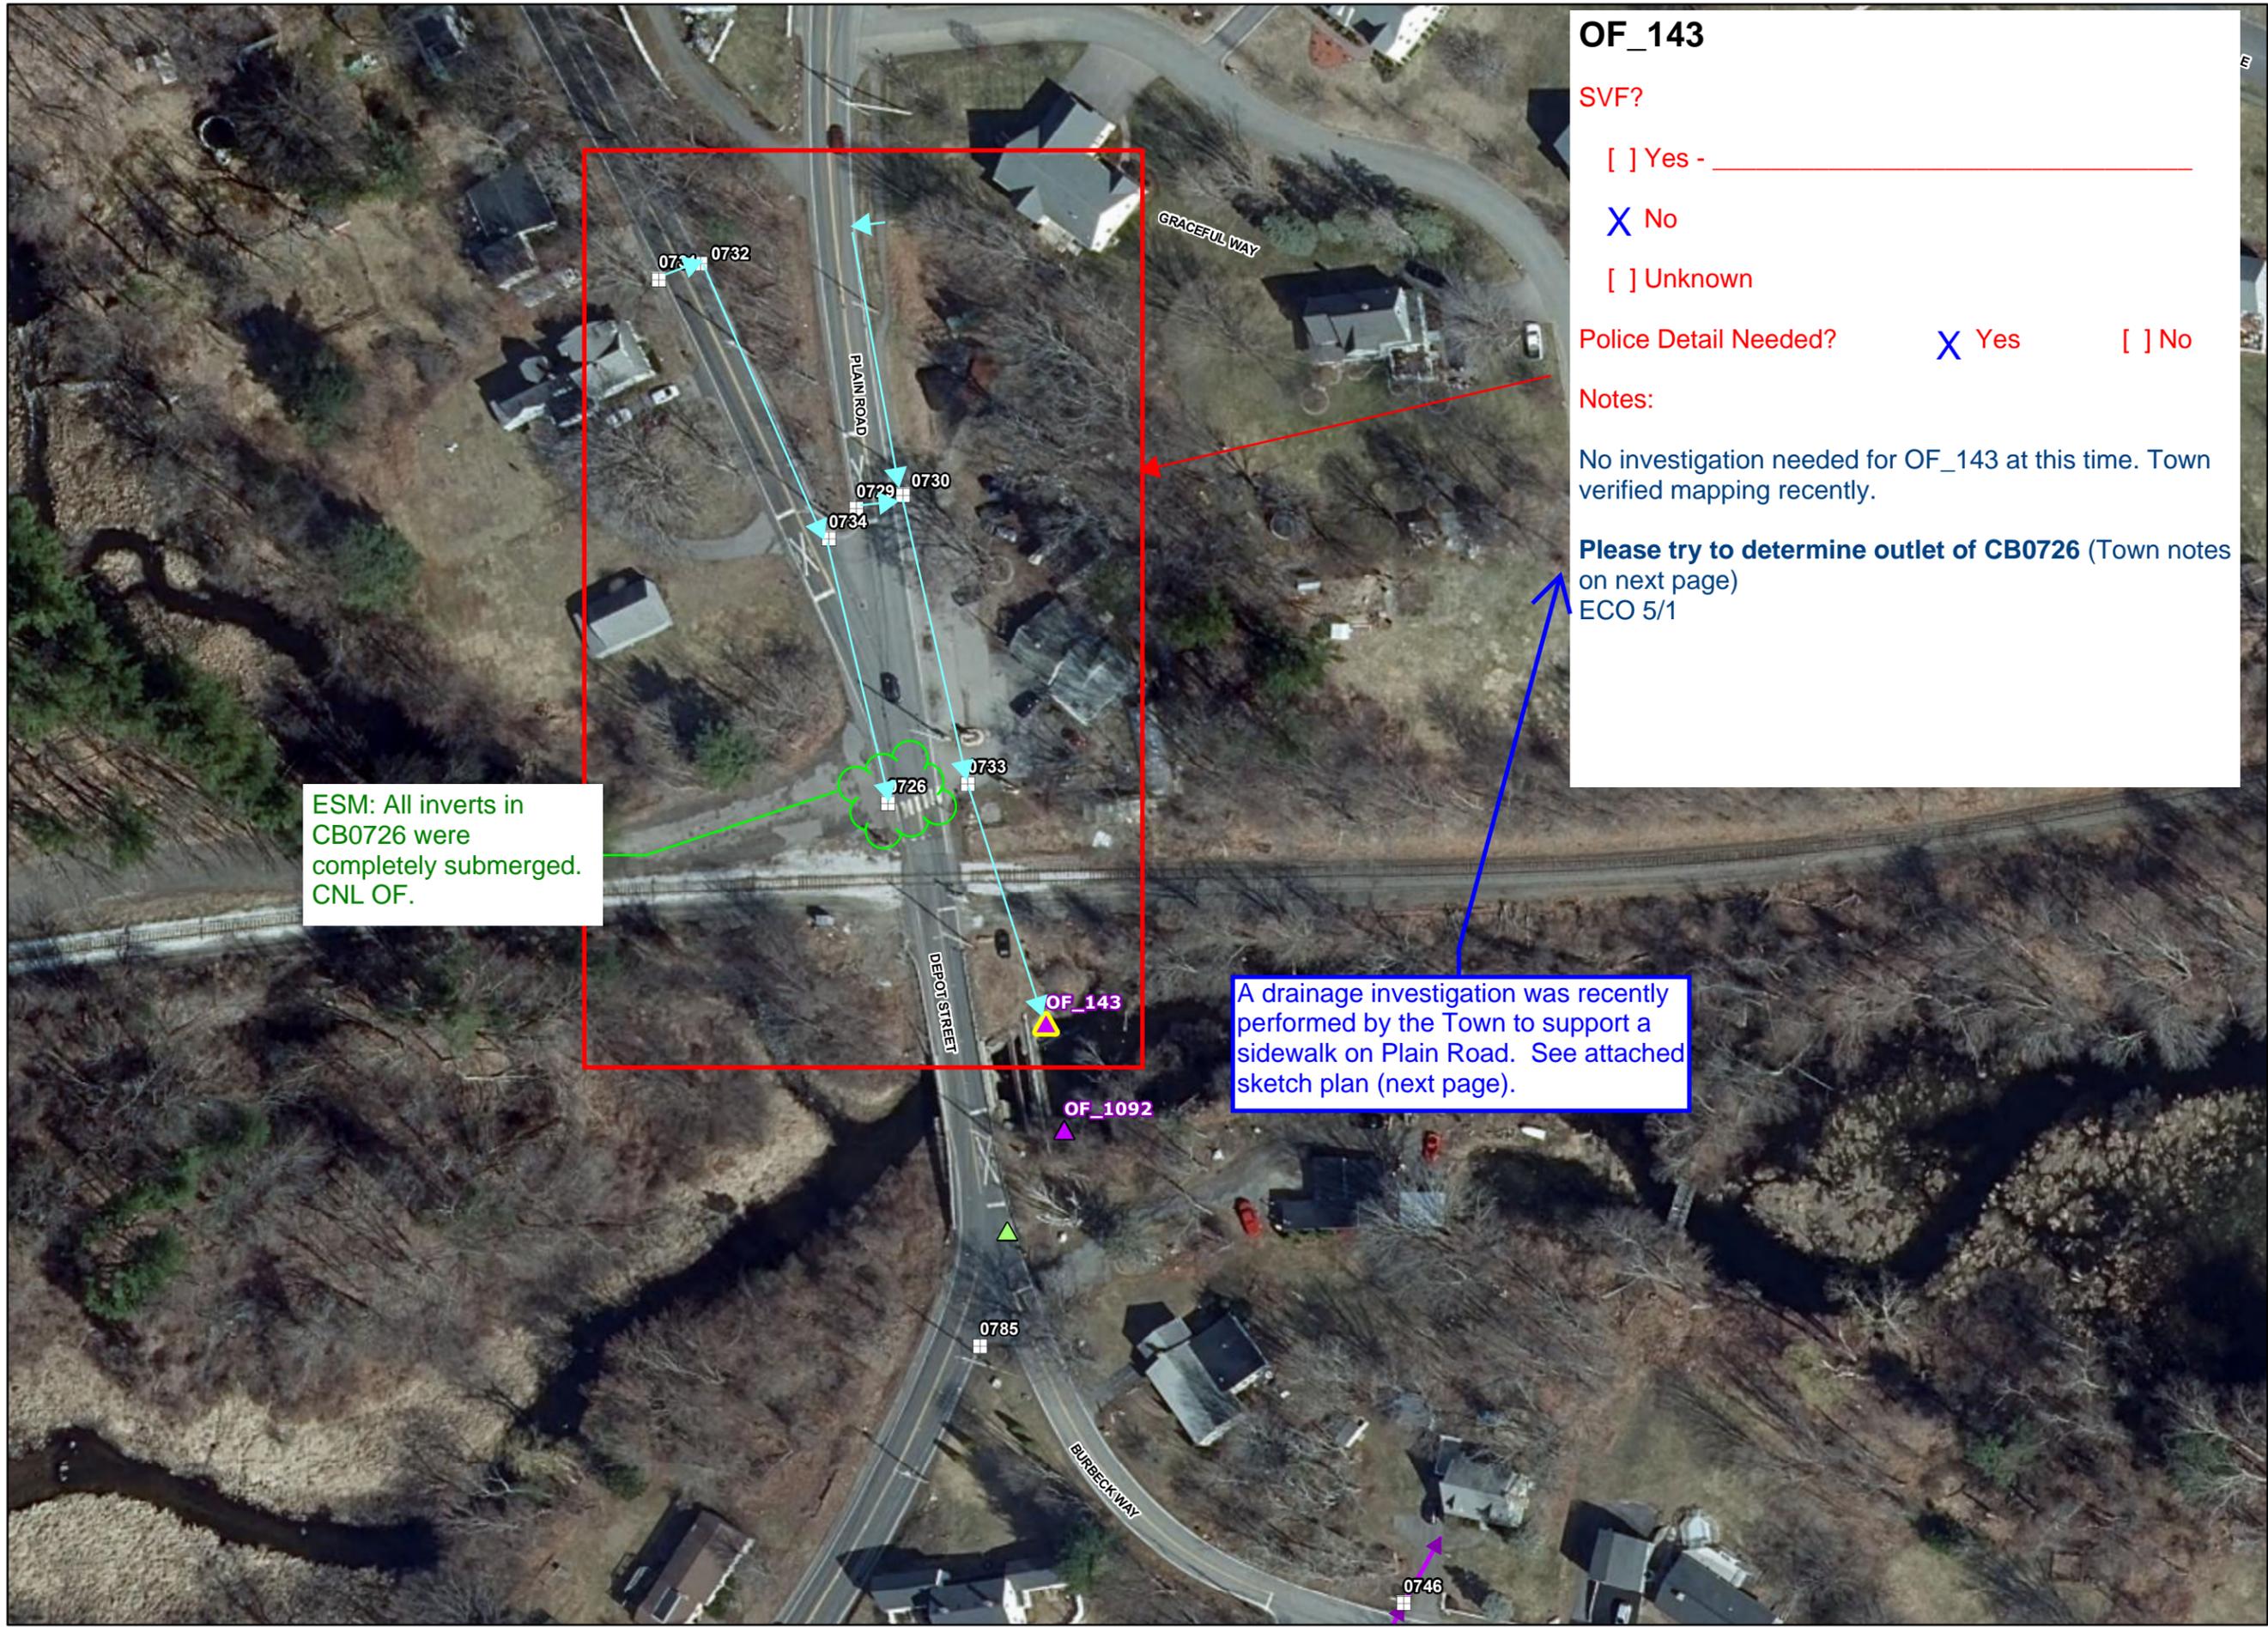
ESM: All inverts in CB0726 were completely submerged. CNL OF.

A drainage investigation was recently performed by the Town to support a sidewalk on Plain Road. See attached sketch plan (next page).

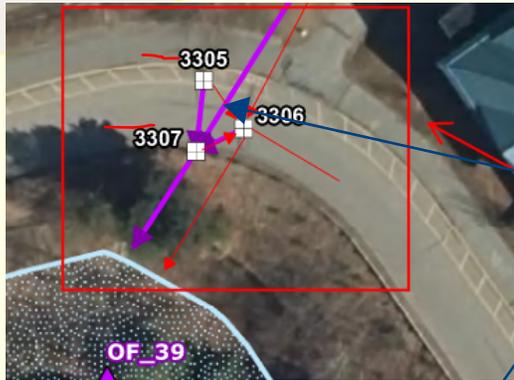
Screenshot of sketch from PY5 below

Inspect DMH at the location of CB3085 (potentially a KJ)
And check for unmapped structures that may connect to the unmapped southeast inlet of CB3085
ECO 5/1
