CATCHMENT INVESTIGATIONS GROUP ONE

Catchment Area of Outfall: OF_206

**Westford, Massachusetts
November 2023**

Tighe & Bond

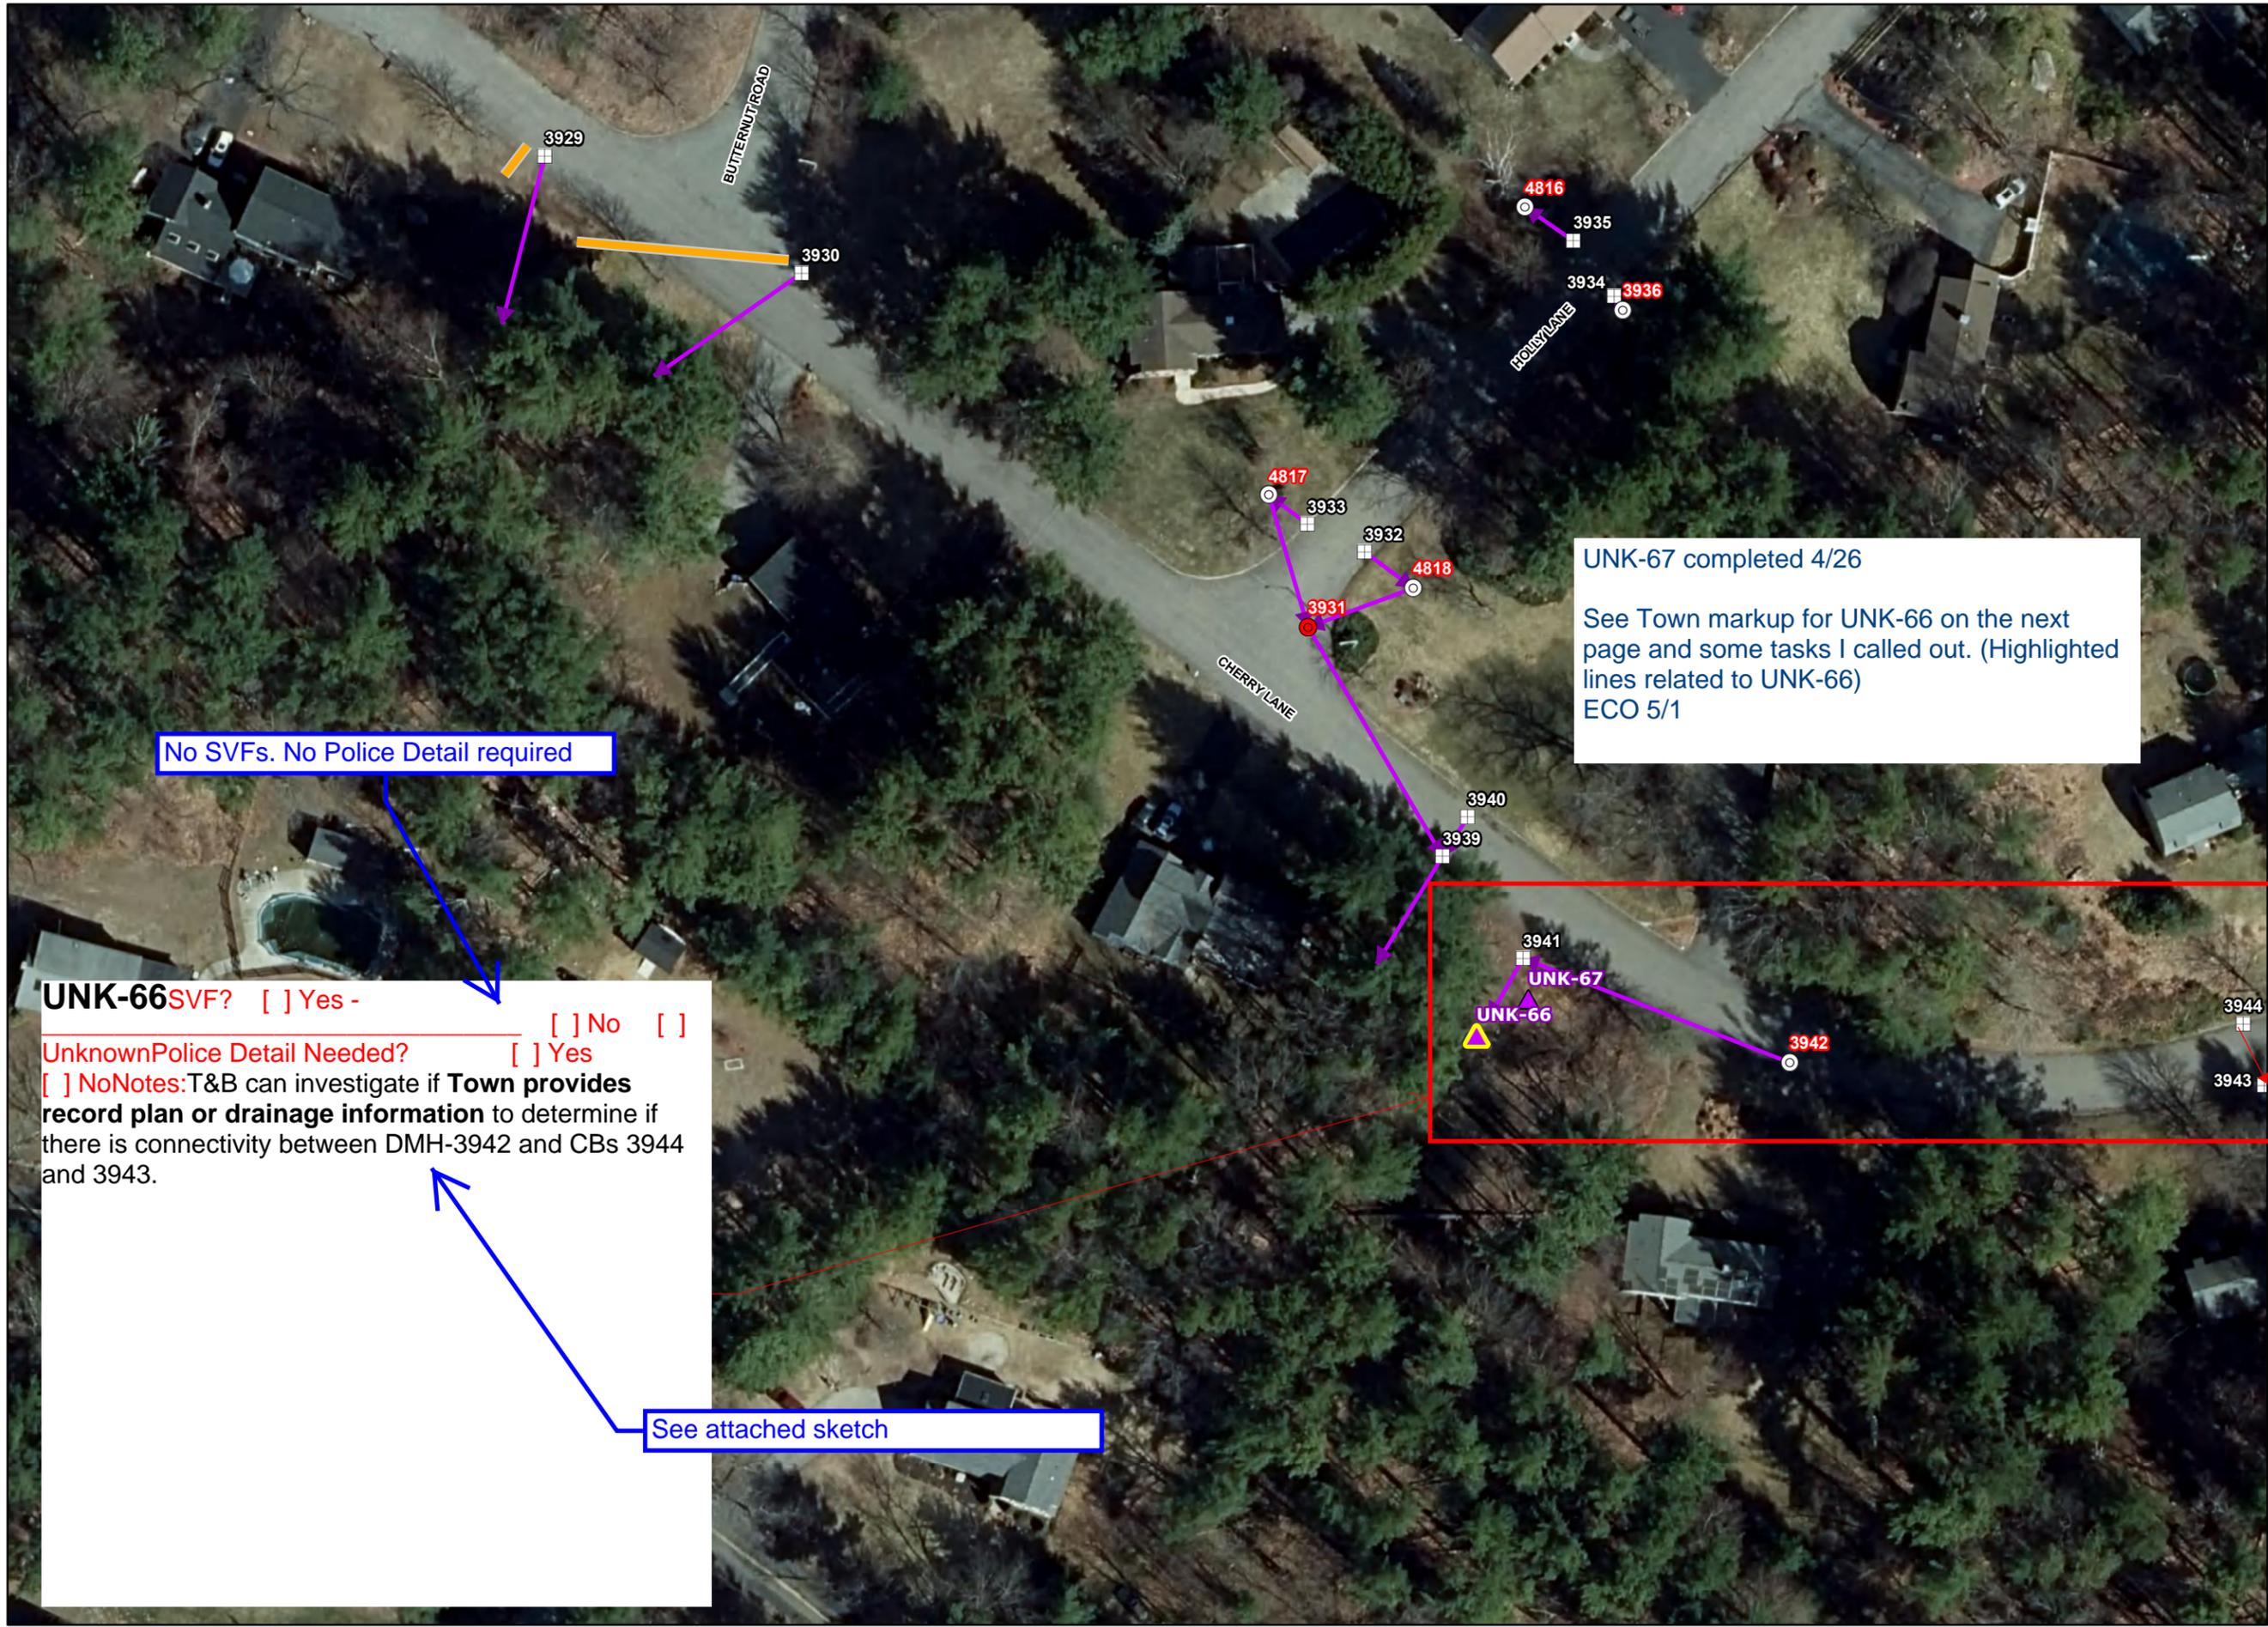
UNK-67 completed 4/26
See Town markup for UNK-66 on the next page and some tasks I called out. (Highlighted lines related to UNK-66) ECO 5/1

No SVFs. No Police Detail required

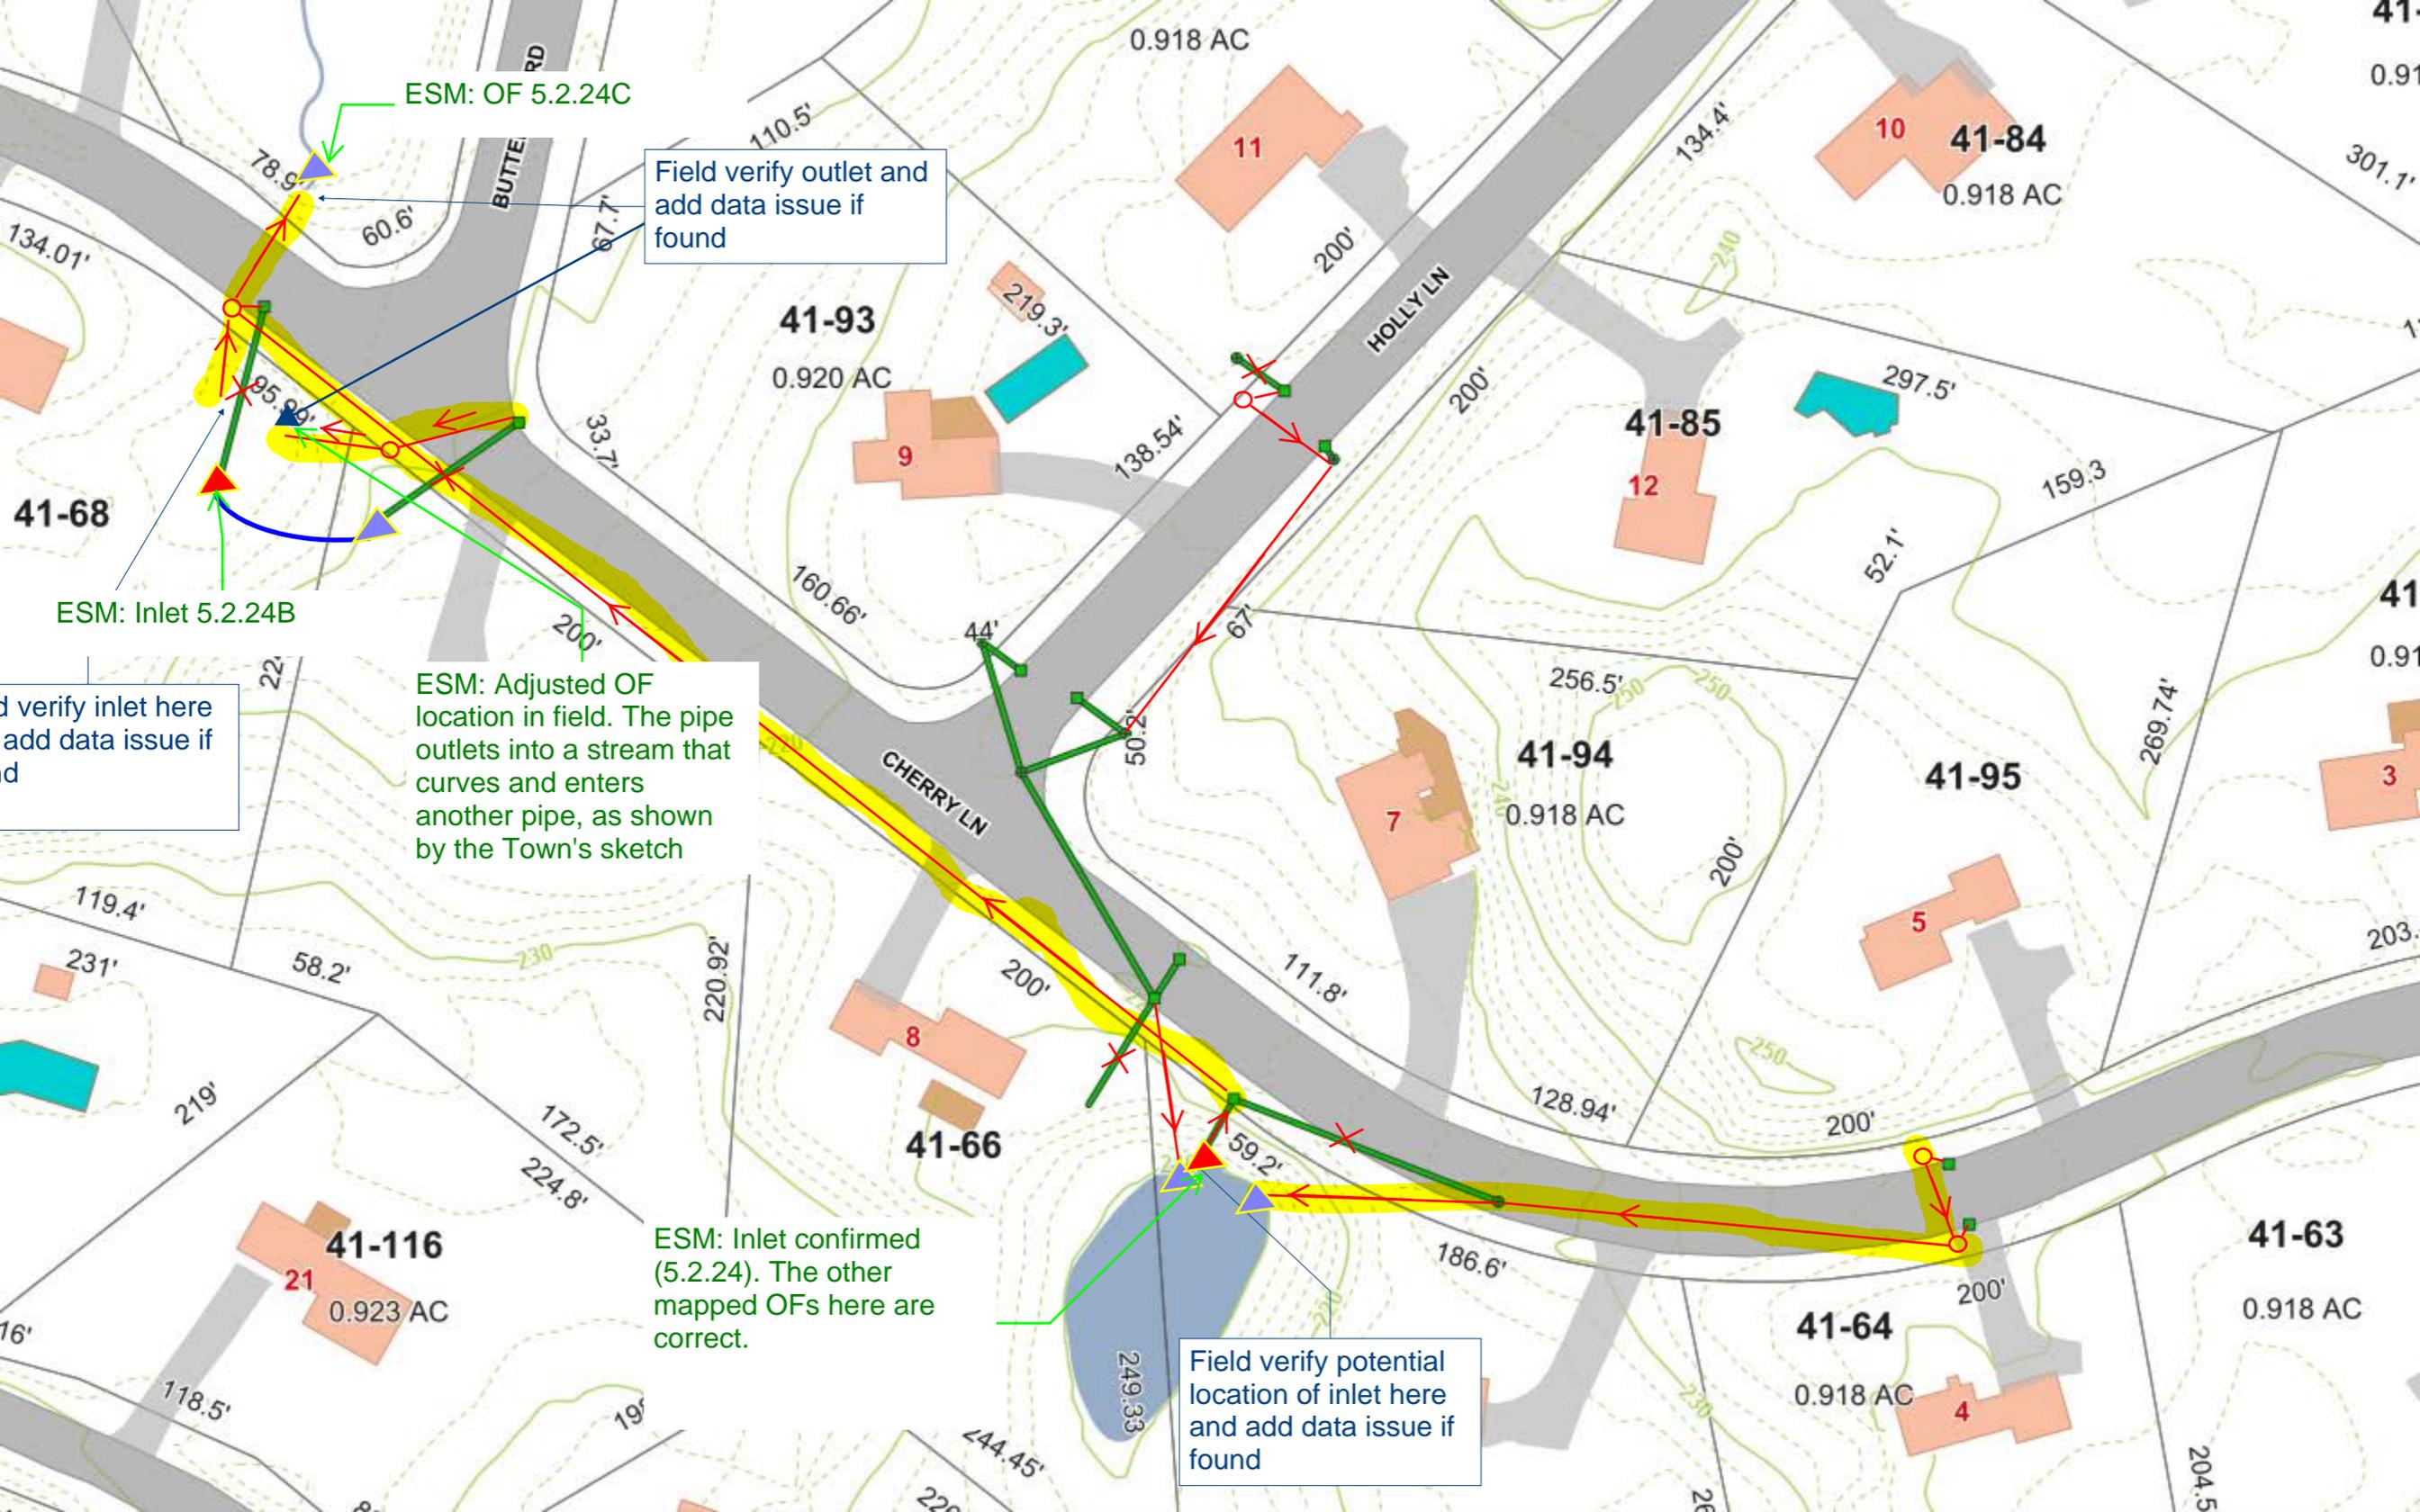
ESM: OF 5.2.24C

Field verify outlet and add data issue if found

Field verify inlet here and add data issue if found

Field verify potential location of inlet here and add data issue if found

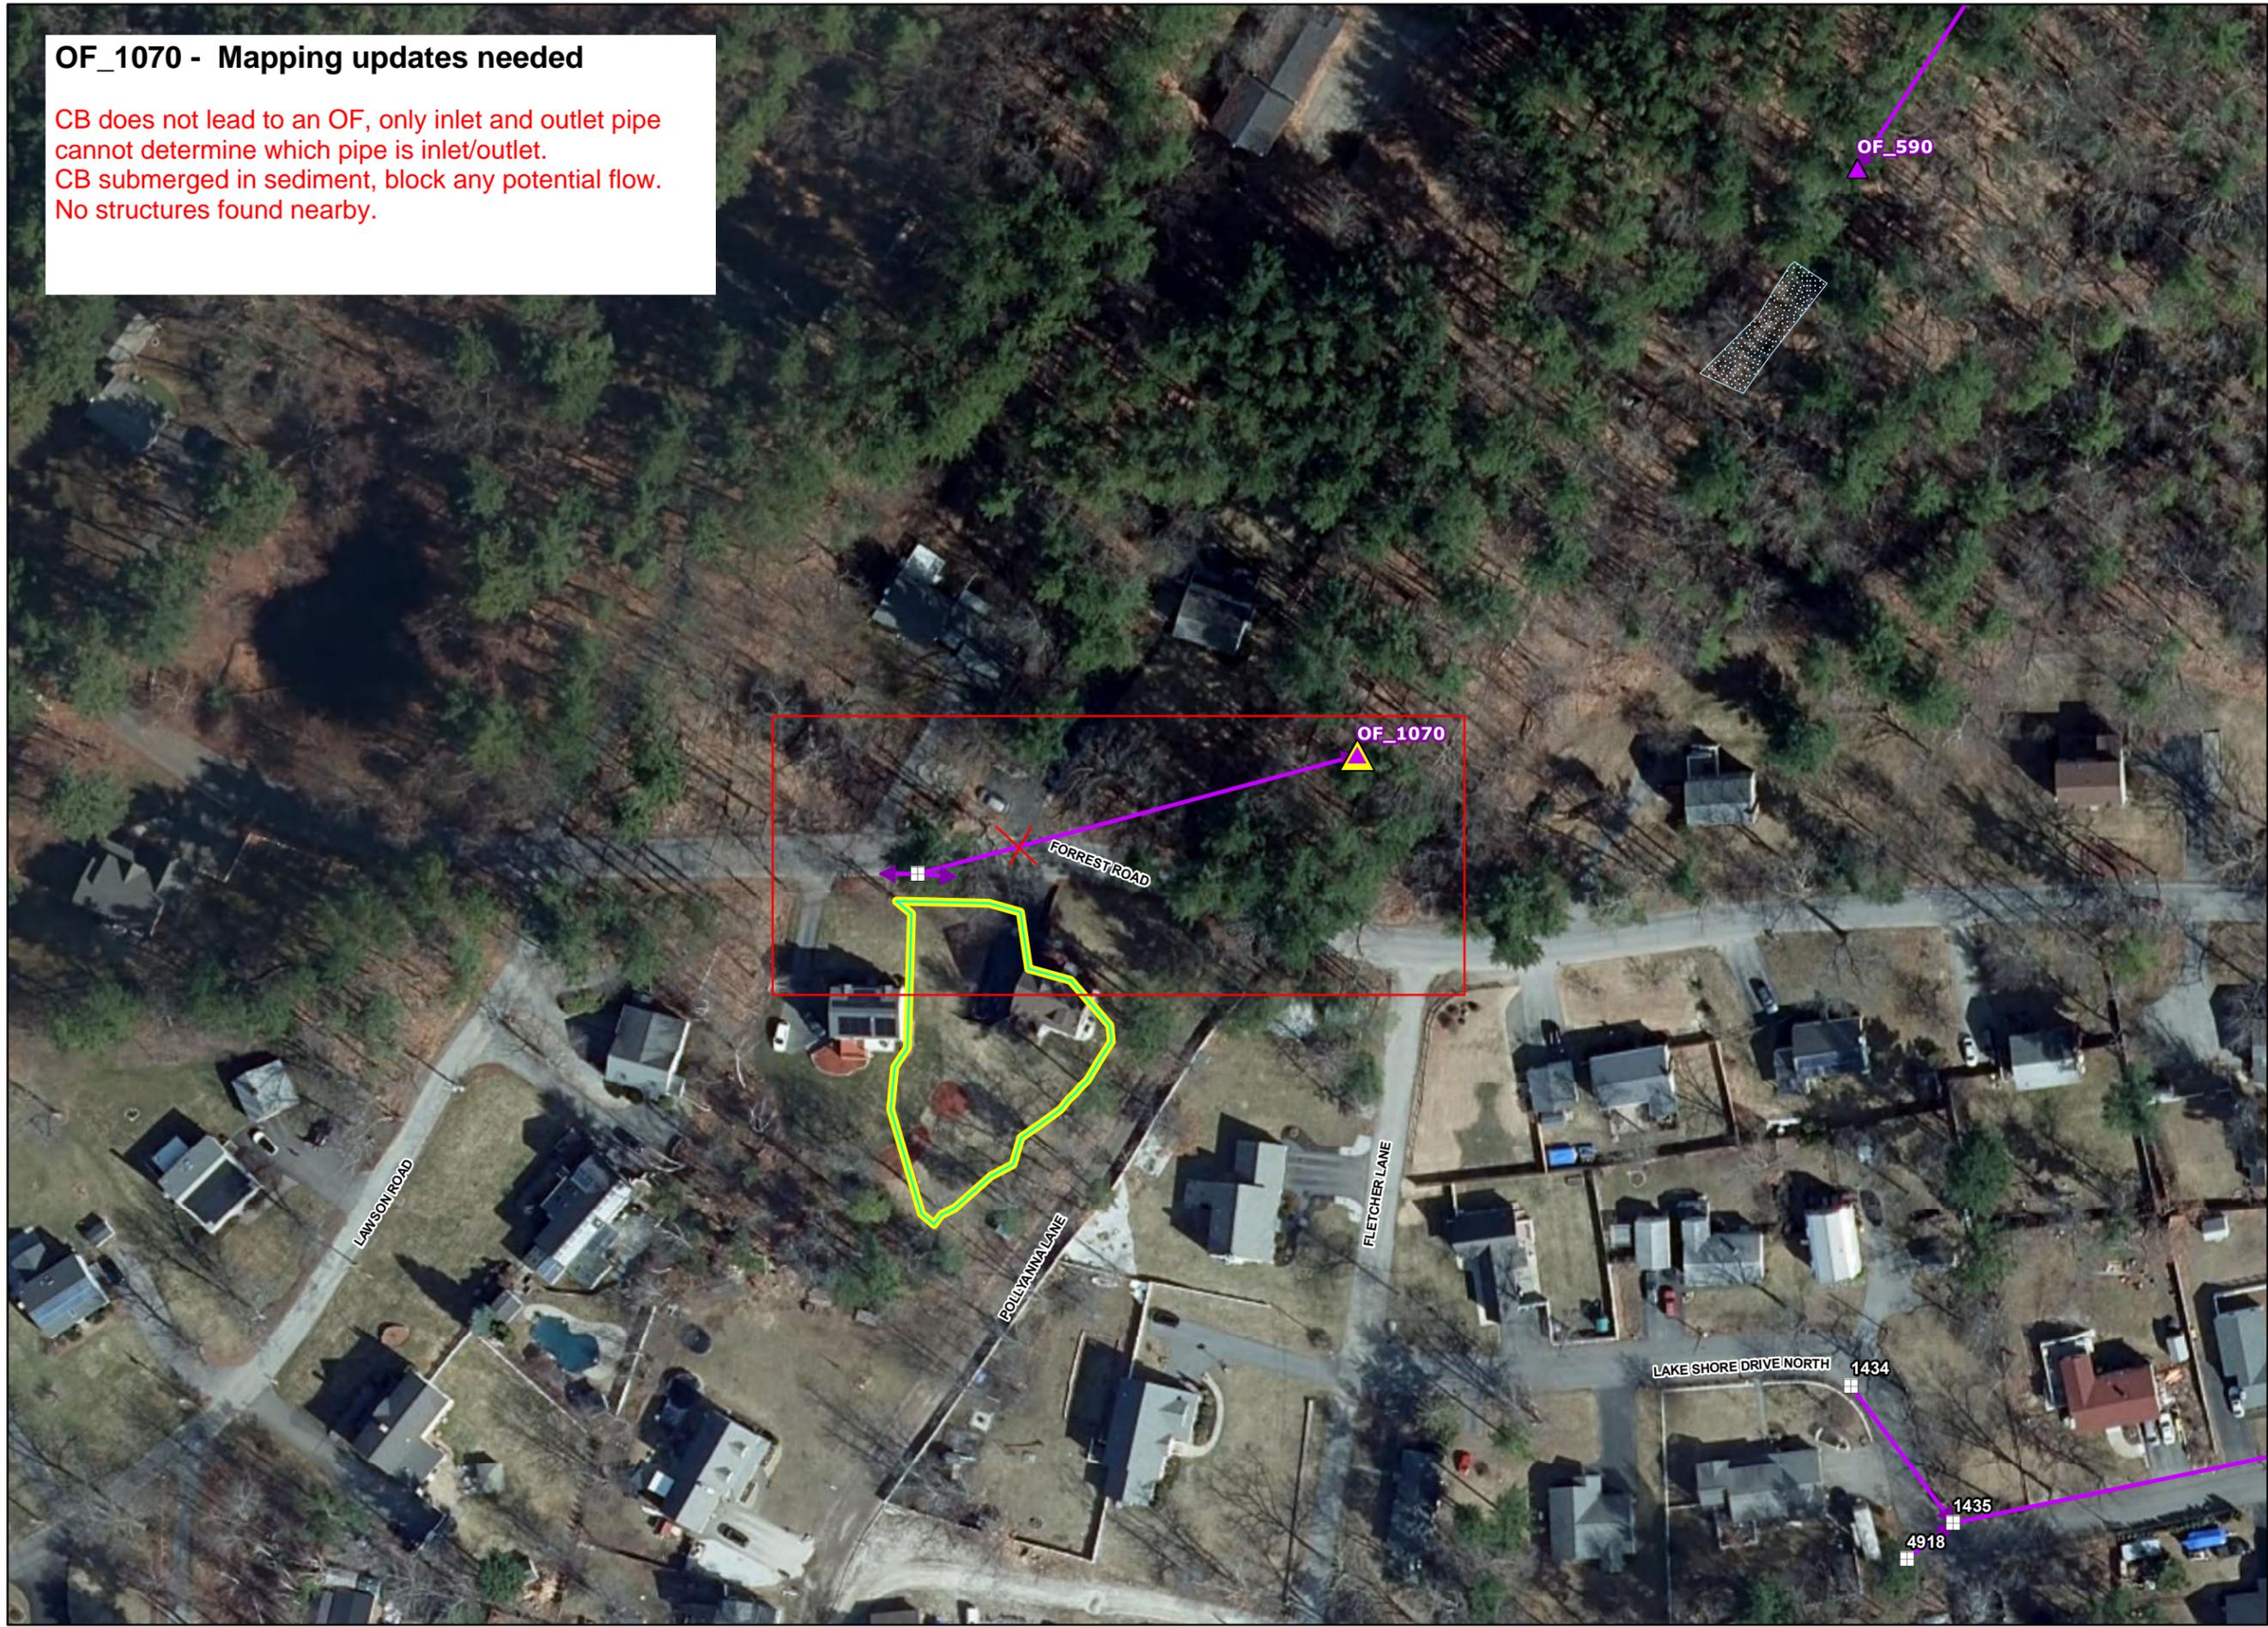
Catchment Area of Outfall: OF_1070

OF_1070 - Mapping updates needed

CB does not lead to an OF, only inlet and outlet pipe cannot determine which pipe is inlet/outlet.
 CB submerged in sediment, block any potential flow.
 No structures found nearby.

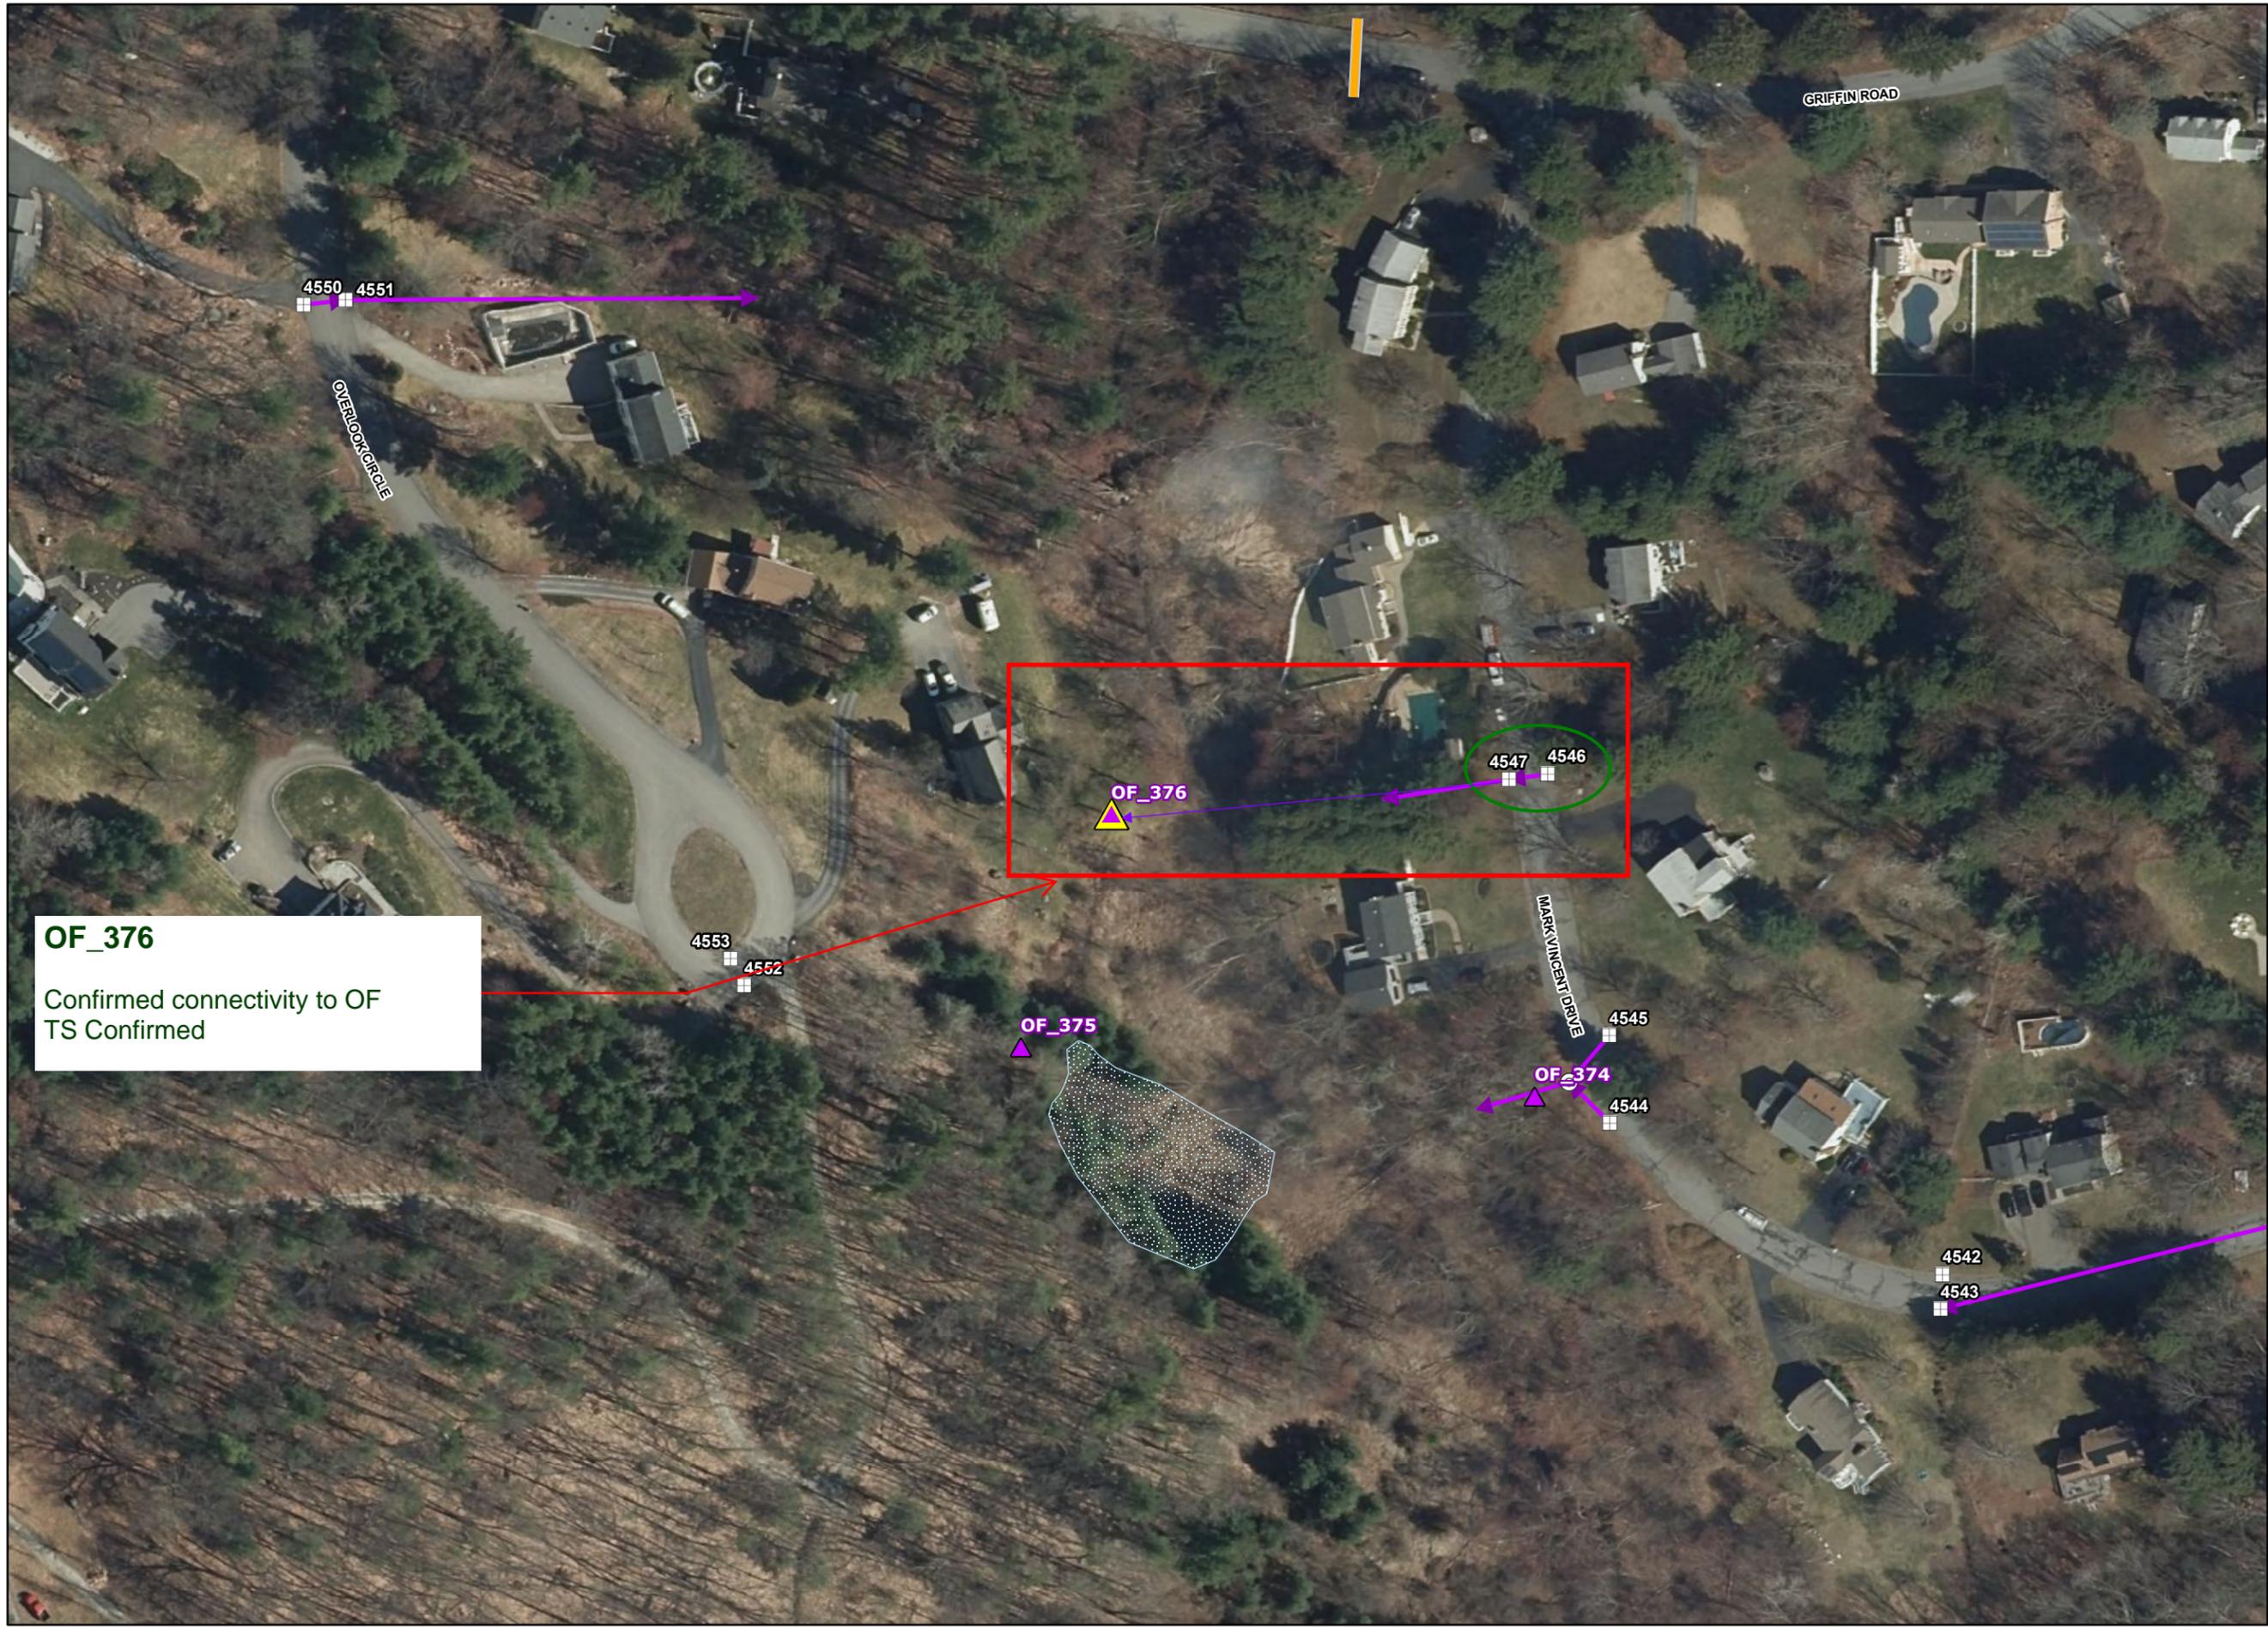
Catchment Area of Outfall: OF_376

OF_376
 Confirmed connectivity to OF
 TS Confirmed

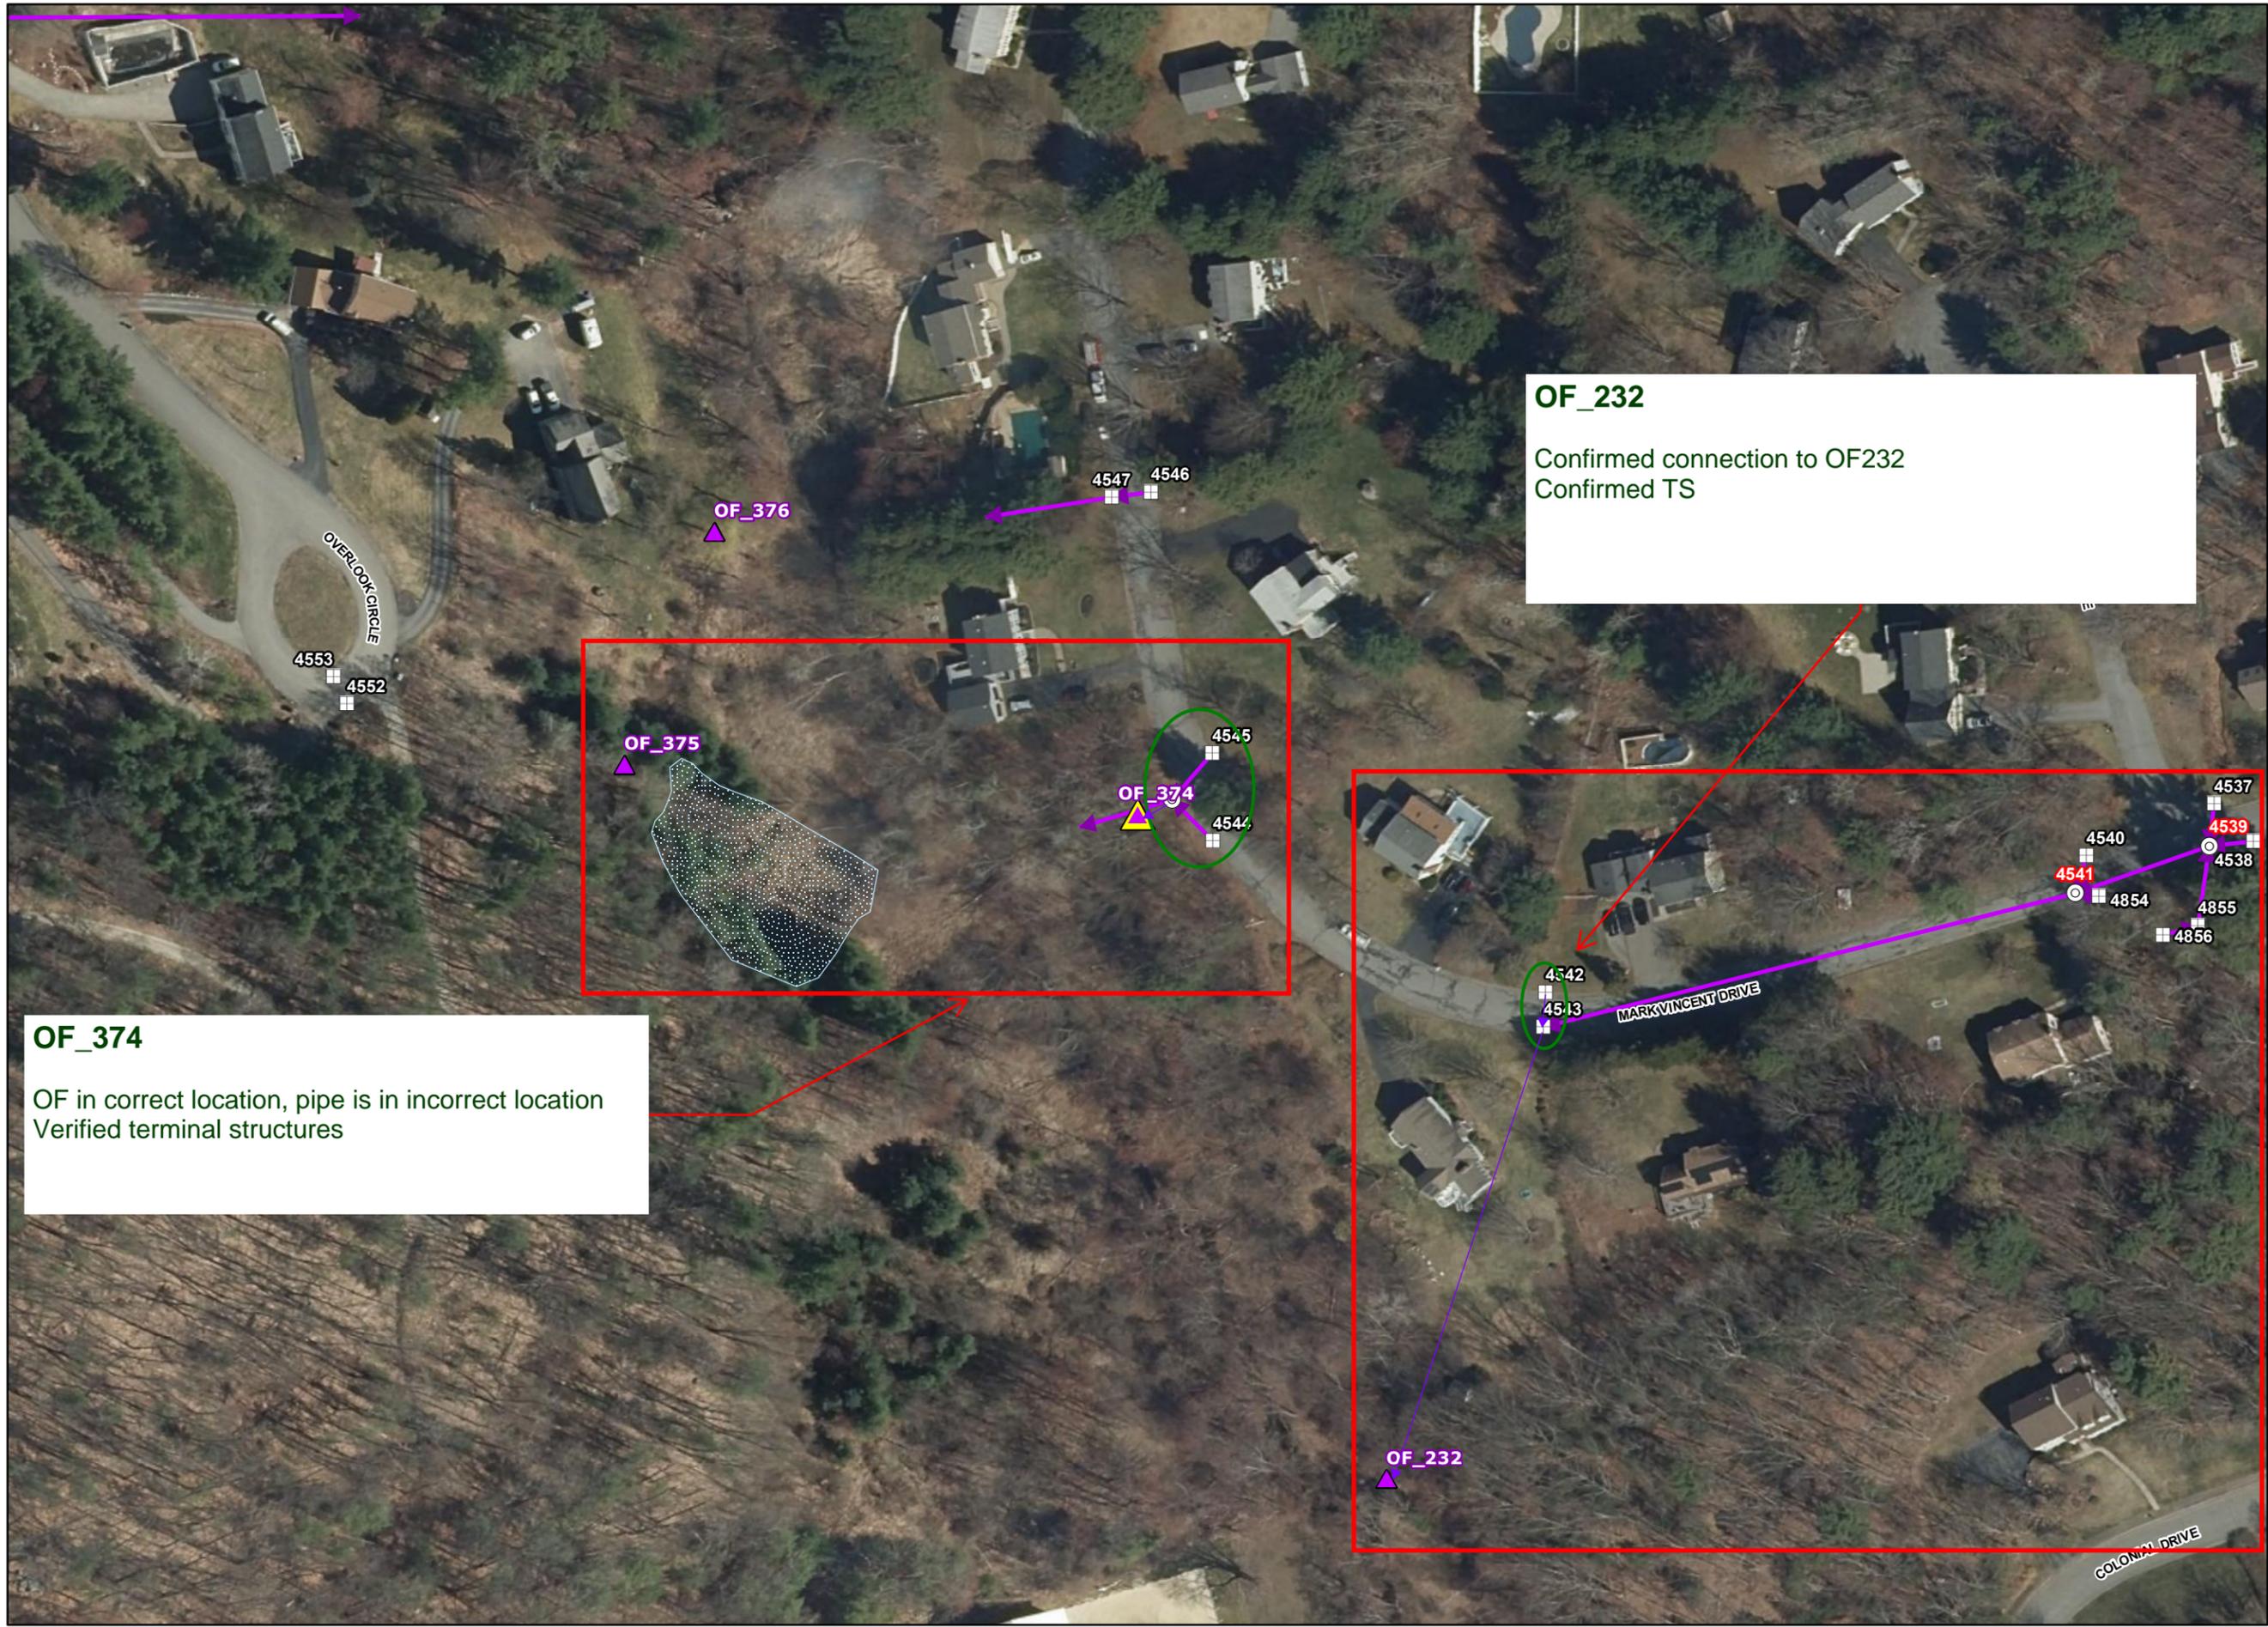
**Catchment Area of
 Outfall: OF_374
 and OF_232
 Outside Receiving**

OF_232
 Confirmed connection to OF232
 Confirmed TS

OF_374
 OF in correct location, pipe is in incorrect location
 Verified terminal structures

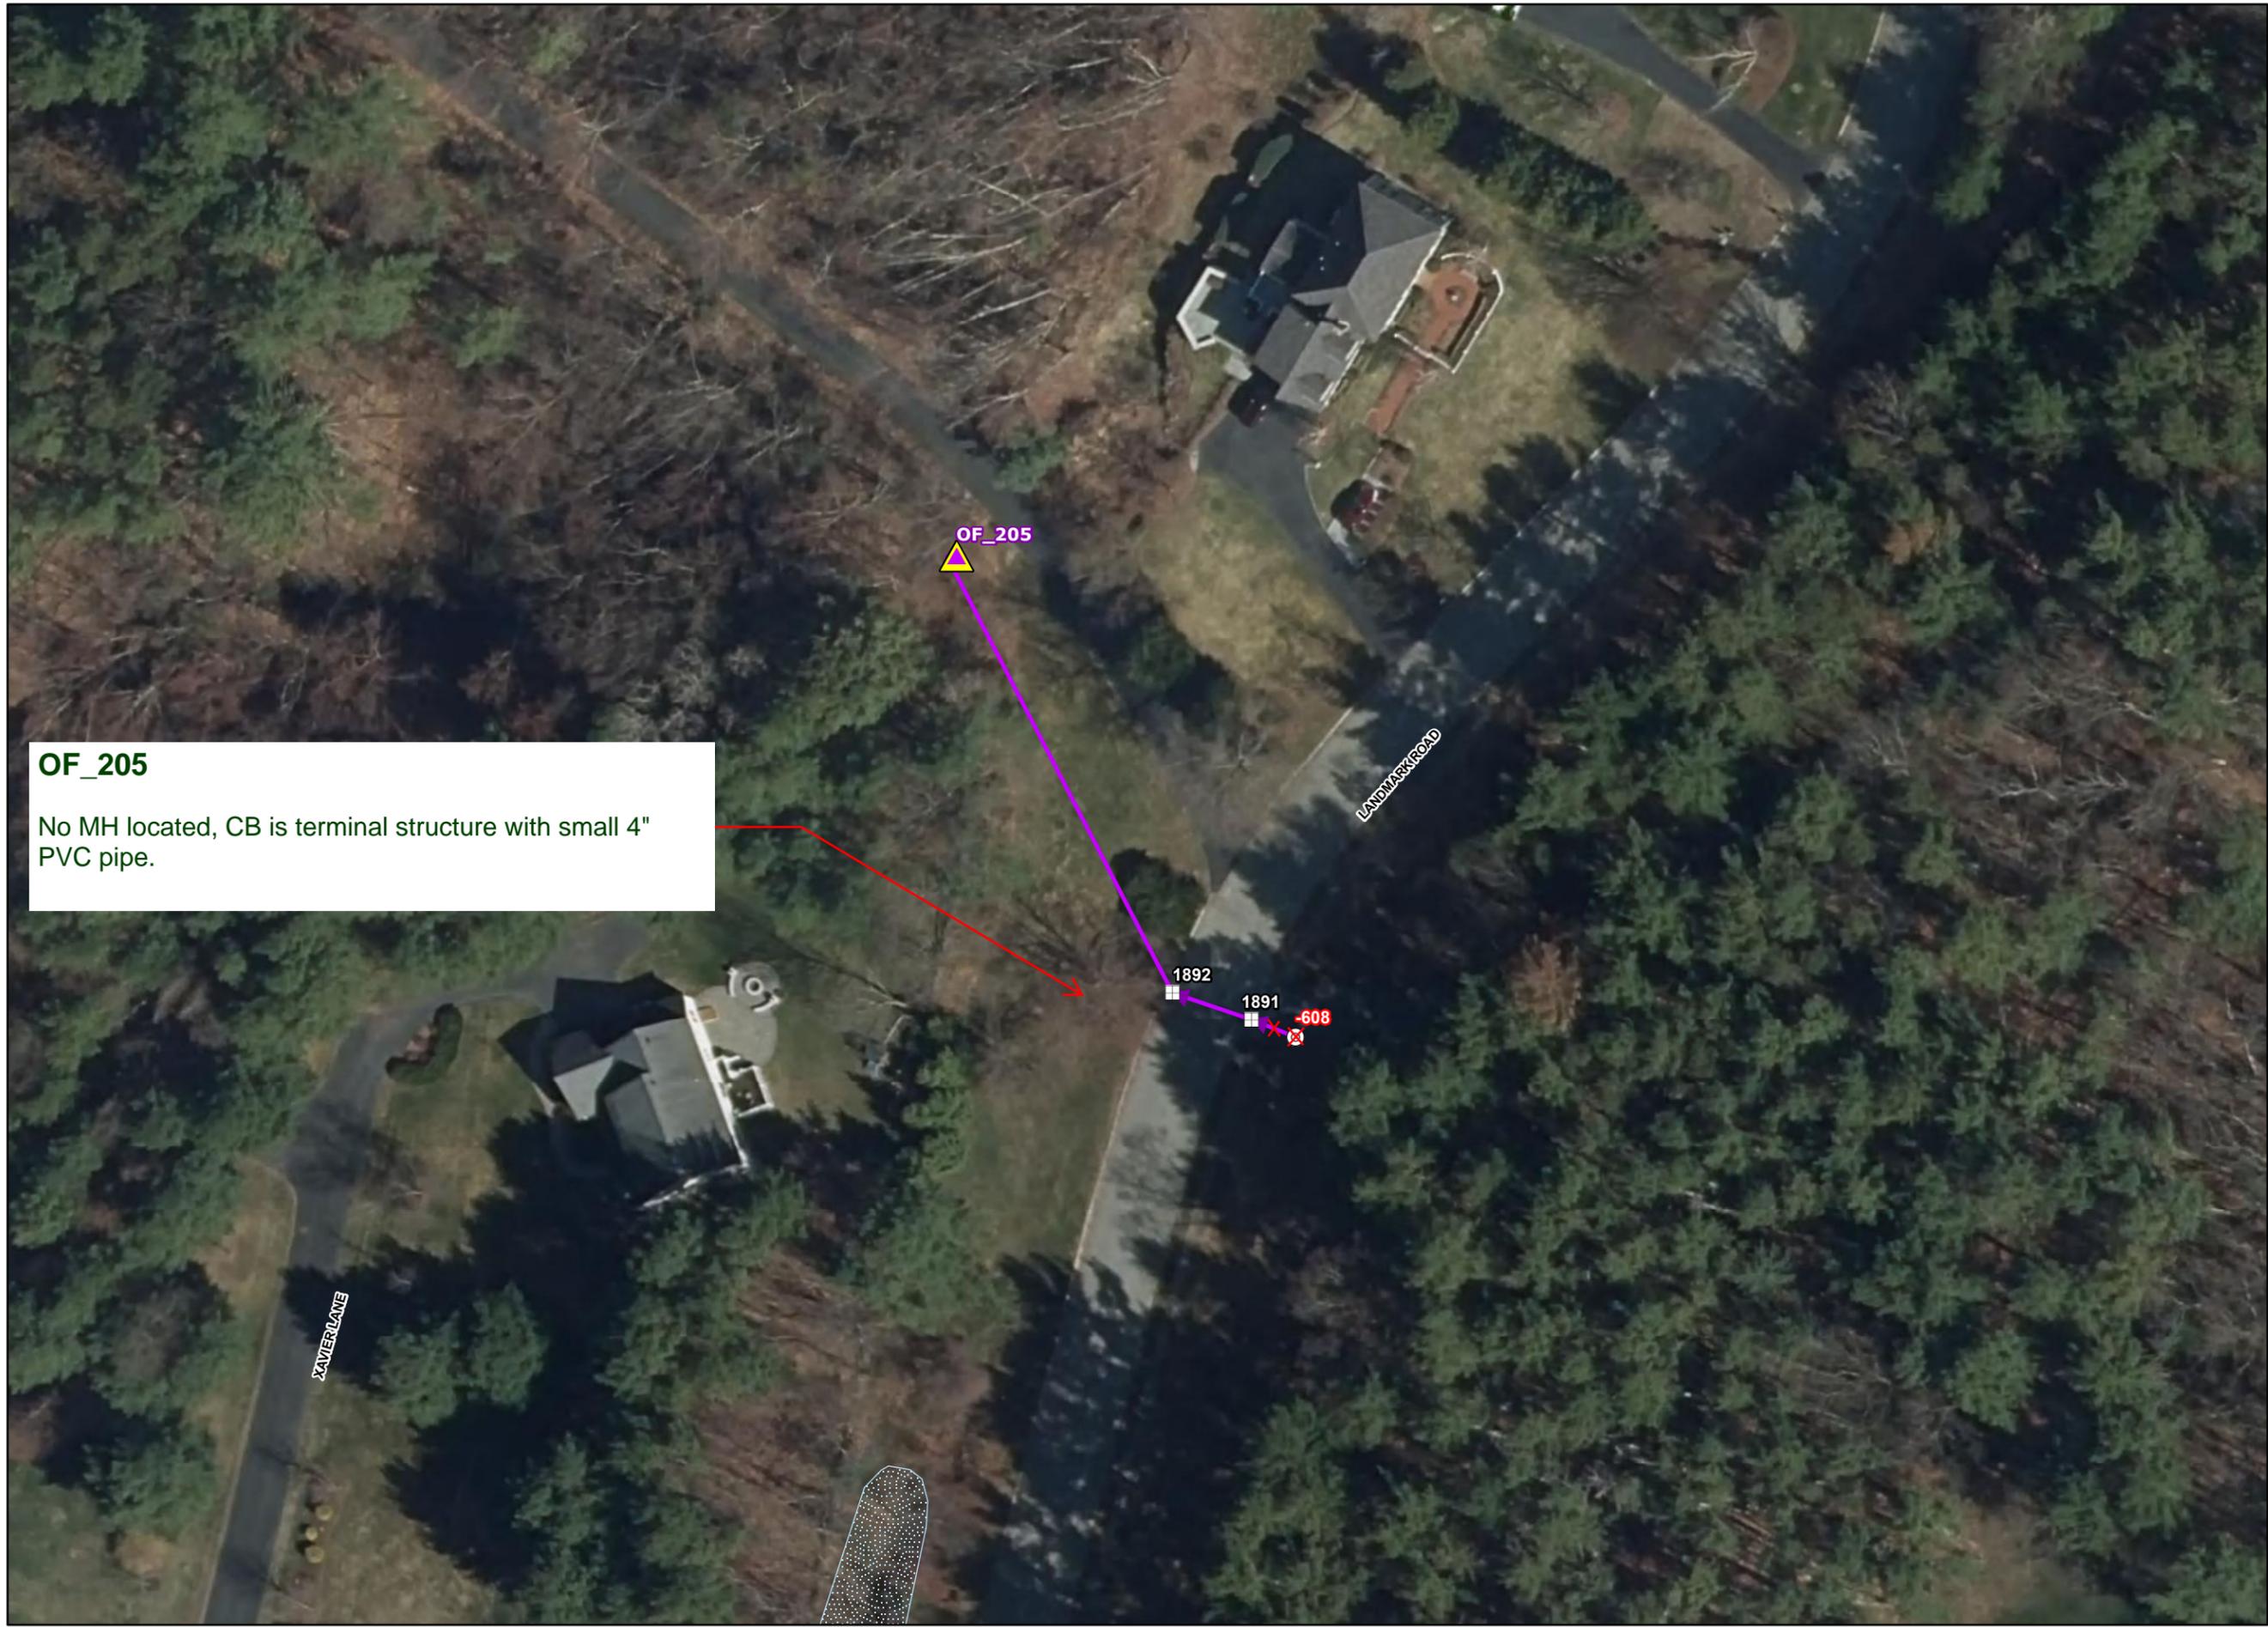
Catchment Area of Outfall: OF_205

OF_205

No MH located, CB is terminal structure with small 4" PVC pipe.
