CATCHMENT INVESTIGATIONS GROUP ONE

Catchment Area of Outfall: OF_206

**Westford, Massachusetts
November 2023**

Tighe & Bond

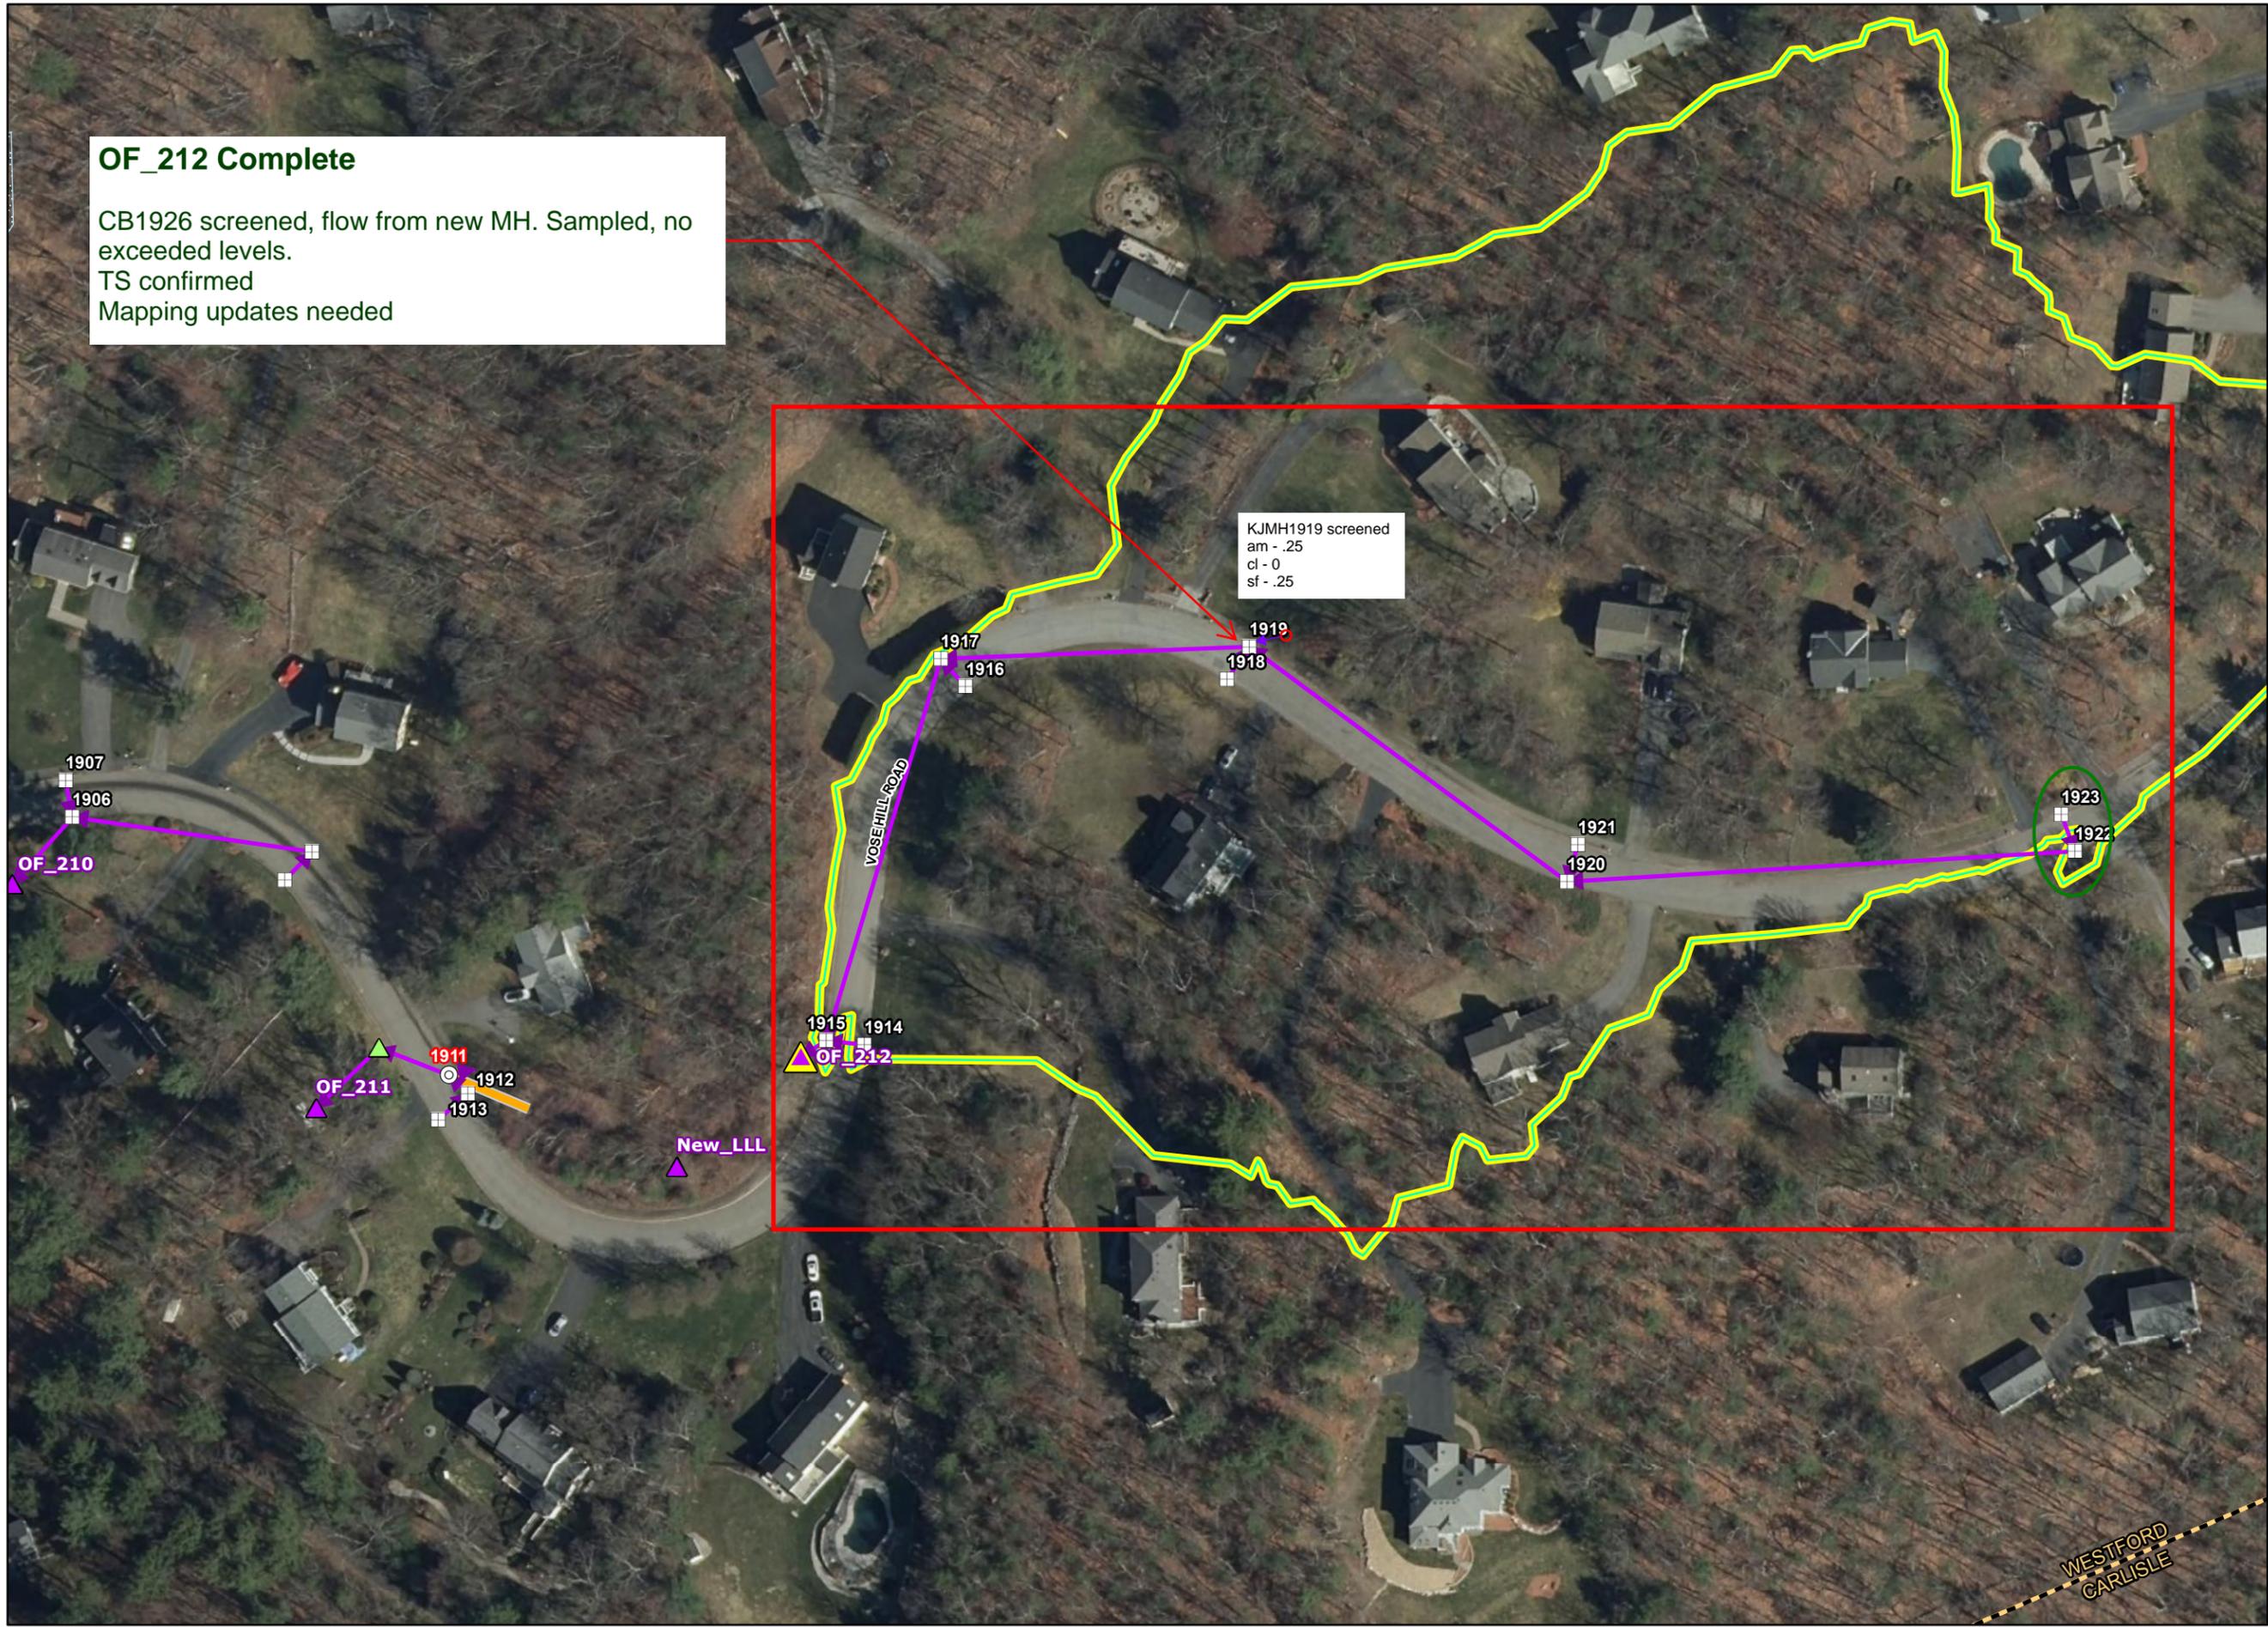
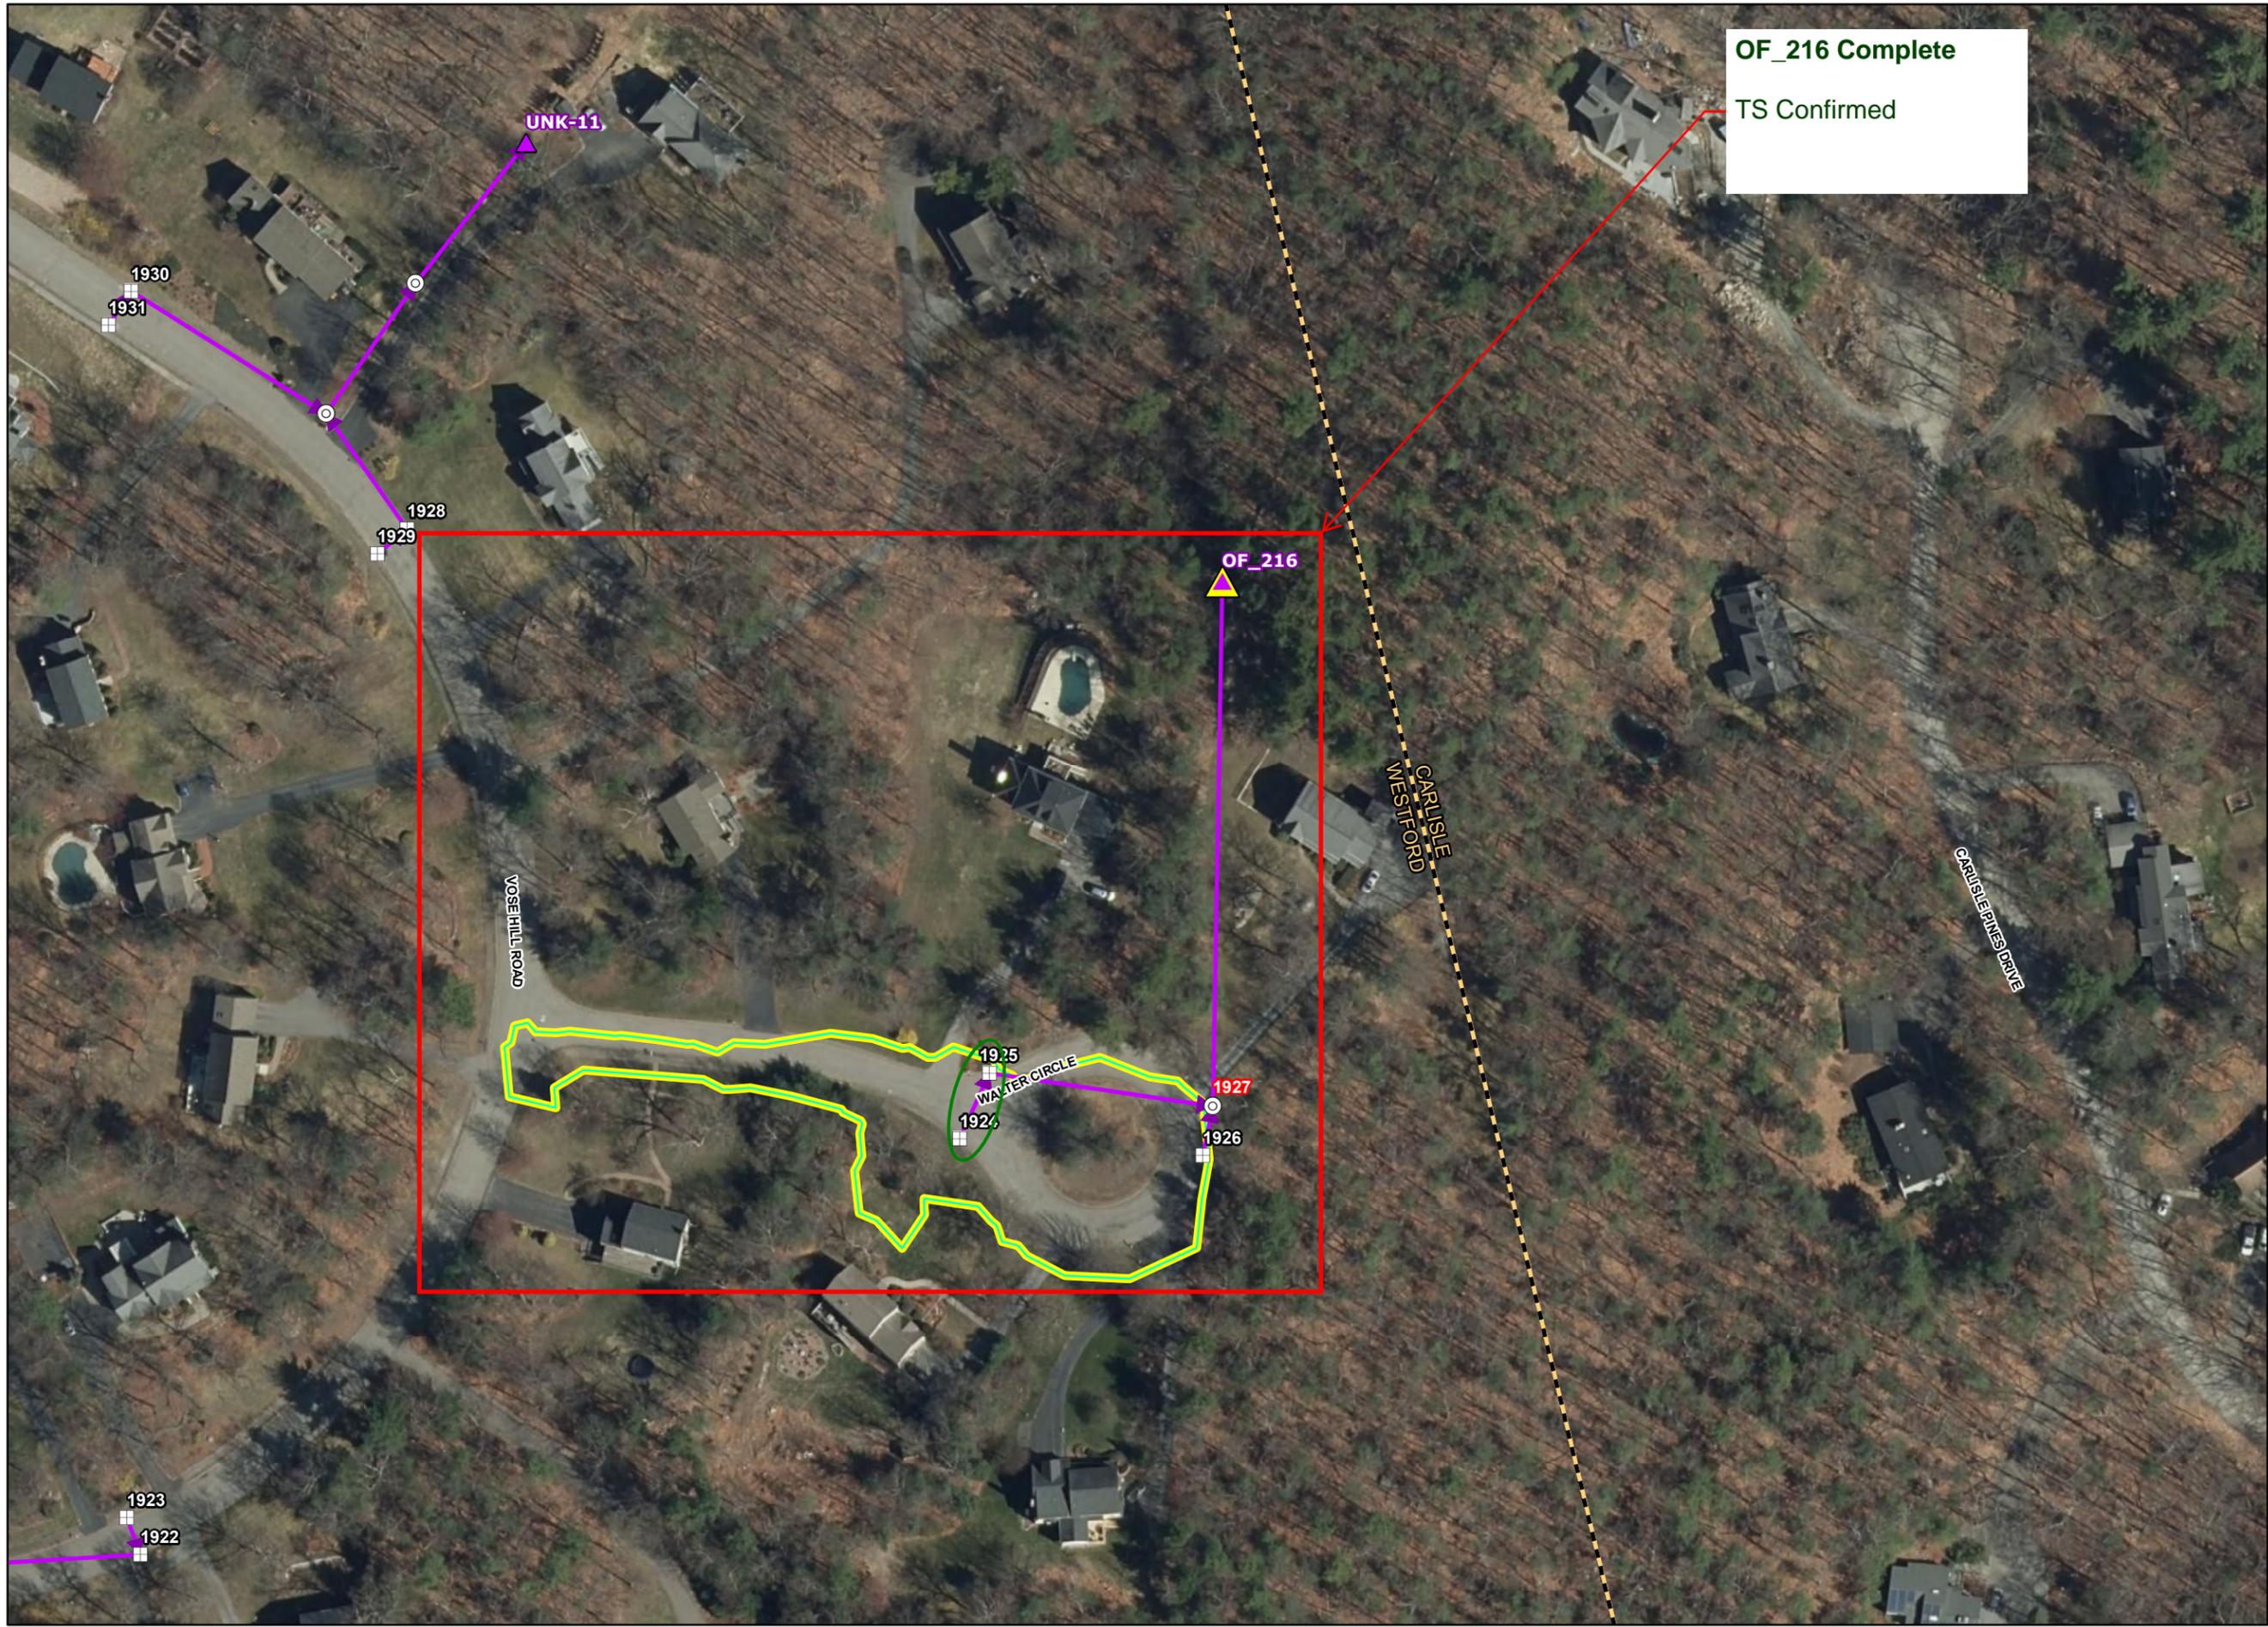
Catchment Area of Outfall: OF_216

OF_216 Complete
 TS Confirmed

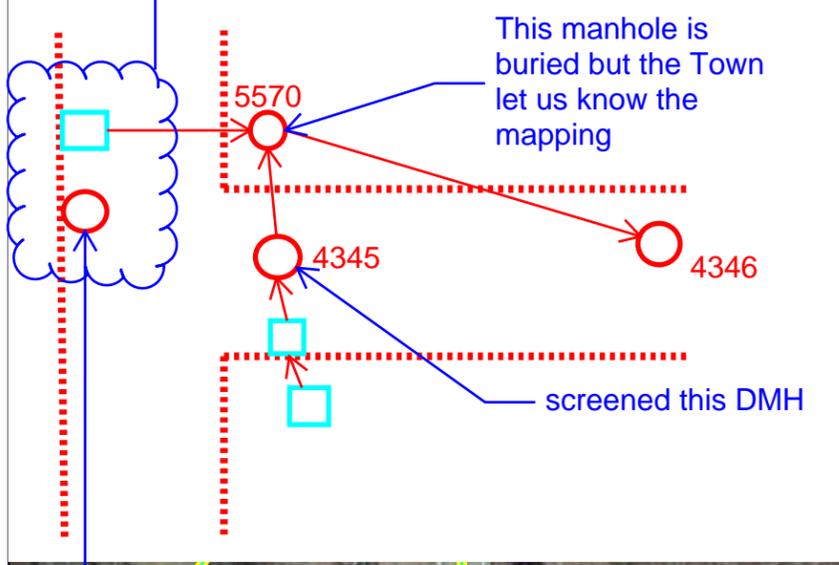
unmapped manhole

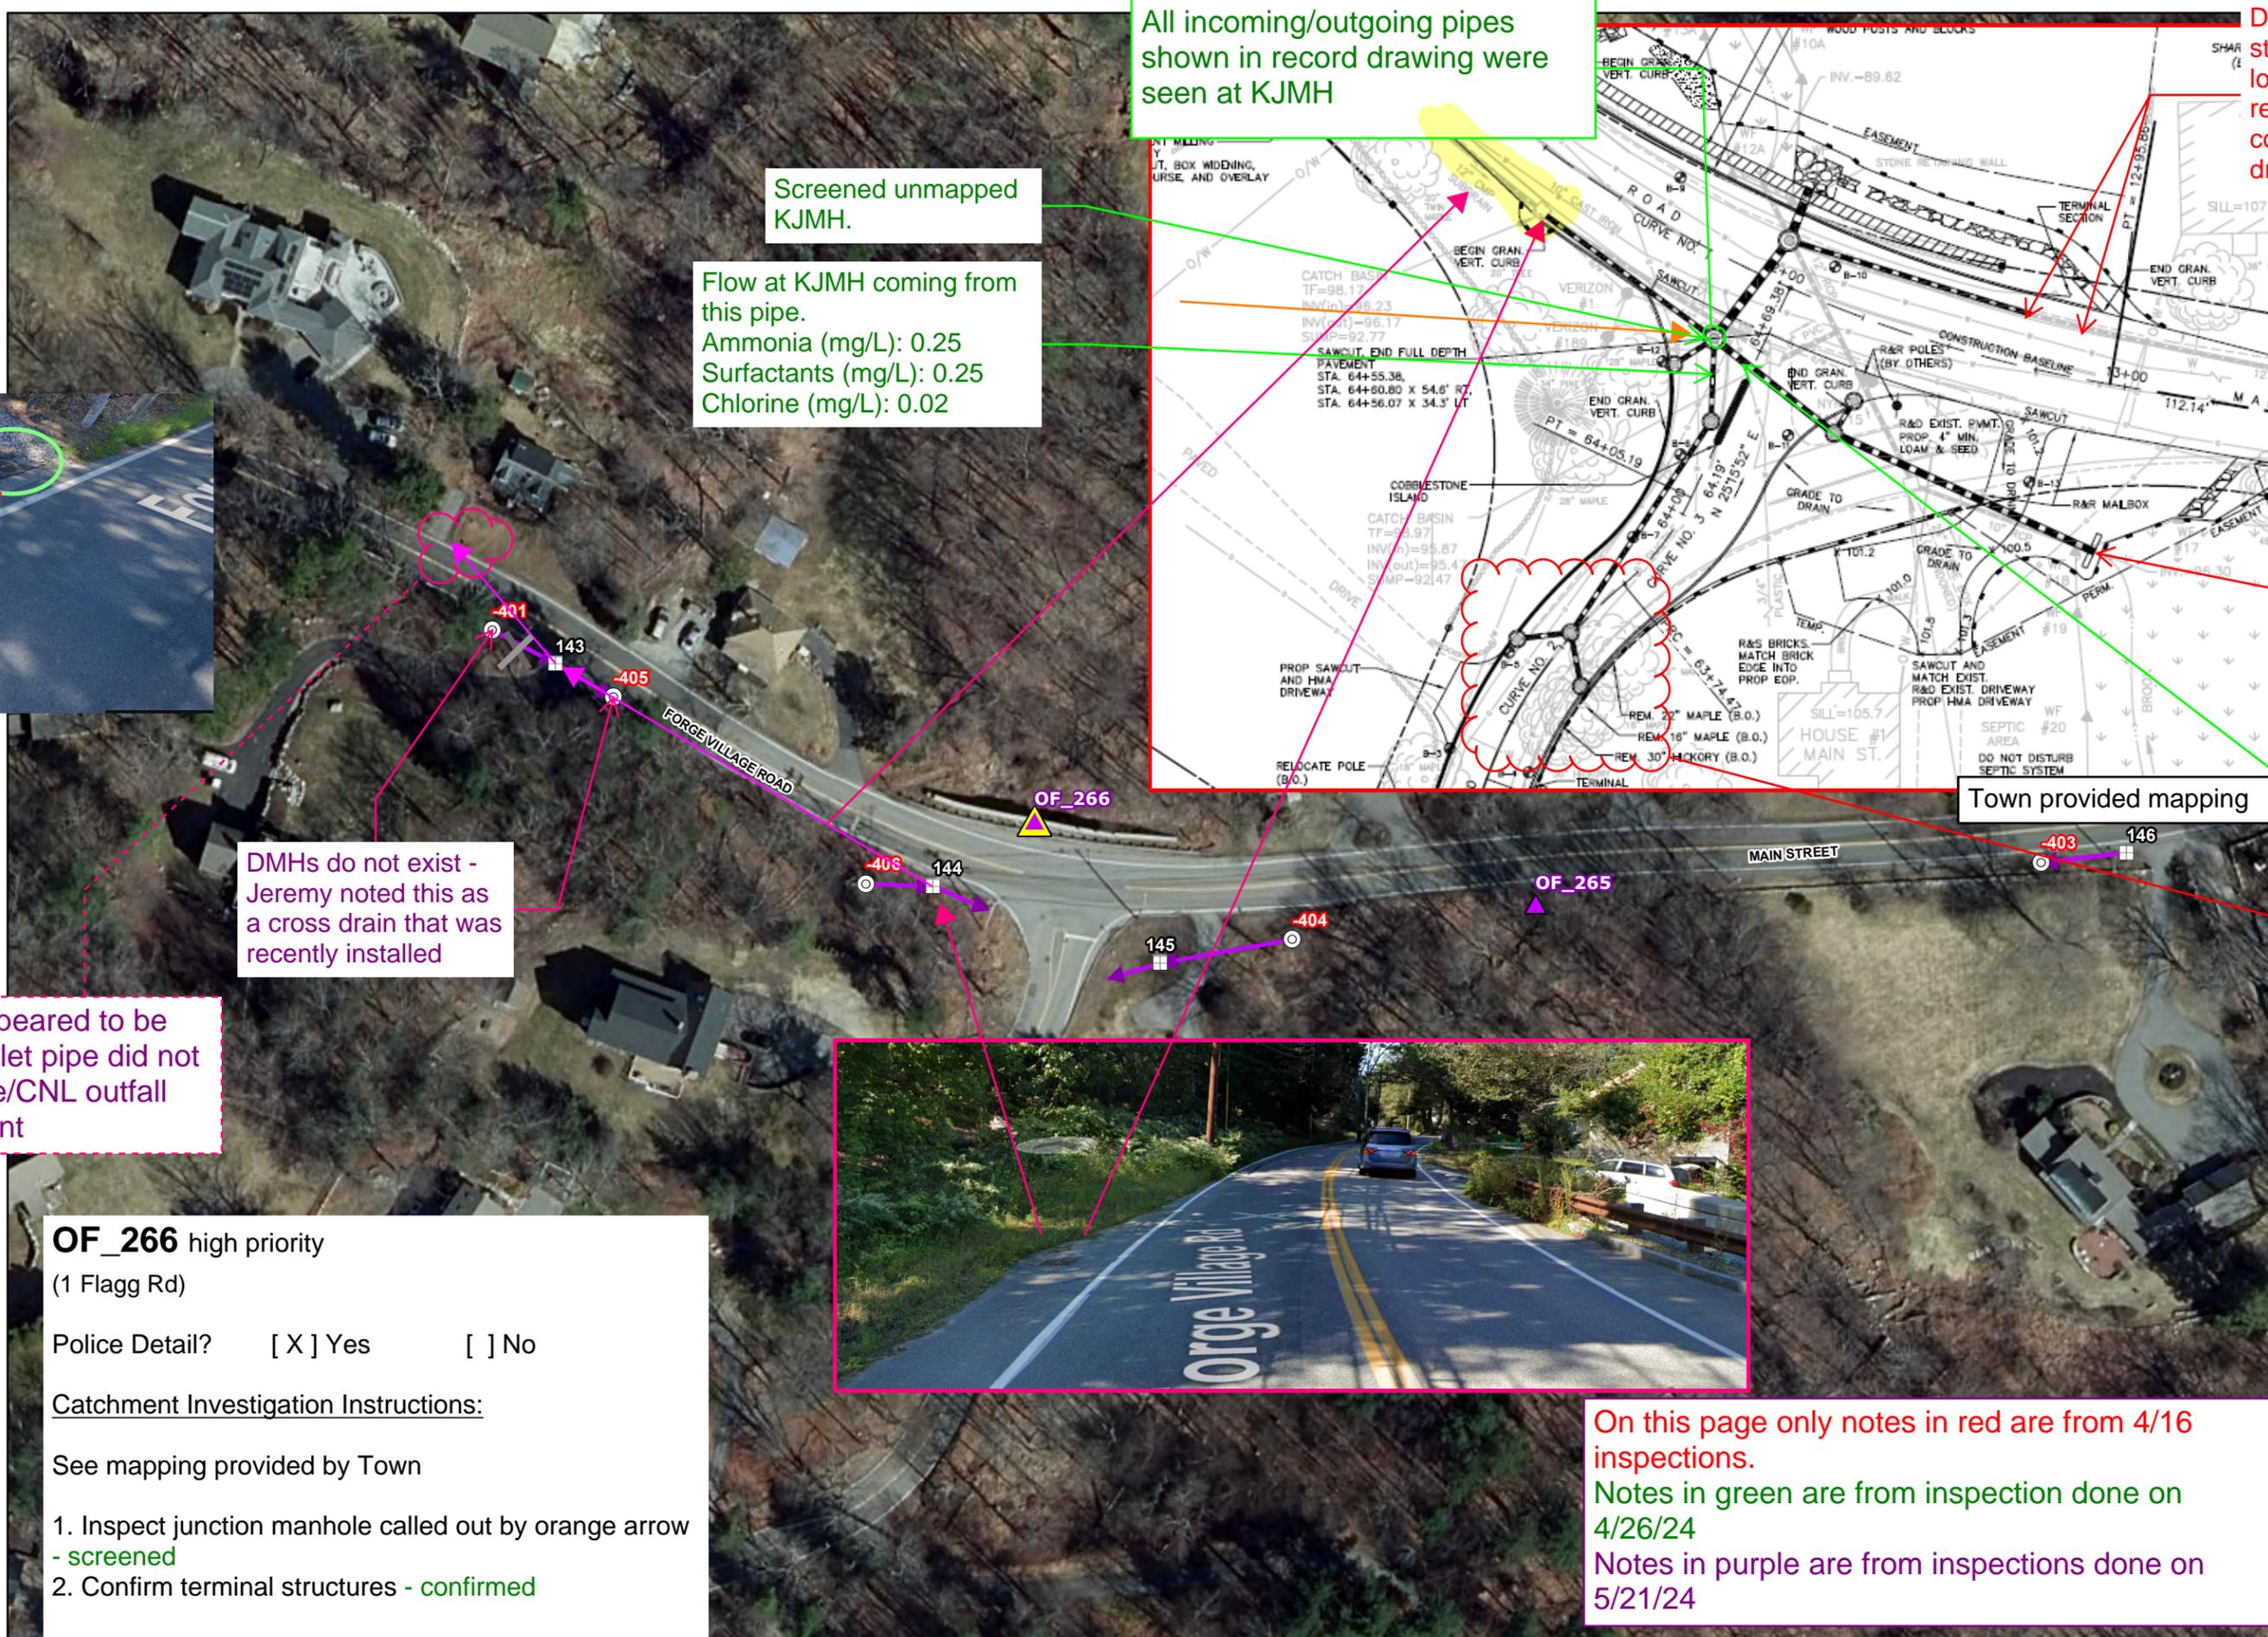
All incoming/outgoing pipes shown in record drawing were seen at KJMH

Screened unmapped KJMH.

DMHs do not exist - Jeremy noted this as a cross drain that was recently installed

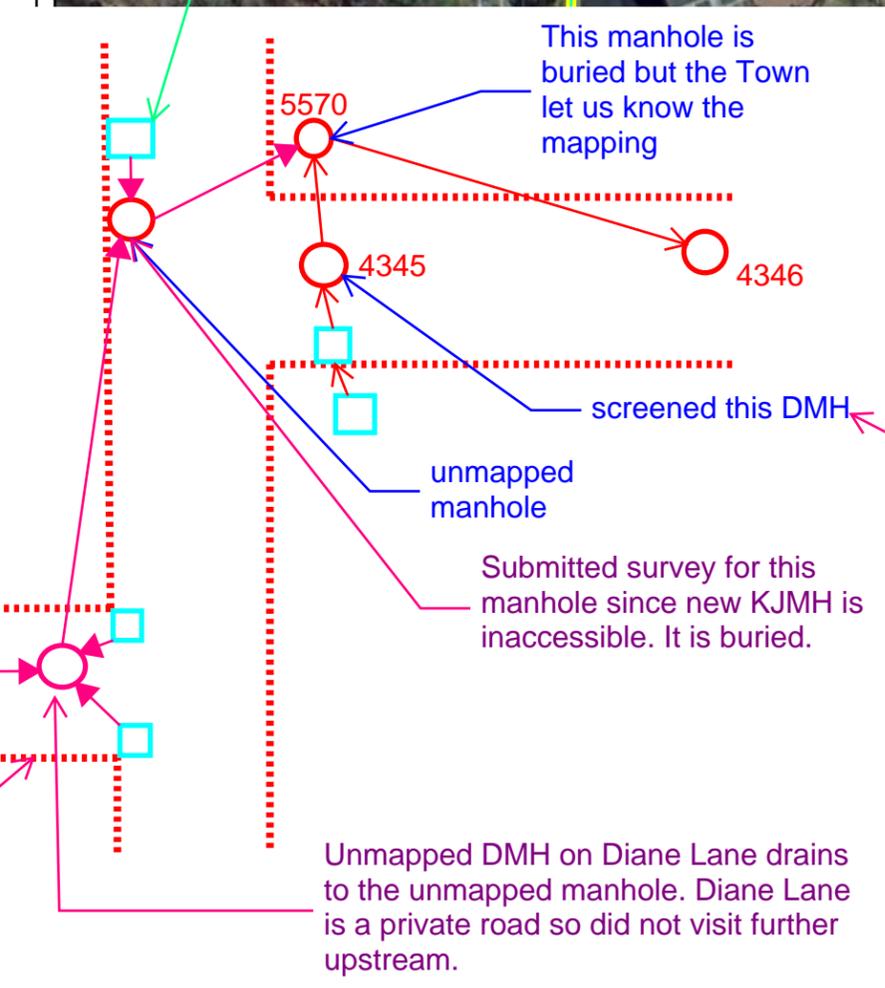
Survey was also previously submitted for this DMH.

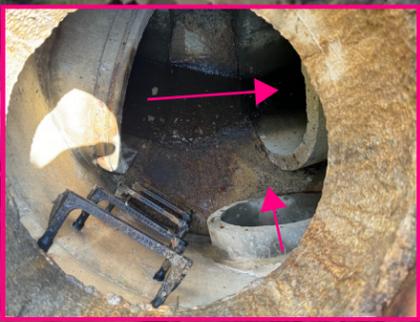
Searched end of culdesac and the woods based on record drawings and still could not locate an inlet

2' RCP pipe with flow could not locate where it comes from. No other drainage structures at end of culdesac

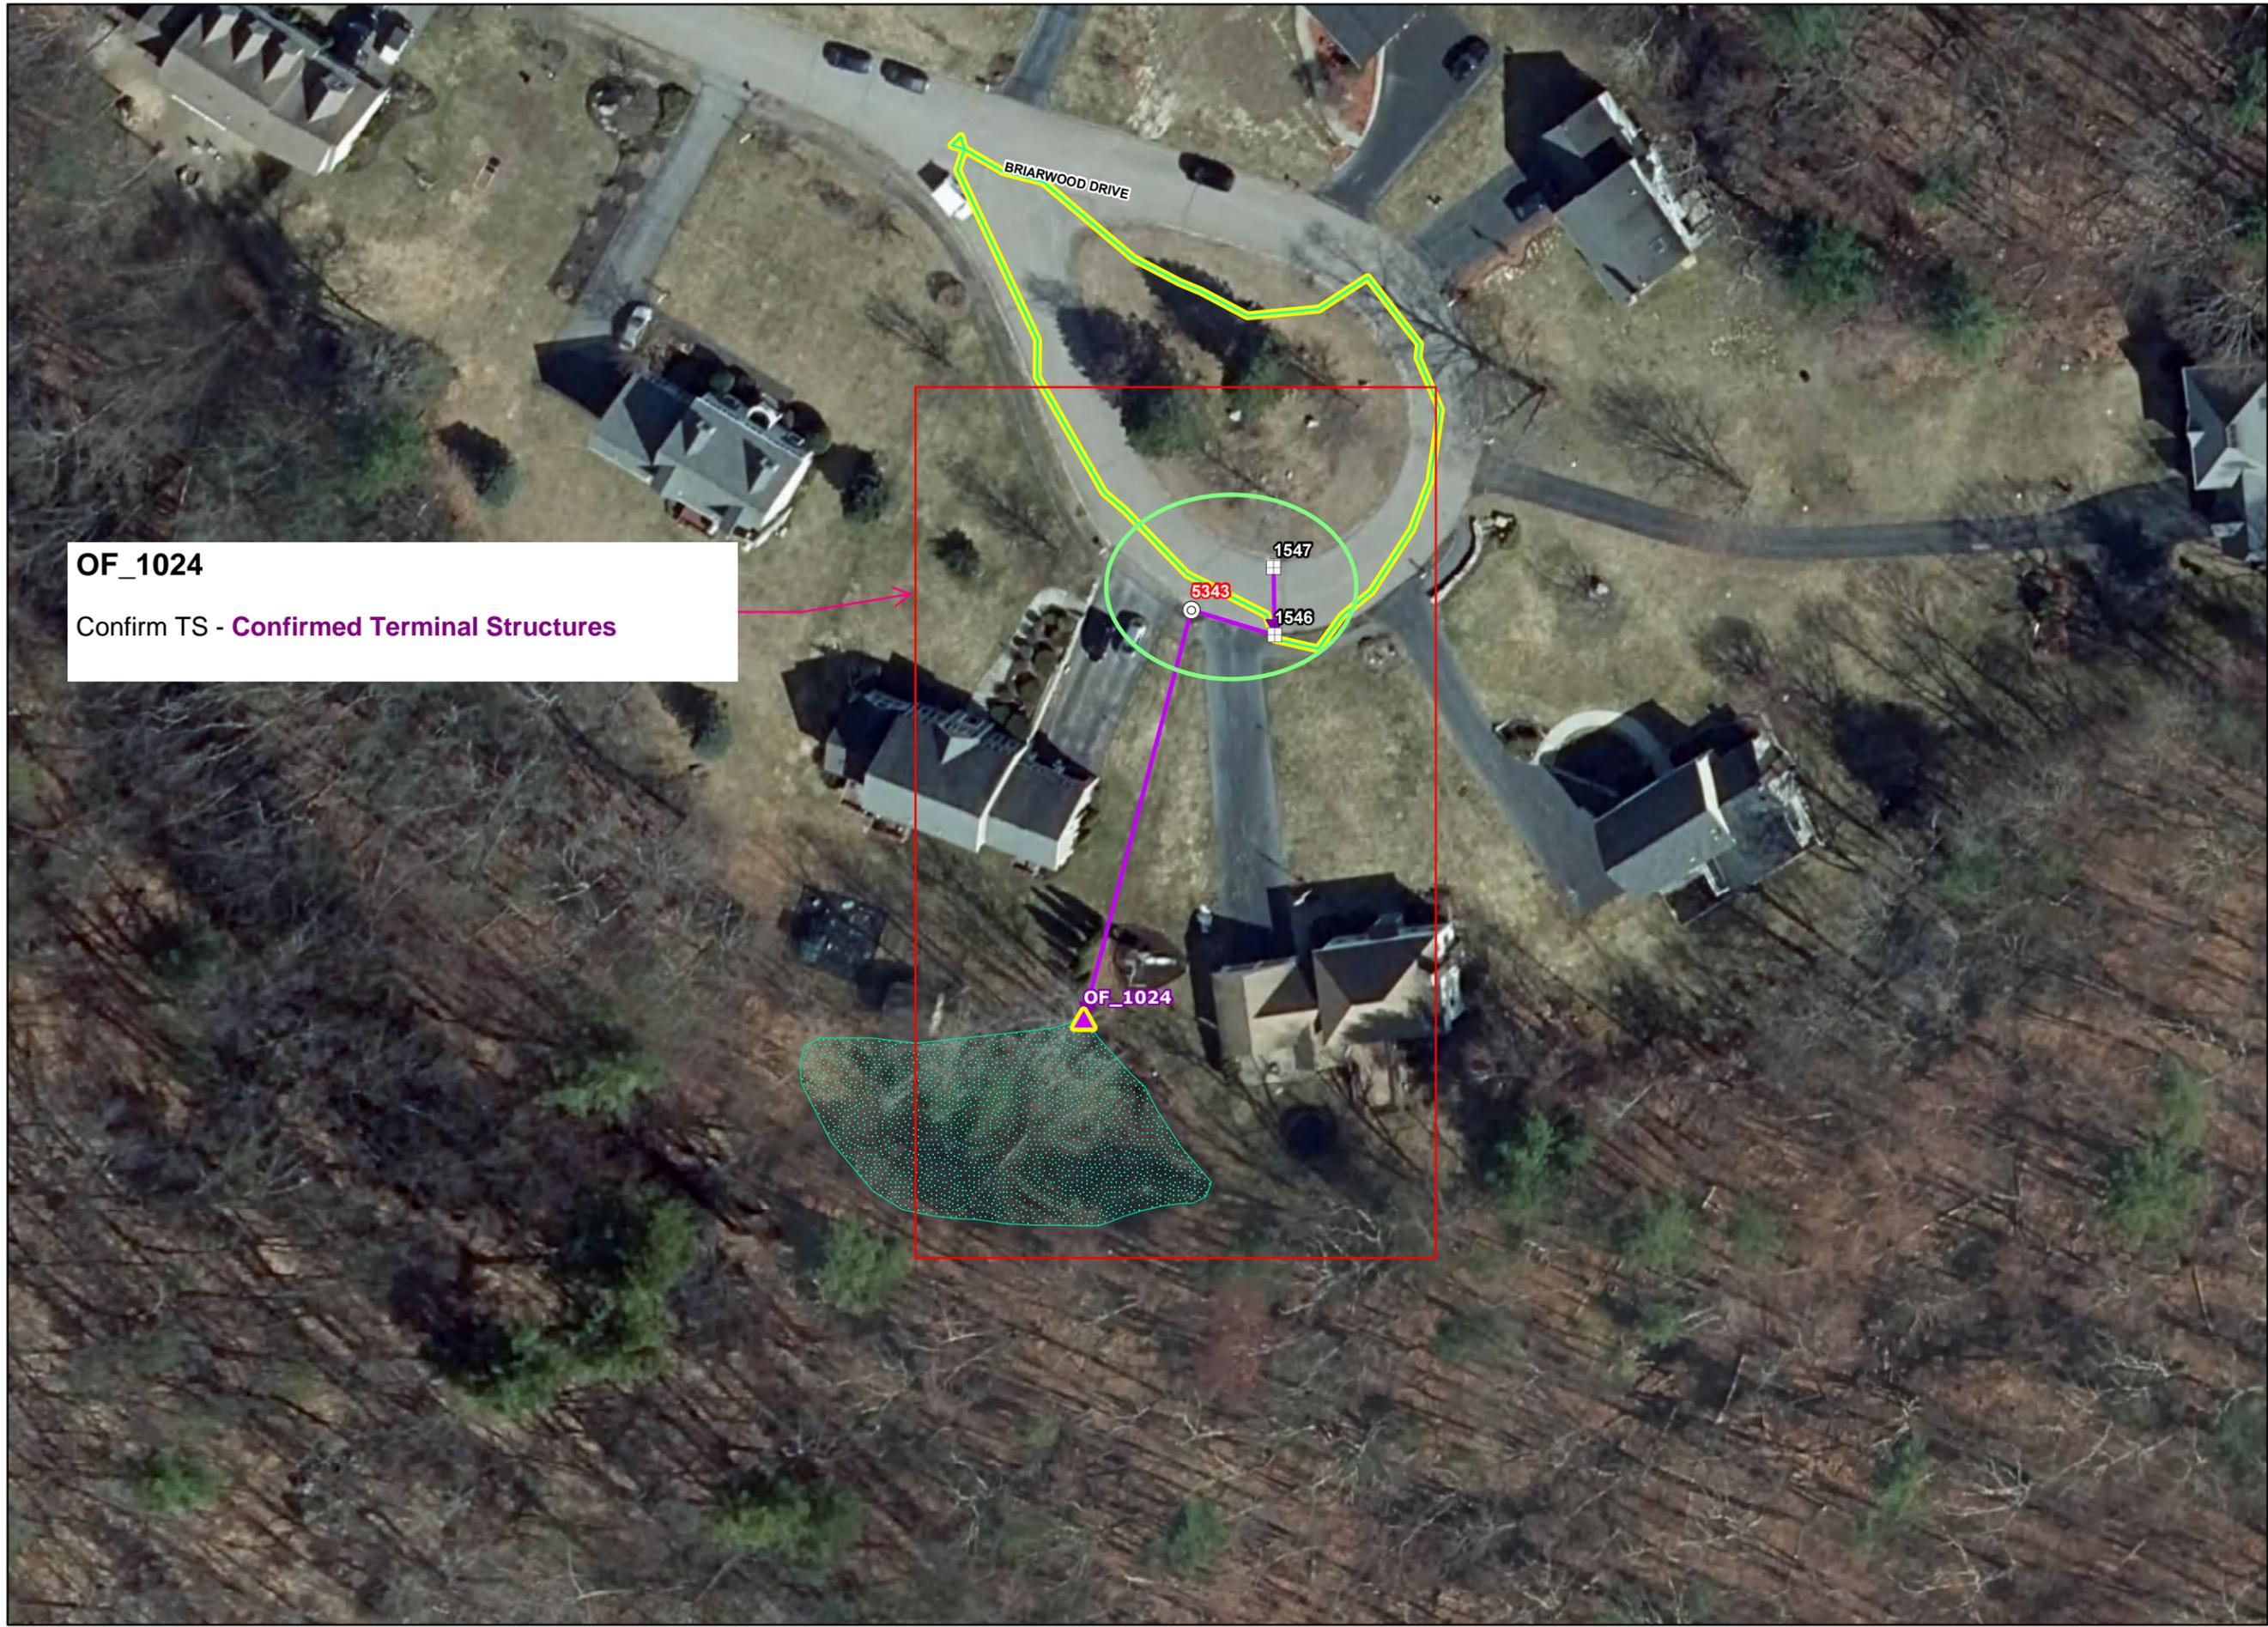
OF_1024
 Confirm TS - **Confirmed Terminal Structures**

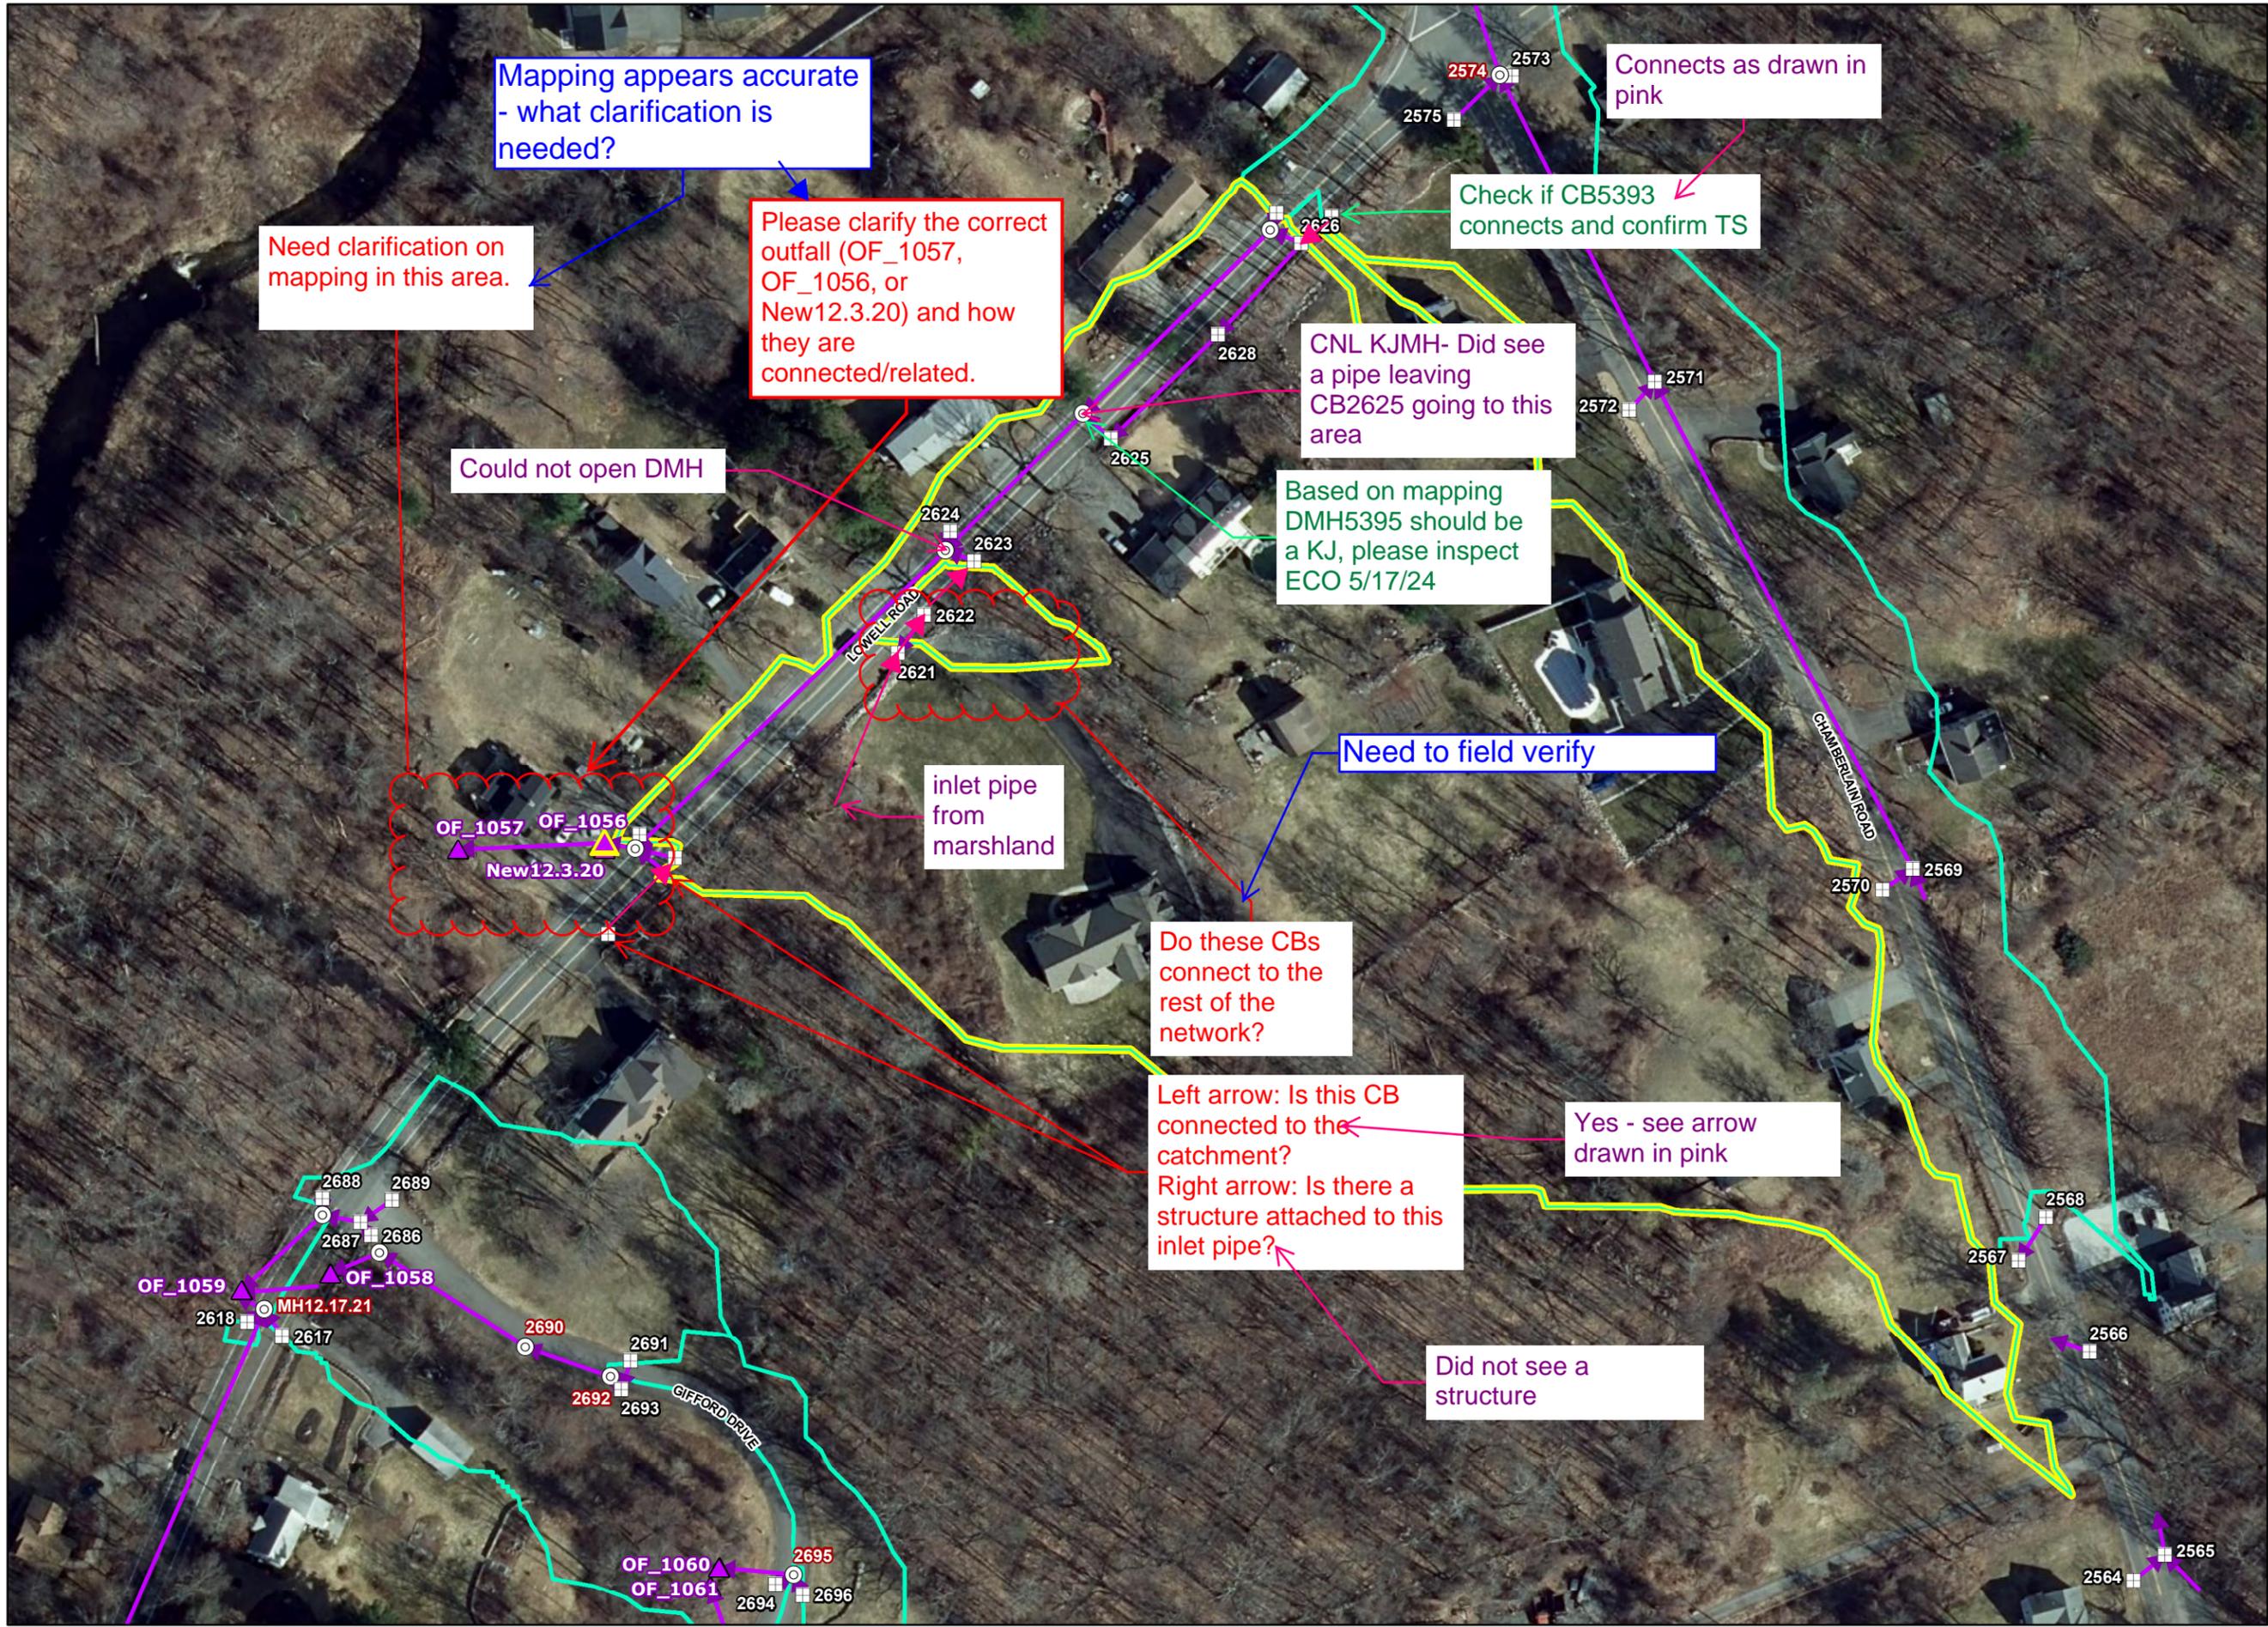
Mapping appears accurate - what clarification is needed?

Need clarification on mapping in this area.
