Proj: Limited Structural Assessment of 12 North Main Street, Westford, RFQ #20-15  
Re: Limited Structural Assessment Report  
CBI Job No. CB200291

In accordance with our Contract, CBI Consulting, LLC, a SOCOTEC Company (CBI), has prepared this limited structural building assessment of the abandoned historic mill building located at 12 North Main Street in Westford, Massachusetts.

**Limited Structural Assessment  
12 North Main St., Westford, MA  
Photo Index  
CBI Job No.: CB200291  
December 4, 2020**

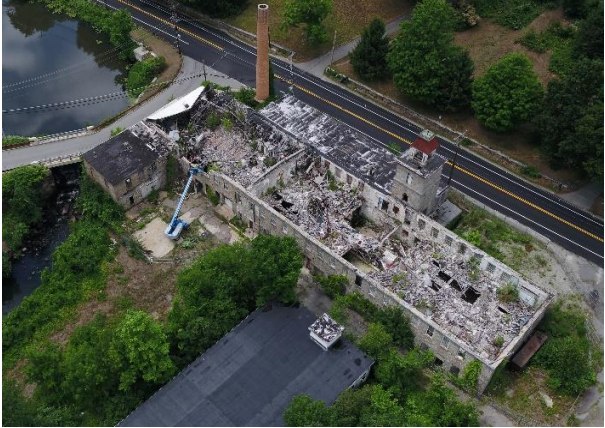
| Photo No. | | Description |
|---|---|---|
| 1. | | Photo 1 of 2 – Overall photo taken from drone of 12 North Main St. |

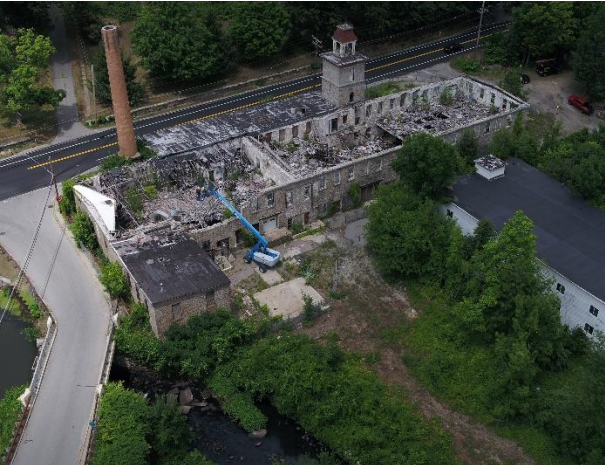
| Photo No. | | Description |
|---|---|---|
| 2. | | Photo 2 of 2 – Overall photo taken from drone of 12 North Main St. |
