IV EXISTING FACILITIES

The Cameron School was originally built in 1872 with an expansion made in 1908 for a total size of about 14,200 square feet. It was used as a school through the late 1980's and in 1993 it was renovated to become the home of the Westford Council on Aging.

CAMERON SENIOR CENTER FEASIBILITY STUDY, Westford, Mass.

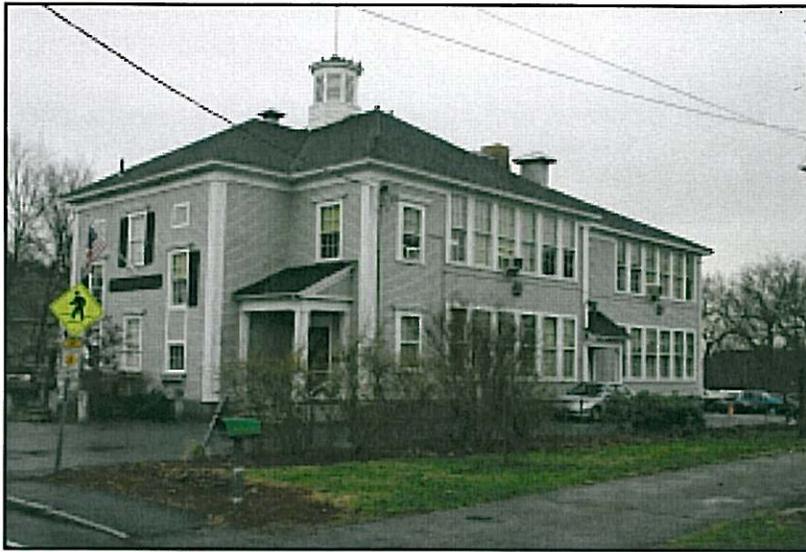
Figure 4.2 Oblique view from northwest.

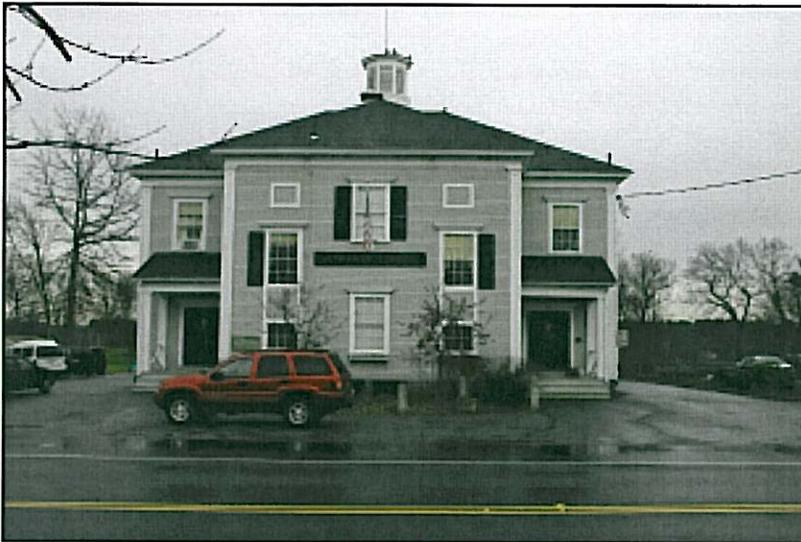
Figure 4.3 Pleasant Street (north) facade of building.

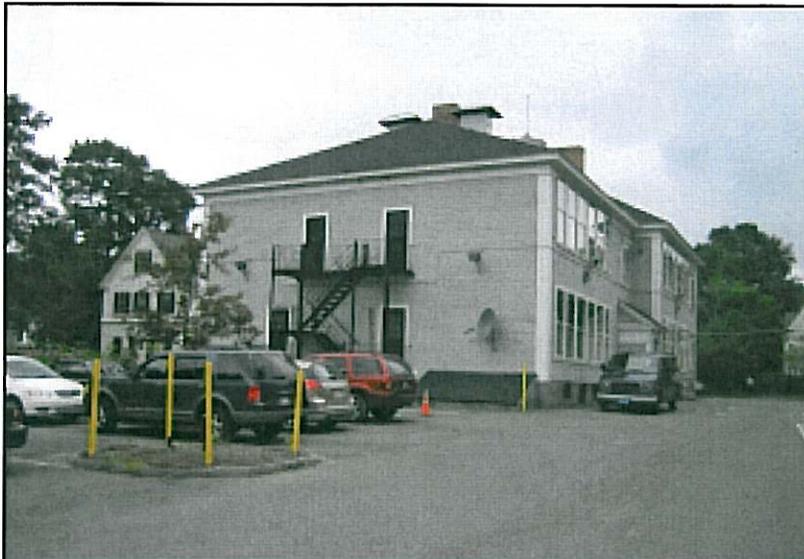
Figure 4.4 View of rear of building (south) and portion of east elevation.

Since there are no gutters along the main roof, there is some water damage to the trim and siding.

Catlin Architecture would encourage the Town to consider replacing the siding with a cementitious plank product and the trim with a PVC product, to significantly reduce the maintenance intervals of the building. The building currently needs to be scraped and painted approximately every 5 to 7 years. The paint on the plank product will fade slightly rather than peel and would require painting approximately every 20 years.

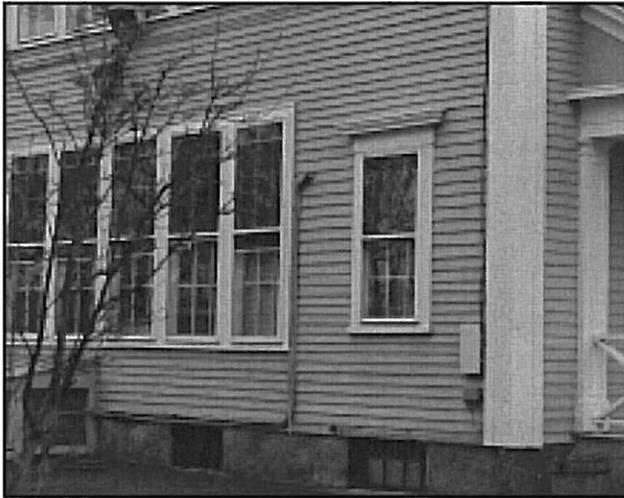
The existing building is clad with wood clapboards with a 4" exposure. The trim is also wood. Individual windows and north porch doors are trimmed with flat stock with molding over the head. The trim around multiple windows and all other exterior doorways is mitered with a small profile moulding at the perimeter. The corner boards (16" wide) have a raised profile and a capital at the eaves. A +/- 8" high frieze runs under the eaves around the full perimeter of the building.

Figure 4.6 Typical window trim types.

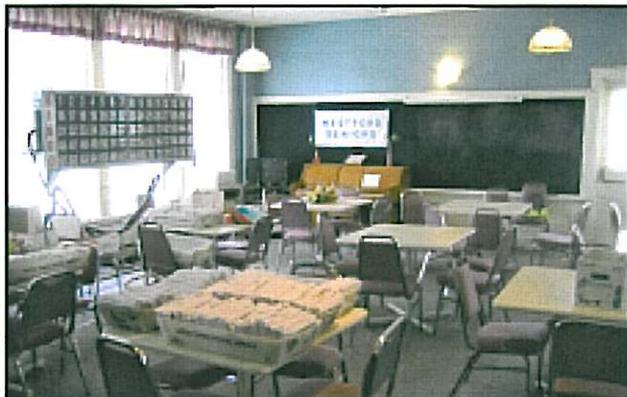
On the first level, the south pair of rooms was combined to create the 1,200 square foot multi-purpose room (dining), with an adjacent non-code compliant kitchen. This room has four free standing columns. The remaining two rooms are used as a lounge and administrative area. Along the full northern edge of the classrooms runs a circulation area that connects the stairs to exterior porches. A janitor's closet / storage room and a handicap accessible toilet room are located along this spine. An open office work space has been located in the western end of this area. Both offices are in conflict with life-safety and building codes.

Figure 4.10 Multipurpose room -- looking southeast.

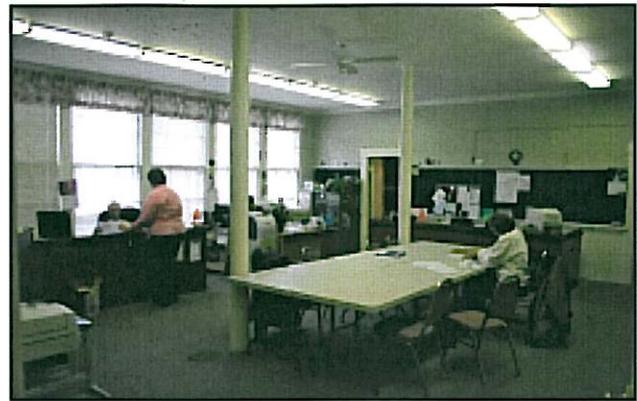
Figure 4.11 Administrative area.

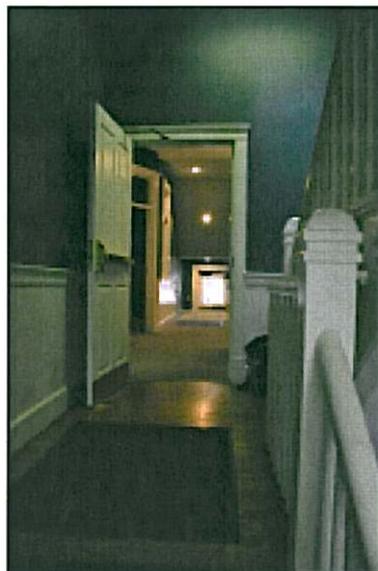
Two of the stairways that mirror each other are located on the north end of the building. These stairways connect all the floors - basement through second - and are open on the first and second levels. Offices, toilets, mechanical rooms are located off of these stairs. Office work areas are also located within this circulation area which is in violation of building code requirements.

*Figure 4.24
View from west stair
through building to
east entry door.*

Under current code (780 CMR 3404.13) all required egress stairs must be enclosed. This will be addressed in the proposed design.

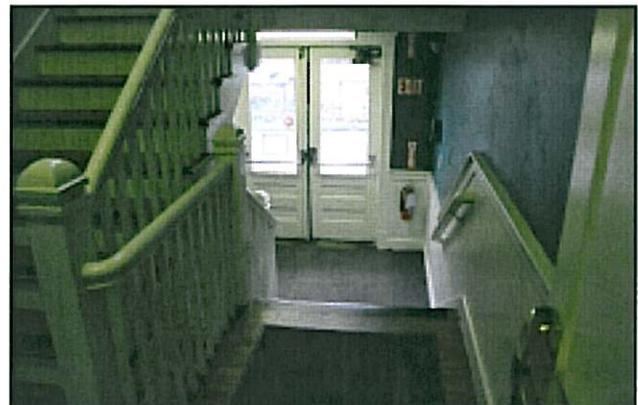
The centrally located stairway has a fire door separating it from the lobby, which was propped open with a wooden wedge. On the second floor level there are double doors separating the stairs from the main level, although these doors do not have a fire rating nor are sealed to prevent smoke from entering the stairwell. Classroom doors on the second floor also open onto the stair landing.

Figure 4.28 Central stair to west service entrance.

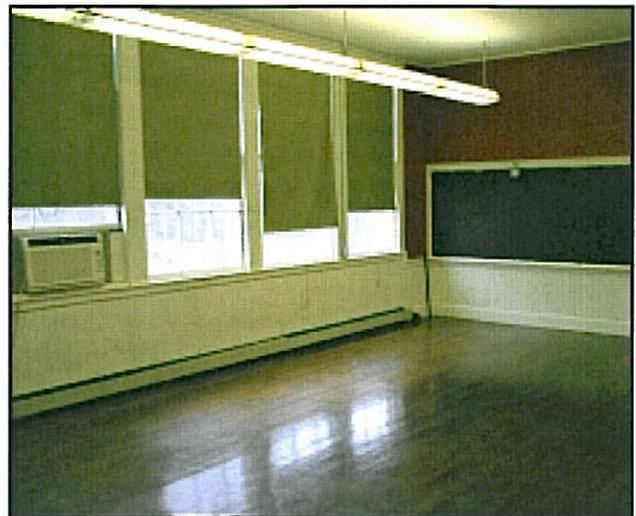
Figure 4.30 Hardwood maple flooring and bead board wainscot in exercise room. Also, note perimeter forced hot water base board and window air conditioning unit.

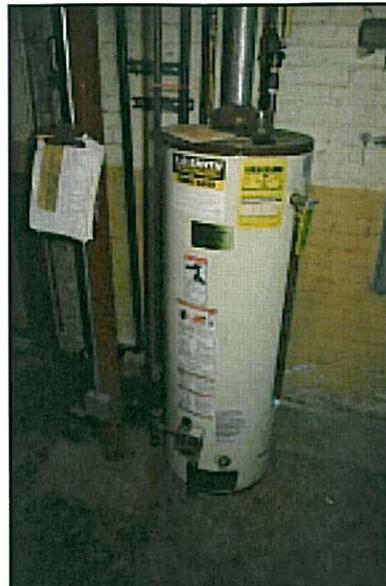
The gas-fired water heater provides domestic hot water to the building.

Figure 4.33 Gas-fired domestic hot water boiler.

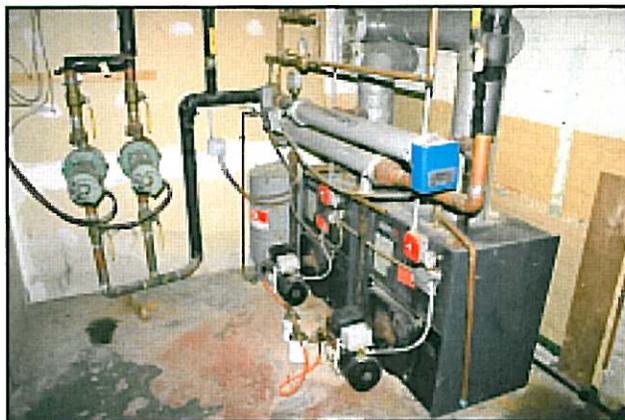
An oil-fired boiler provides forced hot water that is fed throughout the building with perimeter baseboard. The oil tank is located in the parking lot and is slated for removal. Testing is needed to confirm that the tank has not leaked.

Figure 4.31 Oil-fired hot water boilers.

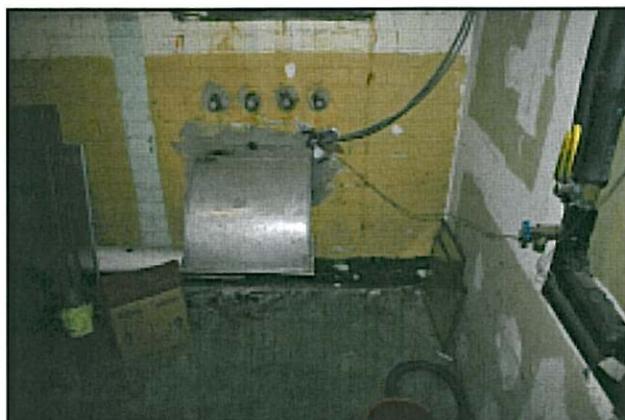
Make-up air is provided to the mechanical room via a vent.

Figure 4.32 Make-up air in boiler room.

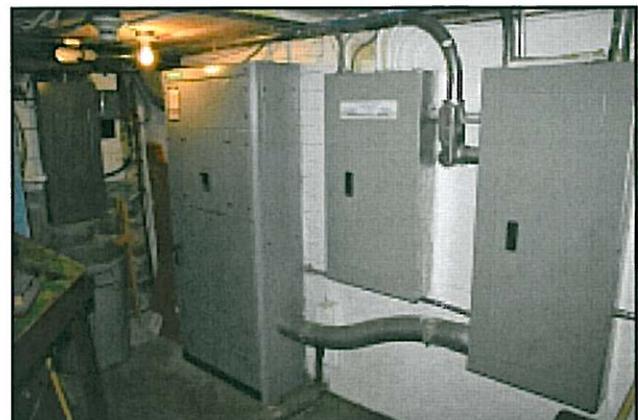
Electrical service 400 Amp

Figure 4.36 Main 440 AMP 120/208 power panels.
