STORMWATER MANAGEMENT MASTER PLAN

Volume 2: Long-Term Capital Improvement Plan

December 2018 - Revised February 2019

WESTFORD

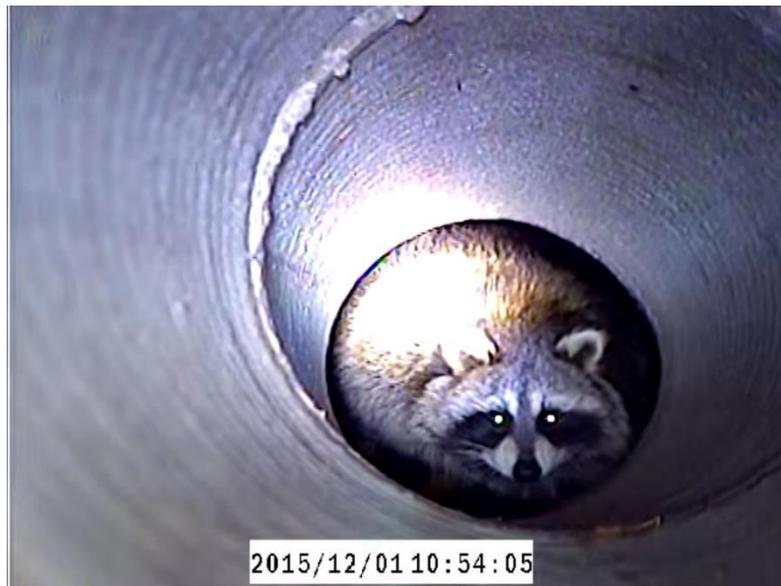
Figure 4-3 A Raccoon was Found in a Drain During Inspection

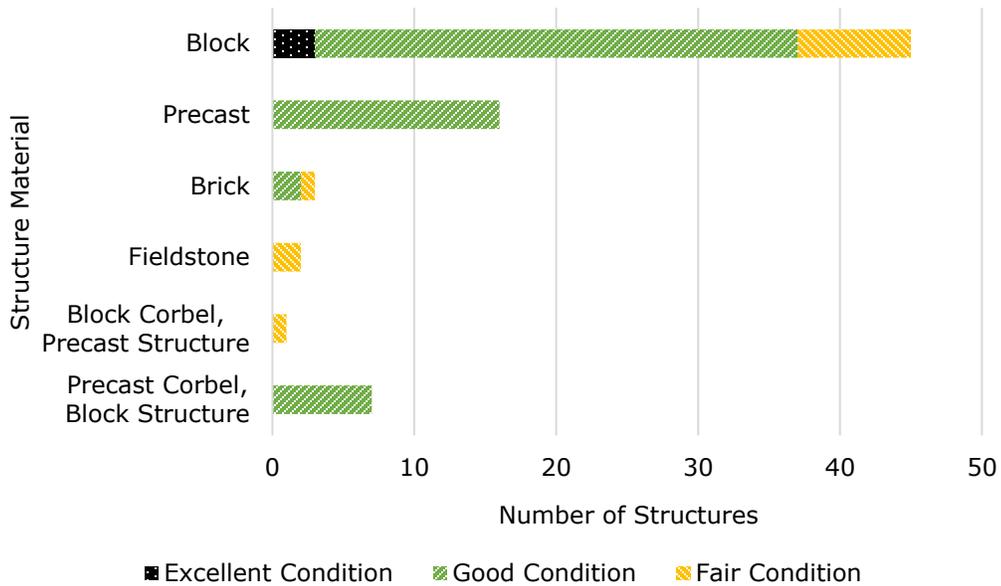
Figure 5-5 Condition of Inspected Structures by Material

Figure 5-5 includes the condition of each of the inspected drain structures by material. **84 percent of the inspected structures were in good or excellent condition. Only 16 percent were in fair condition, and no structures were in poor condition.**

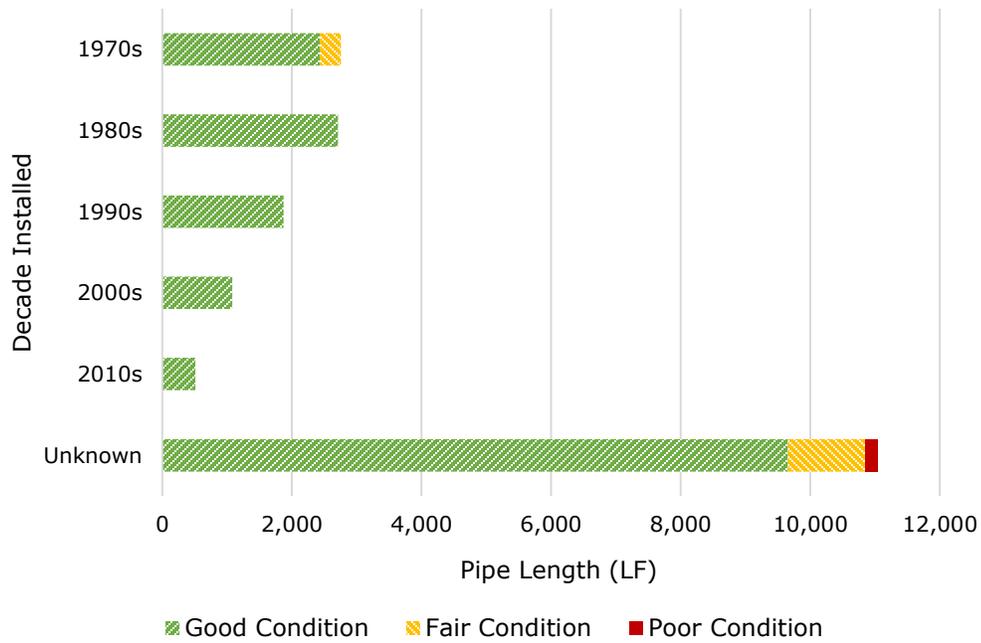
Figure 5-9 Distribution of Pipe Condition of Inspected Pipes by Date Installed

The following figures include charts of the condition of the inspected pipes. Figure 5-9 includes the drain pipes in "good", "fair", and "poor" condition by the decade of installation. Since most of the pipes do not have known installation dates (reference discussion in Section 3.2.6 for more details), most of the pipes are in an "Unknown" installation date category.

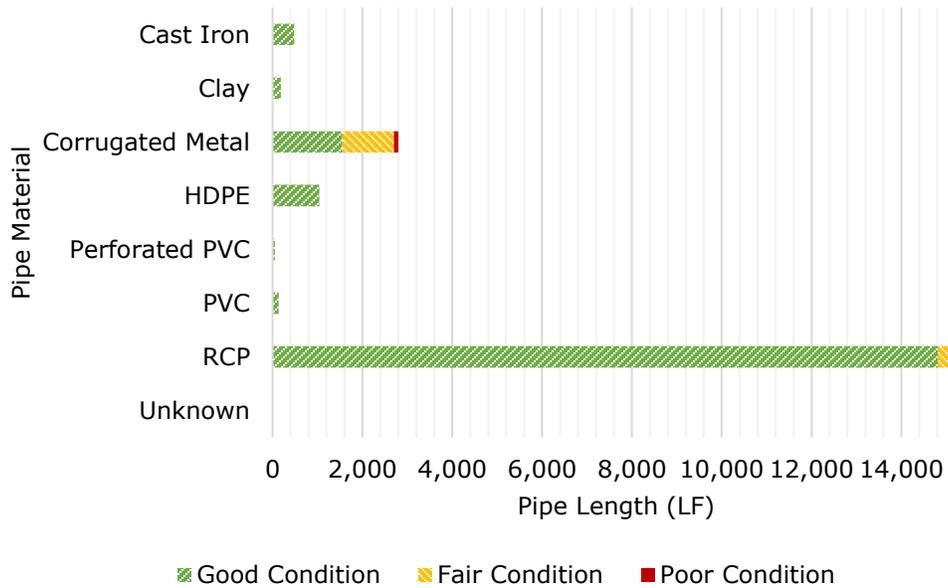
Figure 5-10 Distribution of Pipe Condition of Inspected Pipes by Material

Figure 5-10 includes the breakdown of pipe condition by pipe material. Almost all of the reinforced concrete pipes inspected were in good condition. Almost half of the corrugated metal pipes were in fair or poor condition. It is evident from Figure 5-10 that corrugated metal pipes are in worse condition than the rest of the pipe materials in the drainage system.

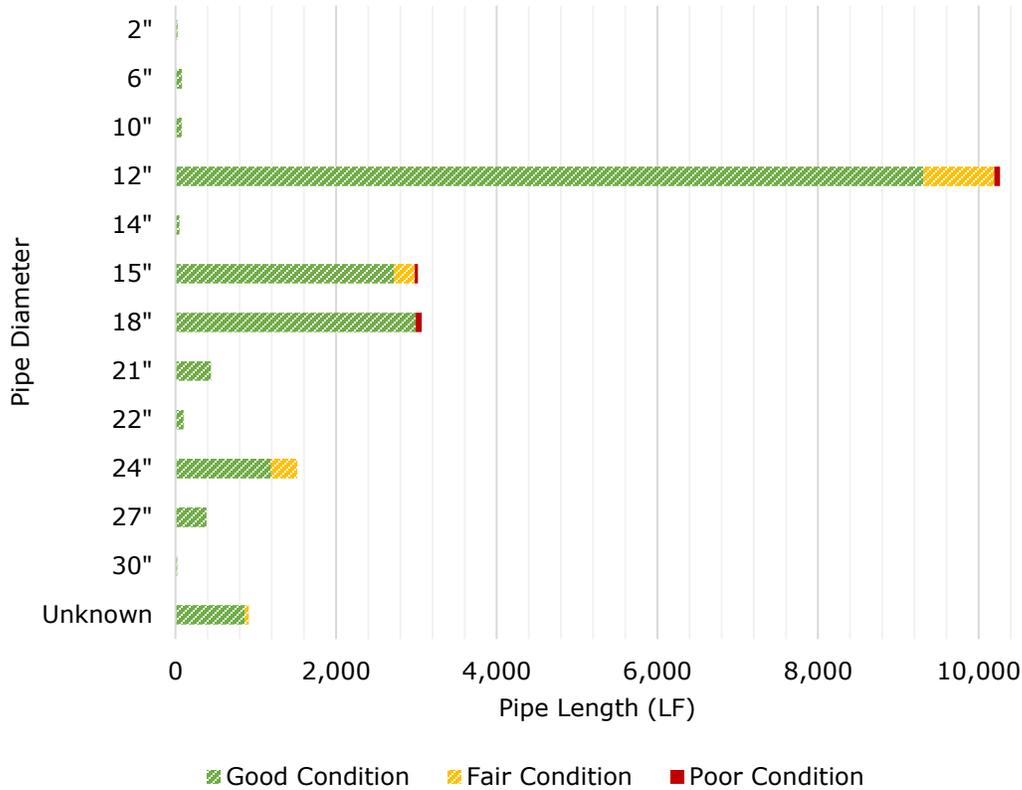
Figure 5-11 Distribution of Pipe Condition of Inspected Pipes by Diameter

Figure 5-11 includes the distribution of inspected drain pipe condition by pipe size.

It is evident from these charts that the majority of the inspected pipelines were in good condition.

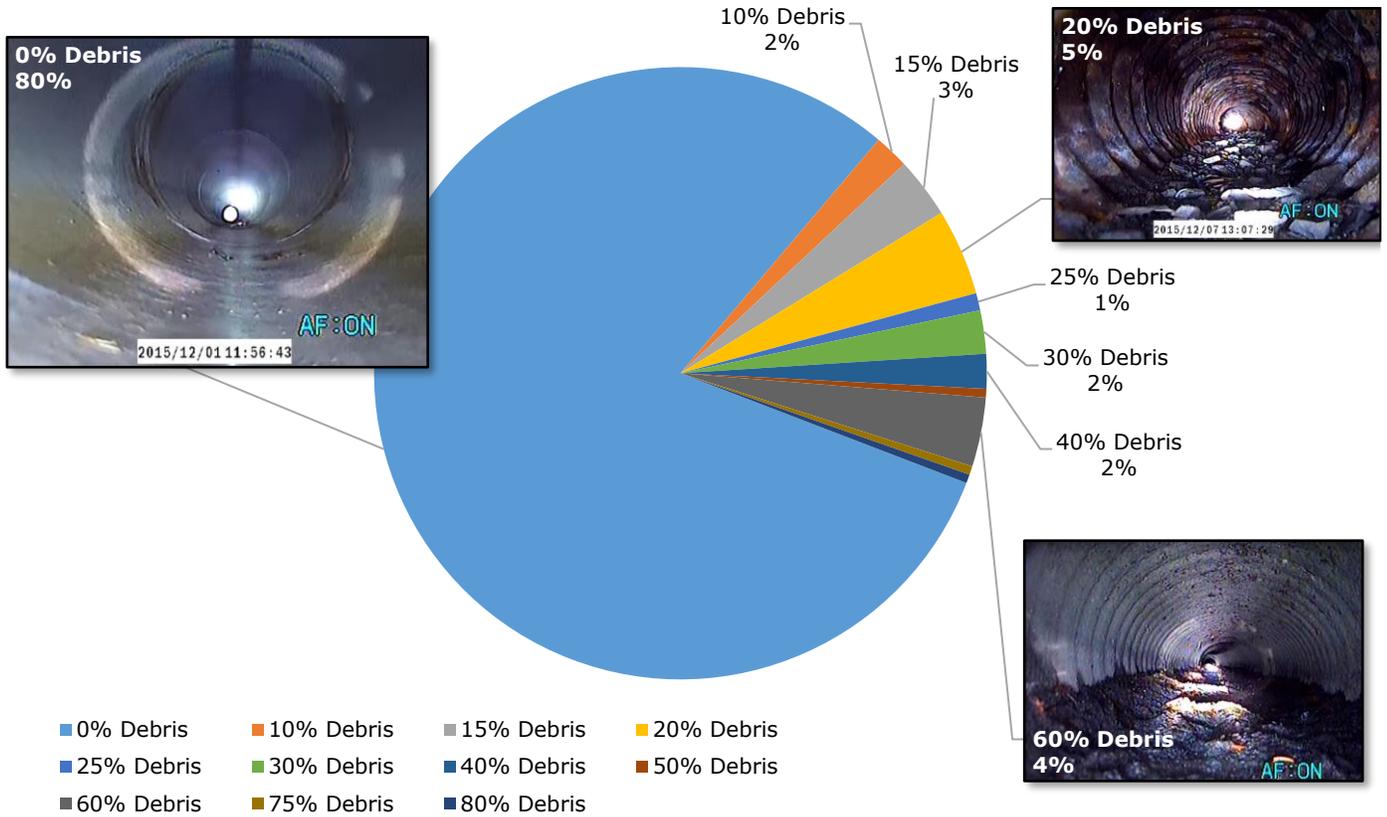
Figure 5-13 Distribution of Inspected Pipes Containing Debris/Sediment Buildup

Figure 5-13 includes the distribution of pipelines with debris. The photos in the chart demonstrate examples of pipelines that were observed to be empty of debris, 20 percent full of debris, and 60 percent full of debris during the field inspections.

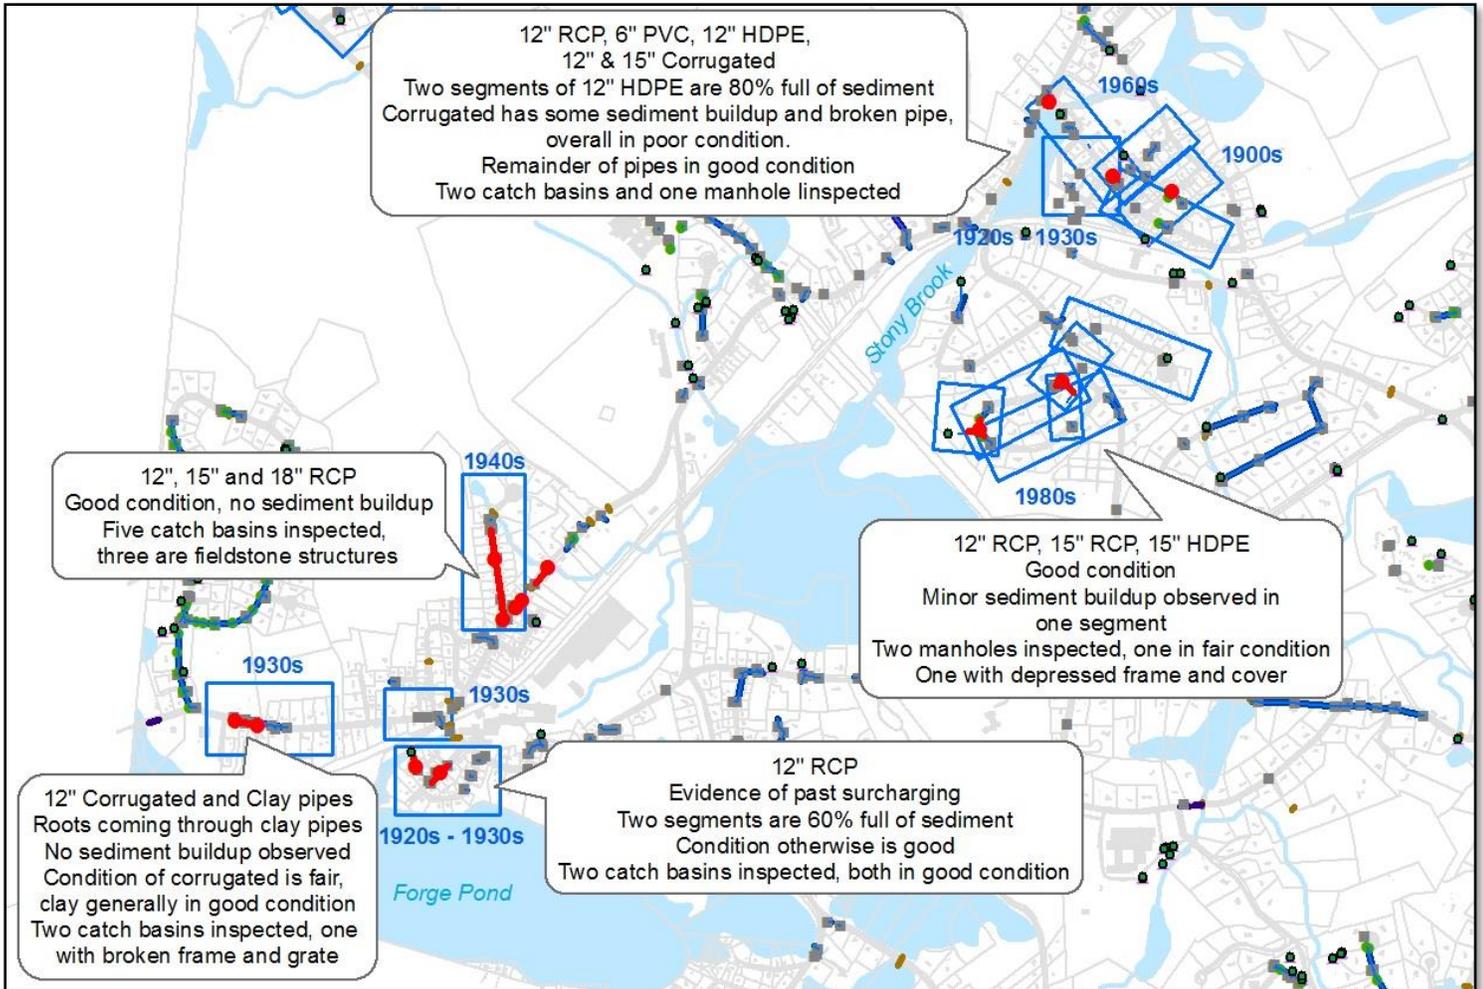
Figure 5-14 Example of Results from Rapid Condition Assessment Field Work

Figure 5-14 demonstrates examples of conclusions that were drawn from the rapid condition assessment field work completed by Tighe & Bond and Town staff. The blue rectangles indicate the plan extents of record drawings that were scanned and added to the Town's GIS.
