BEACON STREET SCHOOL MAINTENANCE FACILITY

28 Beacon Street

Year Constructed: 1963
Year of Renovation/Addition: NONE
Building Type: S-2
Construction Type: III B
Fire sprinklers: No
Total Floor Area: 10,735 SF
Floors: First
Assessor Lot # 030 0045 0000

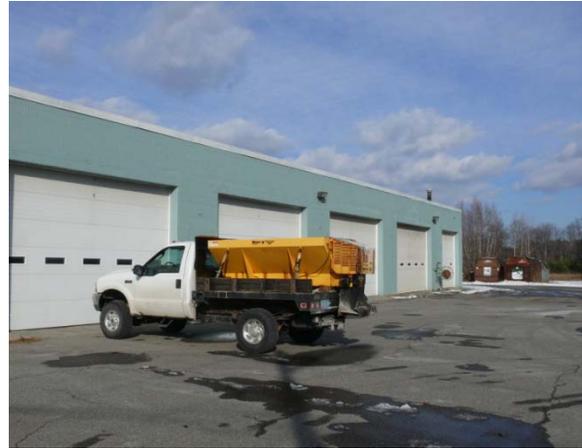
GENERAL: The building appears to provide ample space for the activities and equipment of the School Maintenance Department. The main structure appears basically sound but needs some improvements to prevent future accelerated deterioration. A rear shed has been added to the building with a questionable structure that can be reinforced. Portable spaces have been added to one end of the building. One section should be removed. The other one is not of quality construction but apparently meet the office space needs of the building. Floor levels do not align and an extended ramp system needs to be developed. The office space wing appears underutilized, although it is reported used during the summer months. If this is ever increased to a full year use replacement with a permanent structure should be considered. The septic system is not functioning properly.
