MUSEUM COTTAGE

4 Boston Road

Year Constructed: 1900
Year of Renovation/Addition: Unknown
Building Type: B
Construction Type: VB
Fire sprinklers: No
Total Floor Area: 2,200 SF
Floors: Basement, First and Second.

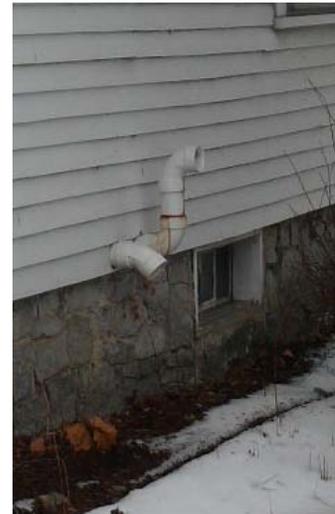
- 2 Furnace is vented out through a side wall at the top of the foundation wall, a sign must be posted since it's termination point is below seven feet above grade.
