ROGER'S FIRE STATION STORAGE BARN

39 Town Farm Road

Year Constructed: 1920
Year of Renovation/Addition: None
Building Type: S-2
Construction Type: IV
Fire sprinklers: No
Total Floor Area: 3,500 SF
Floors: First.
Assessor Lot # 024 0022 0000

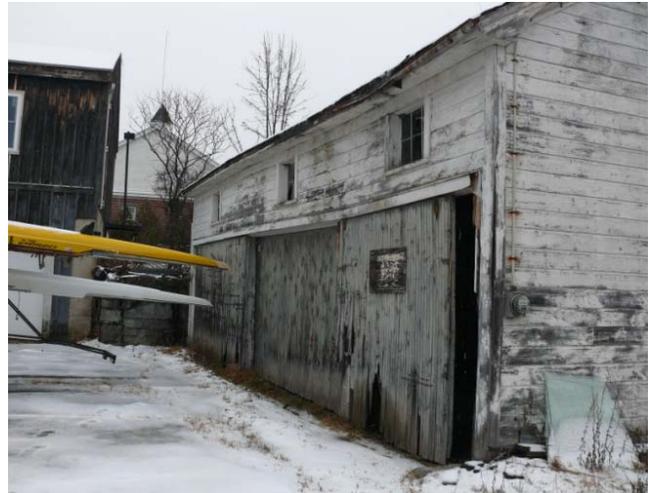
GENERAL: This is a historic structure whose exterior envelop is badly deteriorated and in need of much work. The wood structure will also need work to make this a viable building. Consideration should be given to replace this building with a new structure (if it's use is still required) or to demolish the building. From a historical standpoint, it does share the site with the Town Farm Building and make therefore be considered a contributing building to the complex.
