Proj: Limited Structural Assessment of 12 North Main Street, Westford, RFQ #20-15
Re: Limited Structural Assessment Report
CBI Job No. CB200291

In accordance with our Contract, CBI Consulting, LLC, a SOCOTEC Company (CBI), has prepared this limited structural building assessment of the abandoned historic mill building located at 12 North Main Street in Westford, Massachusetts.

Limited Structural Assessment
12 North Main St., Westford, MA
Photo Index
CBI Job No.: CB200291
December 4, 2020

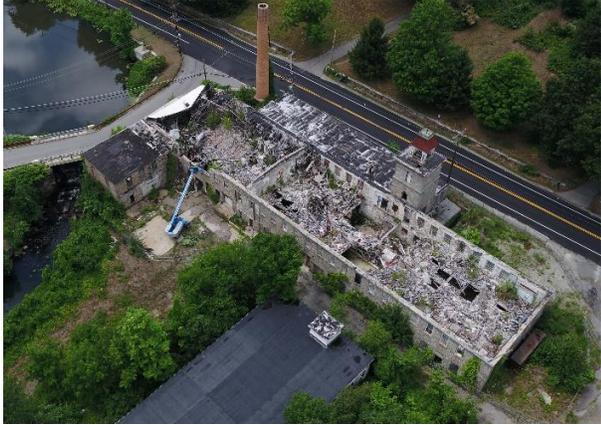
| Photo No. | | Description |
|---|---|--|
| 1. | | Photo 1 of 2 – Overall photo taken from drone of 12 North Main St. |

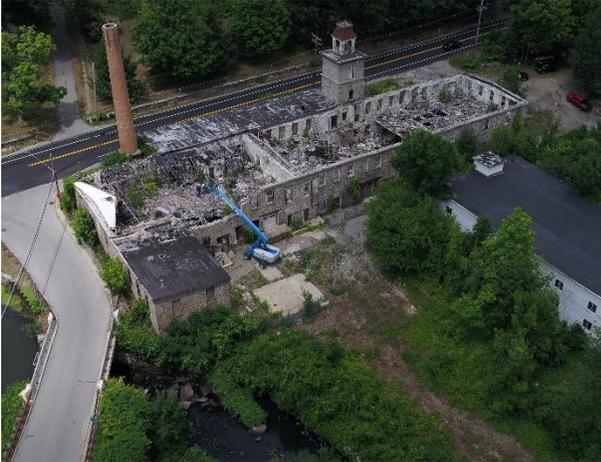
| Photo No. | | Description |
|---|---|--|
| 2. | | Photo 2 of 2 – Overall photo taken from drone of 12 North Main St. |

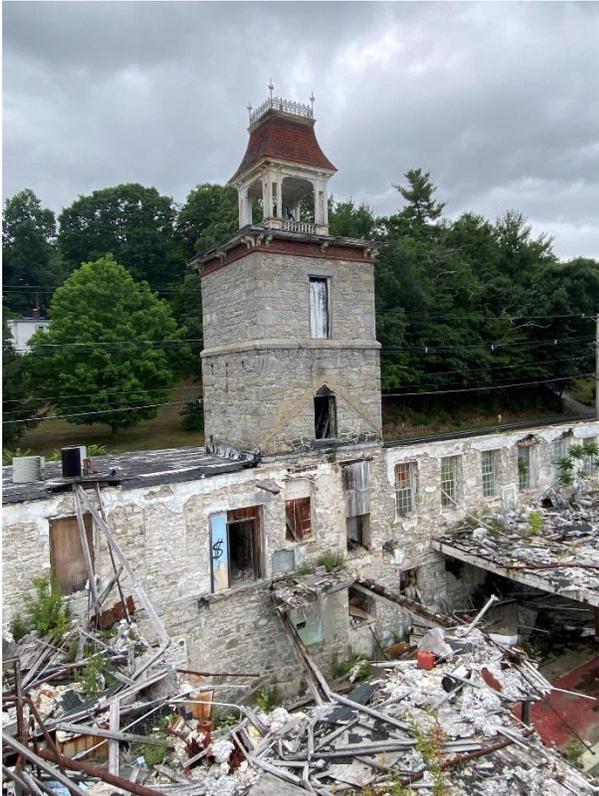
| <p>3</p> | | <p>Partial overall photo taken from the lift showing the south and west elevations of the bell tower.</p> |

- Engage a masonry contractor, and crane, to access the Bell Tower to remove or secure any materials that may pose as potential fall hazards. Additionally, the existing brick masonry smokestack requires deep mortar joint repointing from the exterior. Once the building has been determined safe for interior access, the interior of the Smokestack should also require 100% deep mortar joint repointing to ensure long term structural stability of the structure.

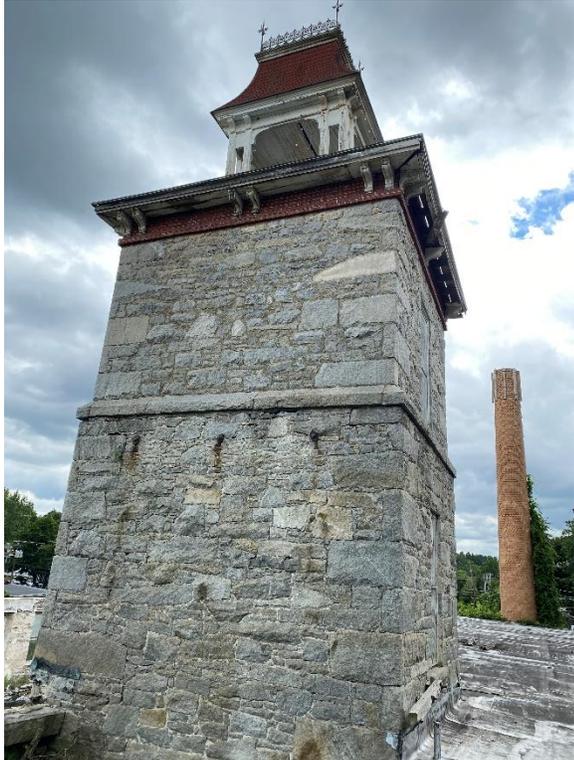
| <p>4</p> | | <p>Partial overall photo taken from the lift showing the north and east elevations of the bell tower.</p> |

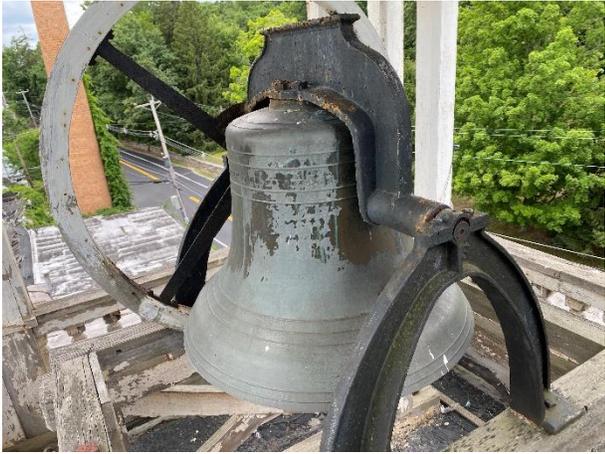
| 5 | | Close up photo taken from the lift showing the existing bell that still remains in the belfry. |

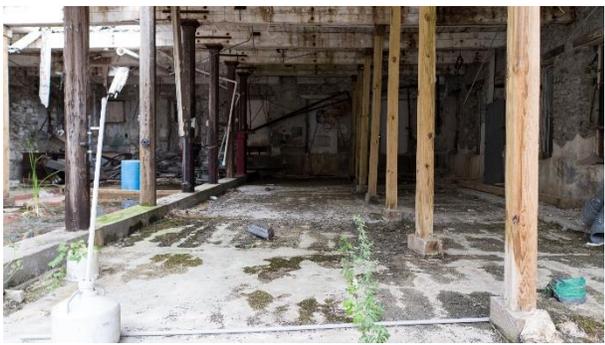
| <p>10</p> | | <p>Interior photo 1 of 3 taken with the drone from inside the east portion of the Central Mill showing the timber shoring posts that were installed to support the first-floor framing during the 2015/2016 stabilization efforts in good condition.</p> |

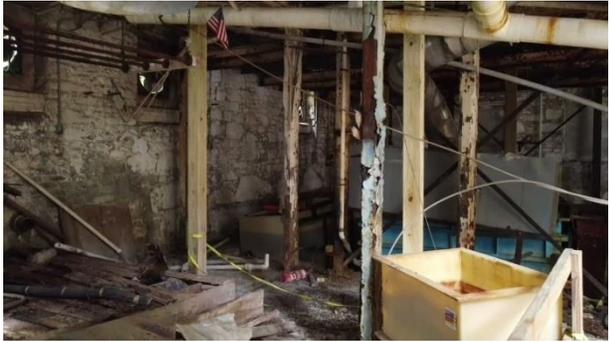
| <p>11</p> | | <p>Interior photo 2 of 3 taken with the drone inside the west portion of the Central Mill showing the timber shoring posts that were installed during the 2015/2016 stabilization efforts in good condition. Note the abandoned materials and debris that will need to be removed and abated for to provide ESM access to complete their groundwater study.</p> |

- With an approved NTAWP, CBI recommends that the remaining materials and debris resting on the first-floor framing at the west end of the Central Mill be carefully removed and abated as specified in order reduce the excess load acting on the existing first-floor framing. The contractor is to be careful not to damage any of the existing first floor structural framing during this process. Additionally, the contractor shall safely remove and abate the materials and debris that will potentially impede or be touched by any personnel during the completion of the groundwater study. This includes contractors, consultants, and machinery. See Appendix B for conceptual work plan.

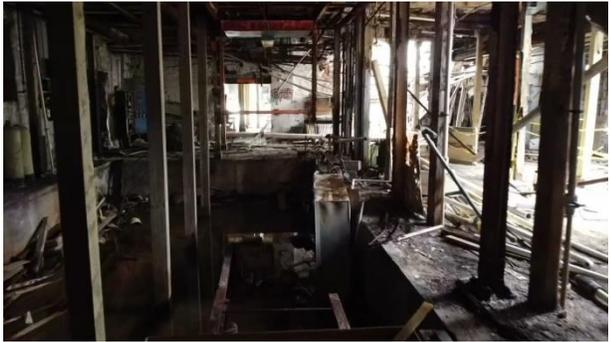
| <p>12</p> | | <p>Interior photo 3 of 3 taken with the drone taken inside the west portion of the Central Mill showing the timber shoring posts that were installed during the 2015/2016 stabilization efforts in good condition. Note the abandoned materials and debris that will need to be removed and abated for to provide ESM access to complete their groundwater study.</p> |

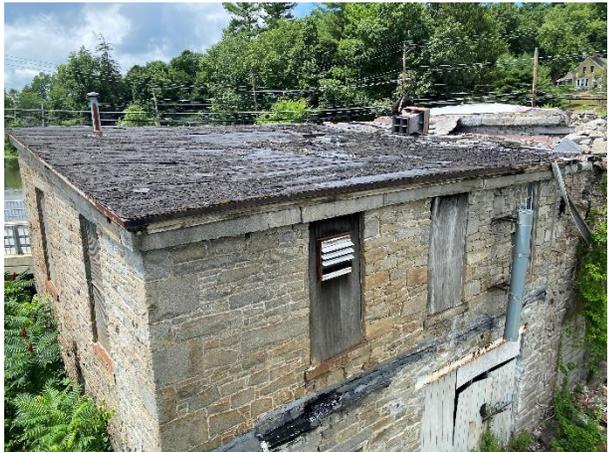
| <p>13</p> | | <p>Partial overall photo of South Wing roof taken from the lift.</p> |

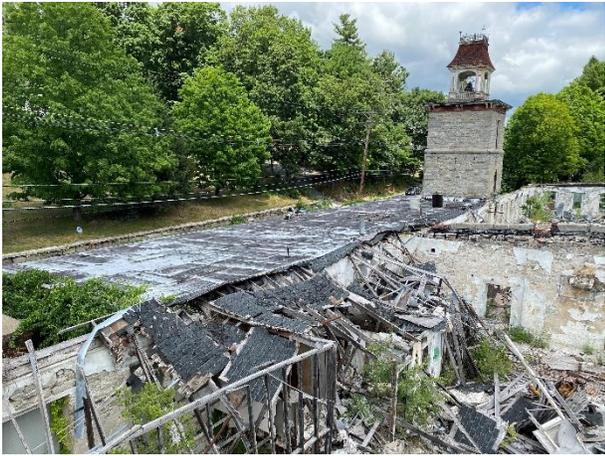
| 15 | | Overall photo of the North Addition Roof taken from the lift. |

- Perform further investigation to interior of north addition and determine if additional repairs or supplemental framing is required.
- Provide protective netting over North Addition, secured to cast in place concrete footings on each side of building.

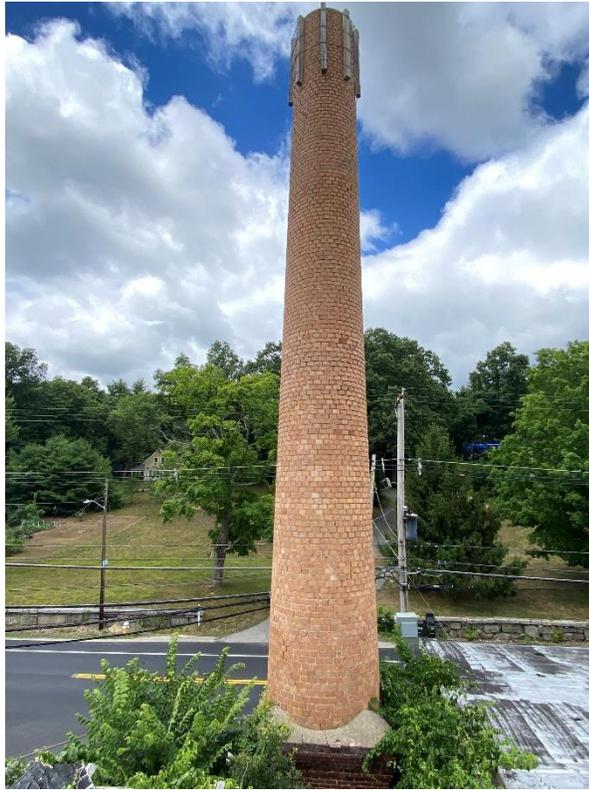
24

Partial overall photo of the Smokestack taken from the lift.

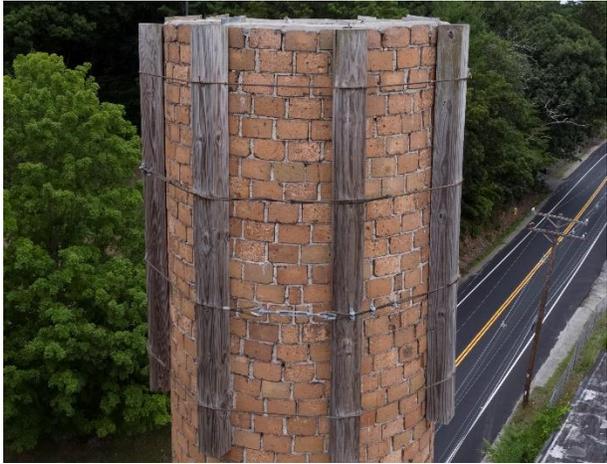
| 26 | | Up-close photo of the top of the Smokestack taken with the drone showing the previous stabilization repairs that were made in 2015/2016. |

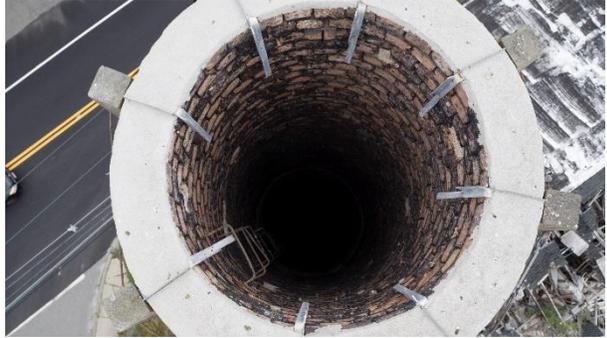
| 27 | | Overall photo taken from the drone looking down on the Smokestack. |

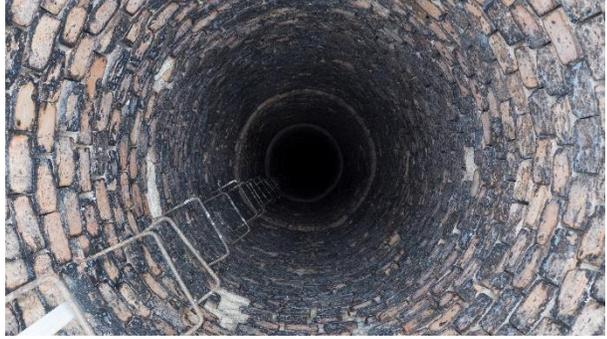
| 28 | | Interior photo 1 of 2 taken from the drone inside of the Smokestack. |

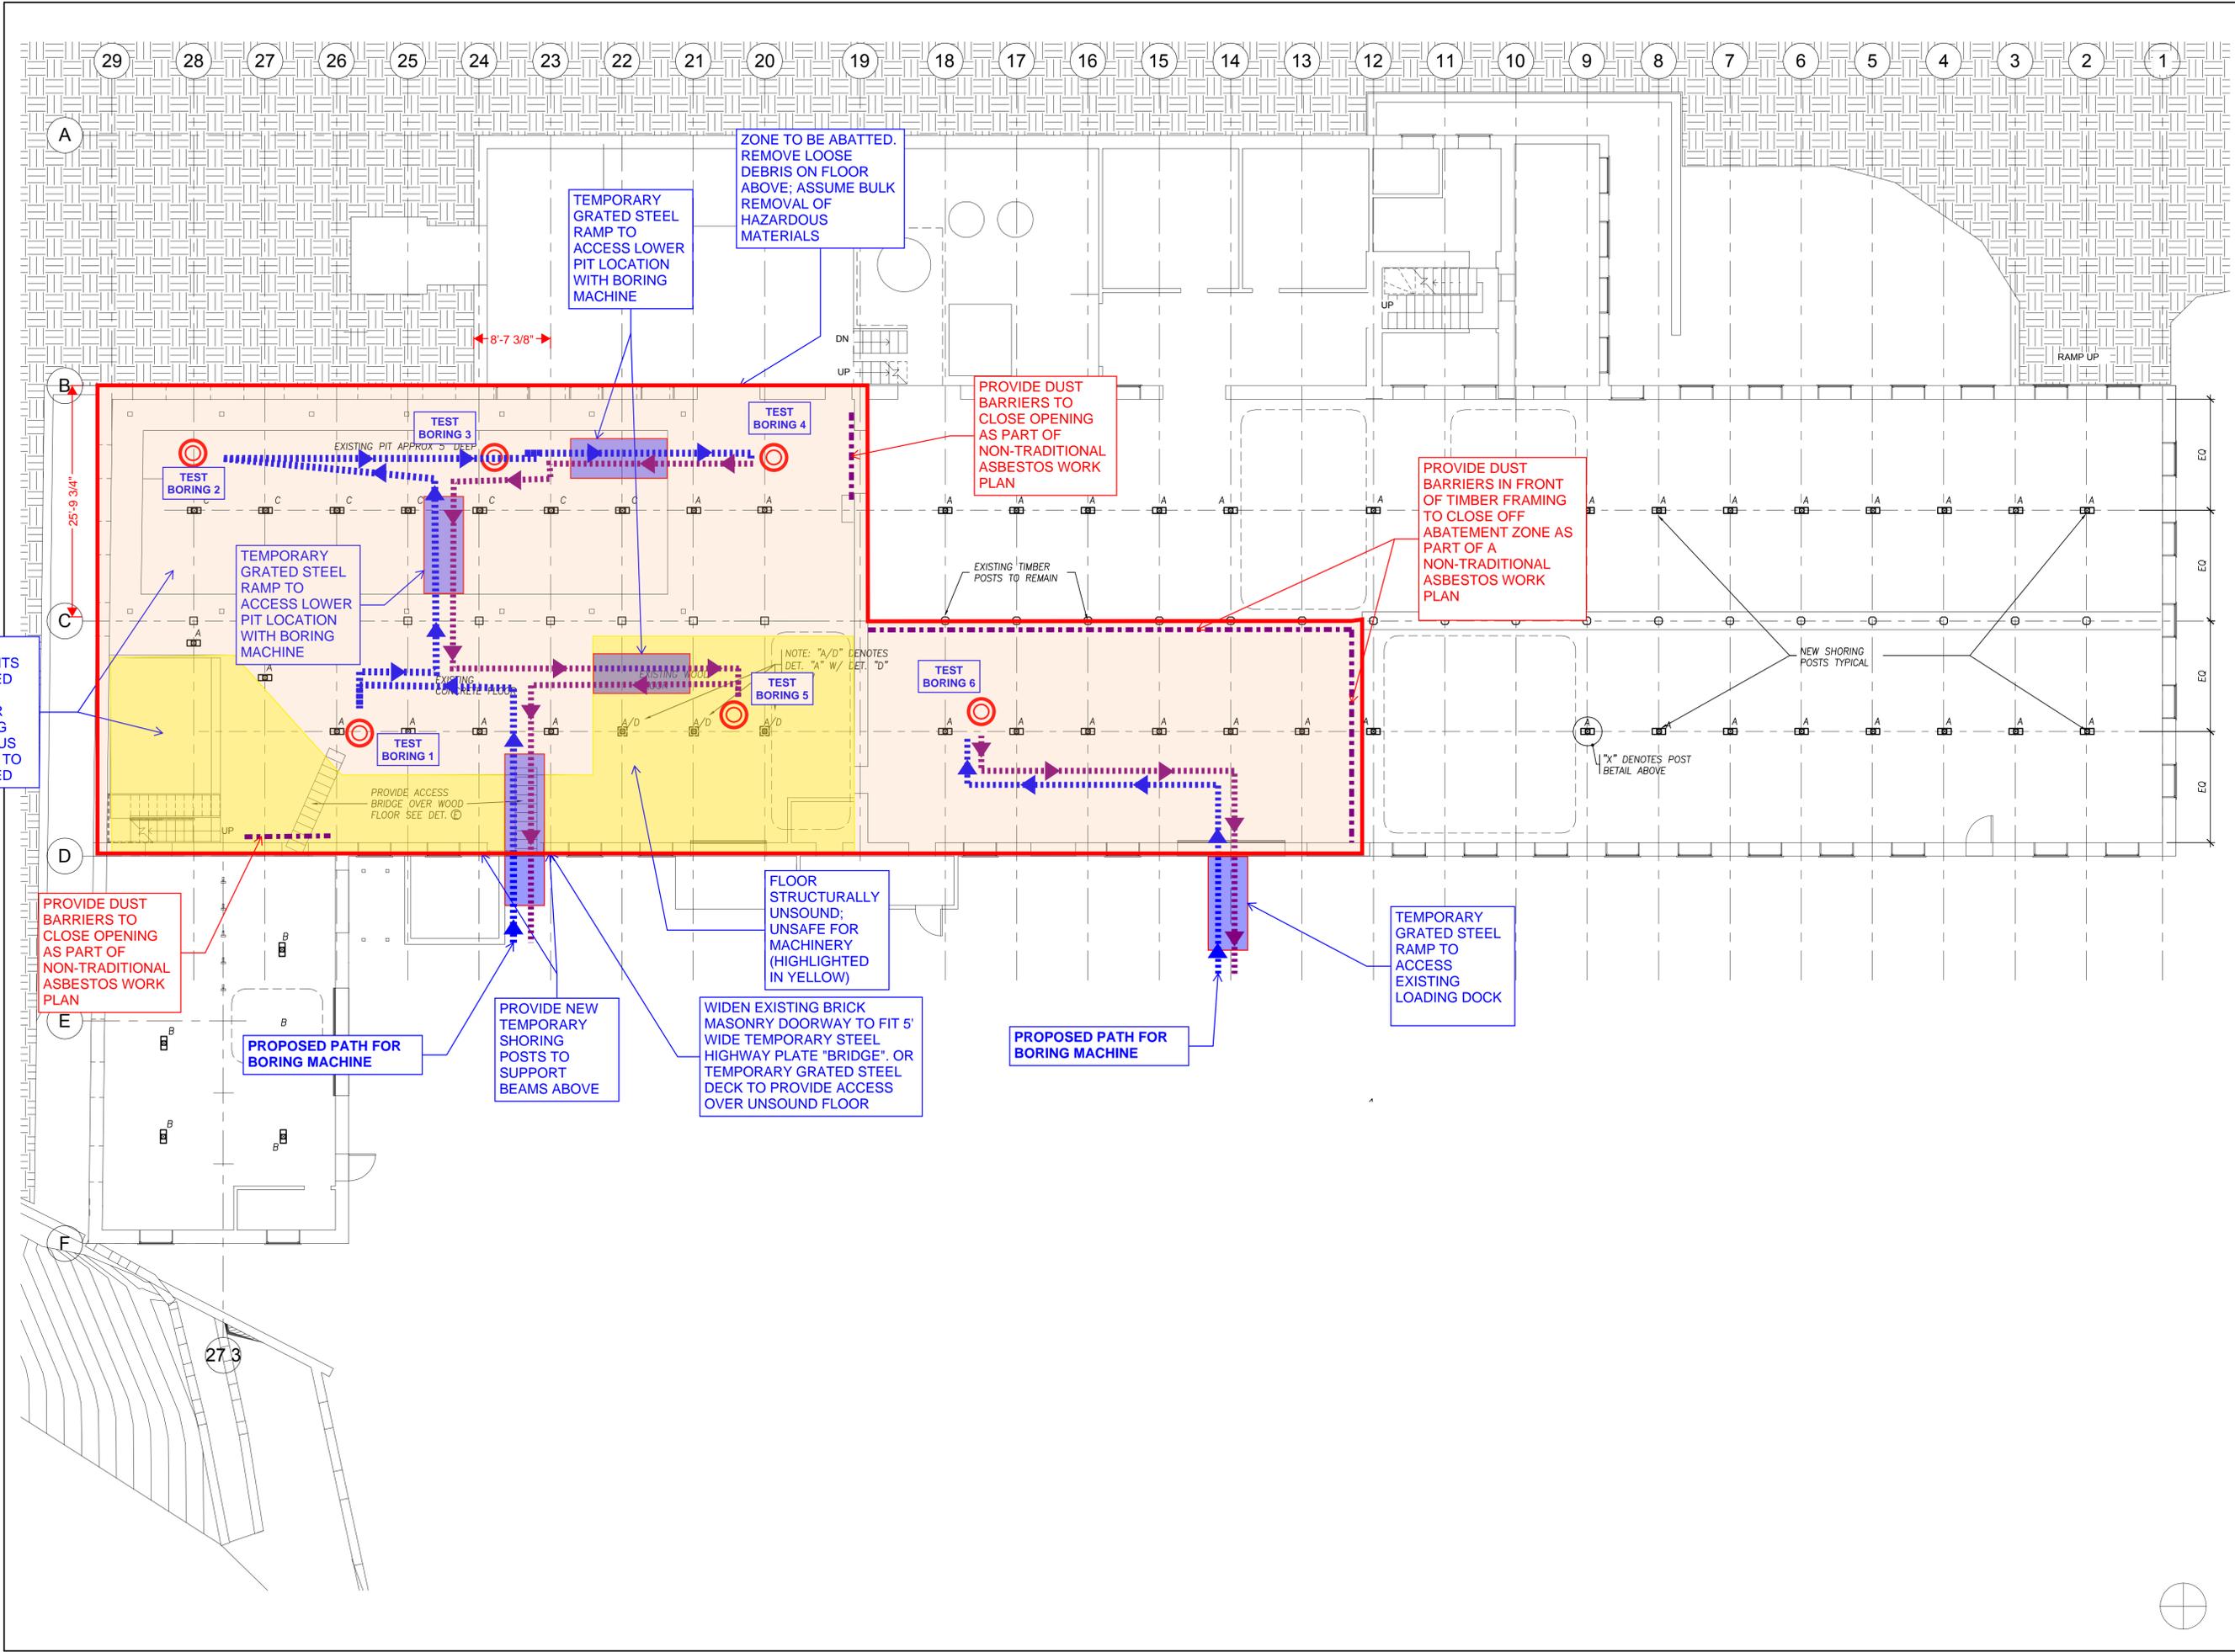
S101

ASSUME EXISTING PITS TO BE FILLED WITH RAINWATER CONTAINING HAZARDOUS MATERIALS TO BE REMOVED

FLOOR STRUCTURALLY UNSOUND; UNSAFE FOR MACHINERY (HIGHLIGHTED IN YELLOW)

PROVIDE DUST BARRIERS TO CLOSE OPENING AS PART OF NON-TRADITIONAL ASBESTOS WORK PLAN

ZONE TO BE ABATTED. REMOVE LOOSE DEBRIS ON FLOOR ABOVE; ASSUME BULK REMOVAL OF HAZARDOUS MATERIALS

TEMPORARY GRATED STEEL RAMP TO ACCESS LOWER PIT LOCATION WITH BORING MACHINE
