**Westford Community Preservation Funding Application**  
**Fiscal Year 2021 Project Submission Form**

Project Name: Westford Museum Window Restoration \_\_\_\_\_

CPA funds requested: \$ 77,000 \_\_\_\_\_

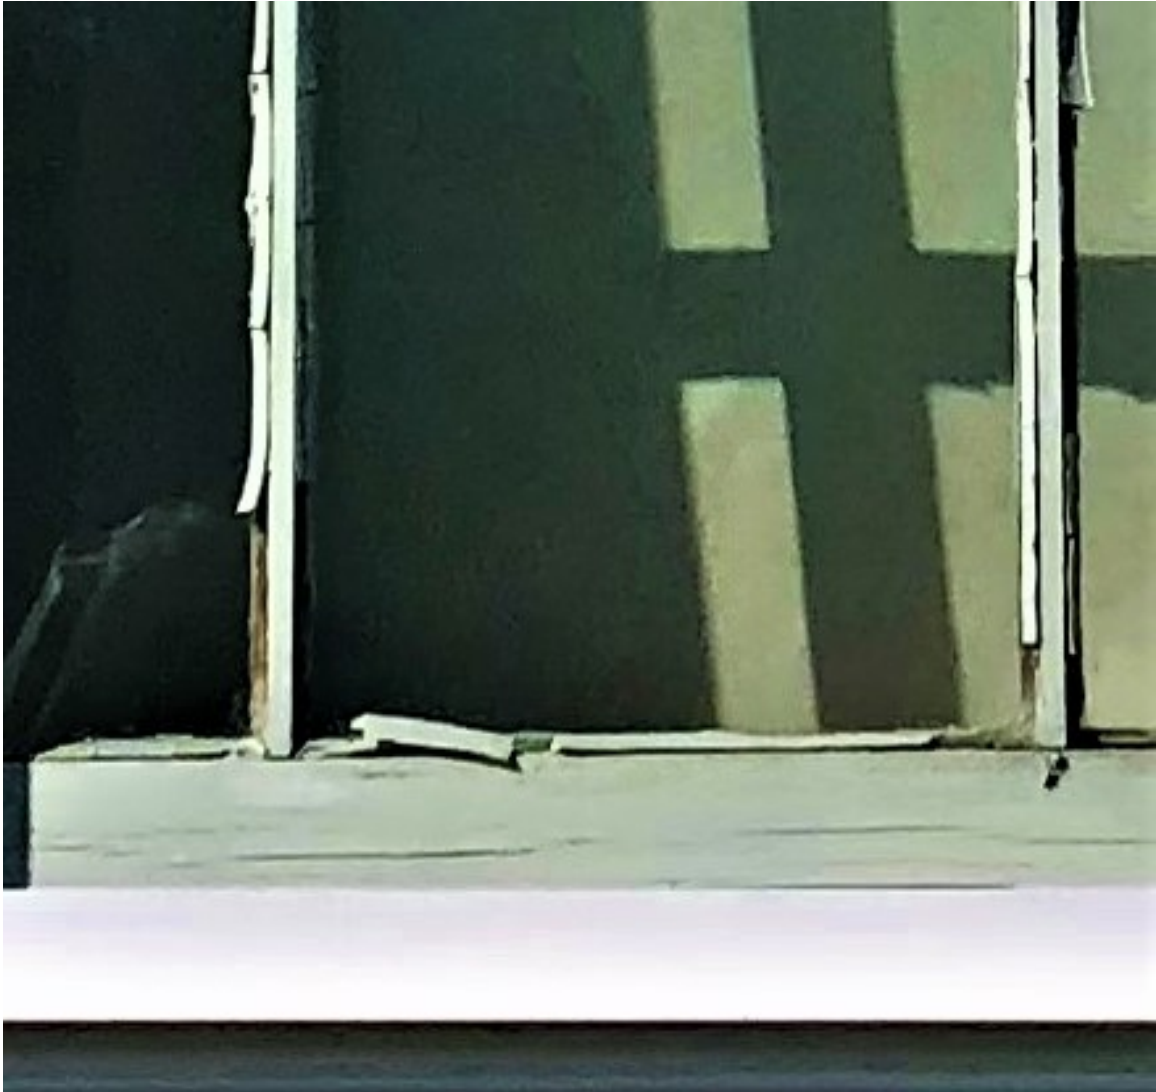
The window glazing material in at least one-half of the windows has deteriorated with age and sunlight. This has resulted in window glass falling out of one window with several additional panes likely to “pop” out with winter wind gusts. Restoration involves a process where steam is used to loosen all glazing and surface paint from each sash. Linseed oil is then applied to each sash followed by paint primer, installation of glass with glazing. At this point there is a delay of several days for the glazing to harden. Finish painting is the final step prior to installation. At this point the sashes are returned to the Museum and installed by the contractor.

Photo 1. Close view of deteriorated window sashes. The east facing windows have shown extreme wear for several years. Several panes of glass are slipping out of the seam.

- Remove sash from building and transport to Heartwood's shop
- Stamp window location at side of sash
- Mark location of glass to assure reinstallation in same location
- Remove all glass and glazing putty using a steam heat method
- Clean glass
- Remove all paint to bare wood using a dry heat method
- Make minor repairs to wood
- Apply a 50/50 blend of boiled linseed oil/turpentine to entire sash for conditioning of wood
- Apply one coat of oil based primer
- Set glass with a traditional linseed oil glazing putty
- Apply two coats of oil based finish paint at the interior and exterior of sash\*
- Clean glass
- Transport sash and install

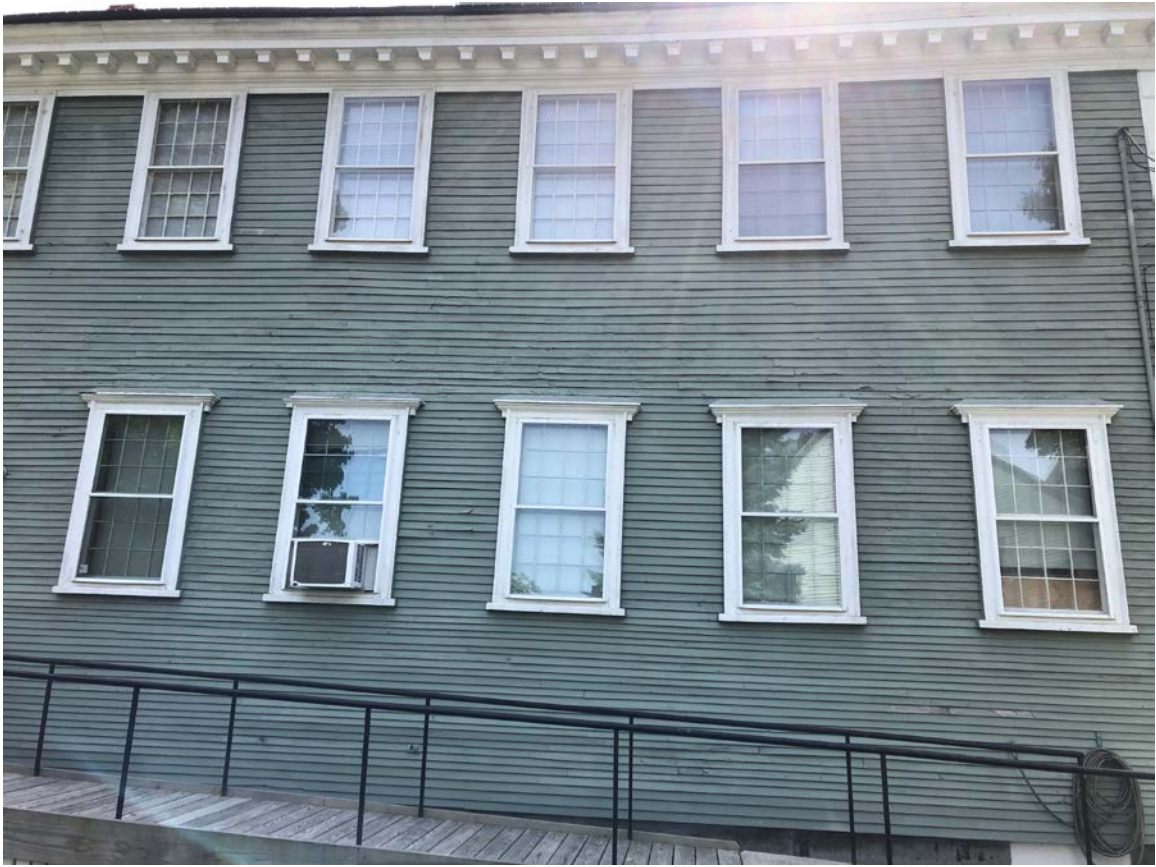
Photo 2. View of west side of museum. Window headers show severe deterioration and wood rot. Tin/aluminum covers are planned to match front facing window restoration work completed during the 2013 museum roof and cupola restoration work.

Covering/repair of headers to match front facing windows.

Window header work concurrently performed during the month of July as window restoration is performed.

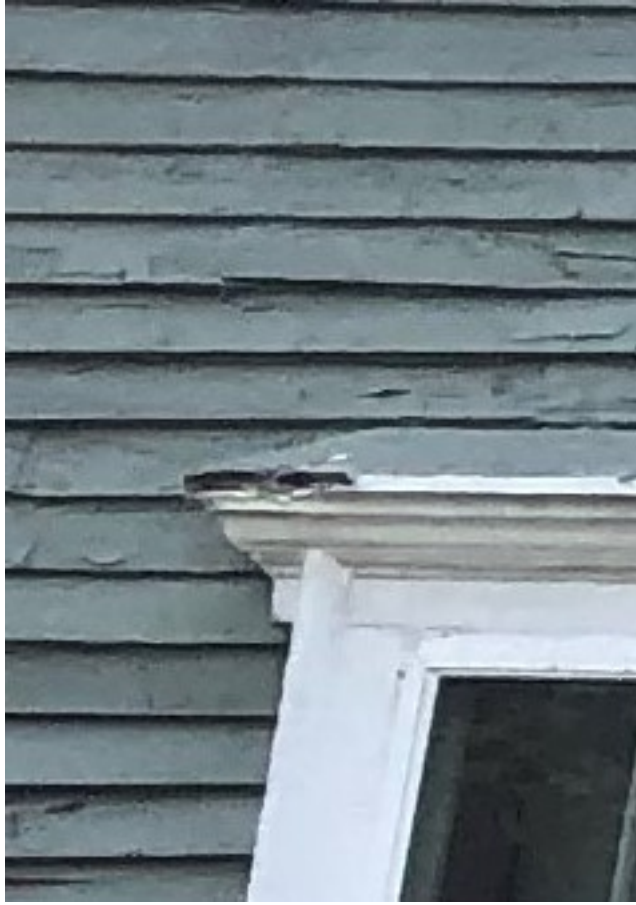
Photo 3. Close up of west facing window with damage wood rot and the beginning of water seepage into window frame.

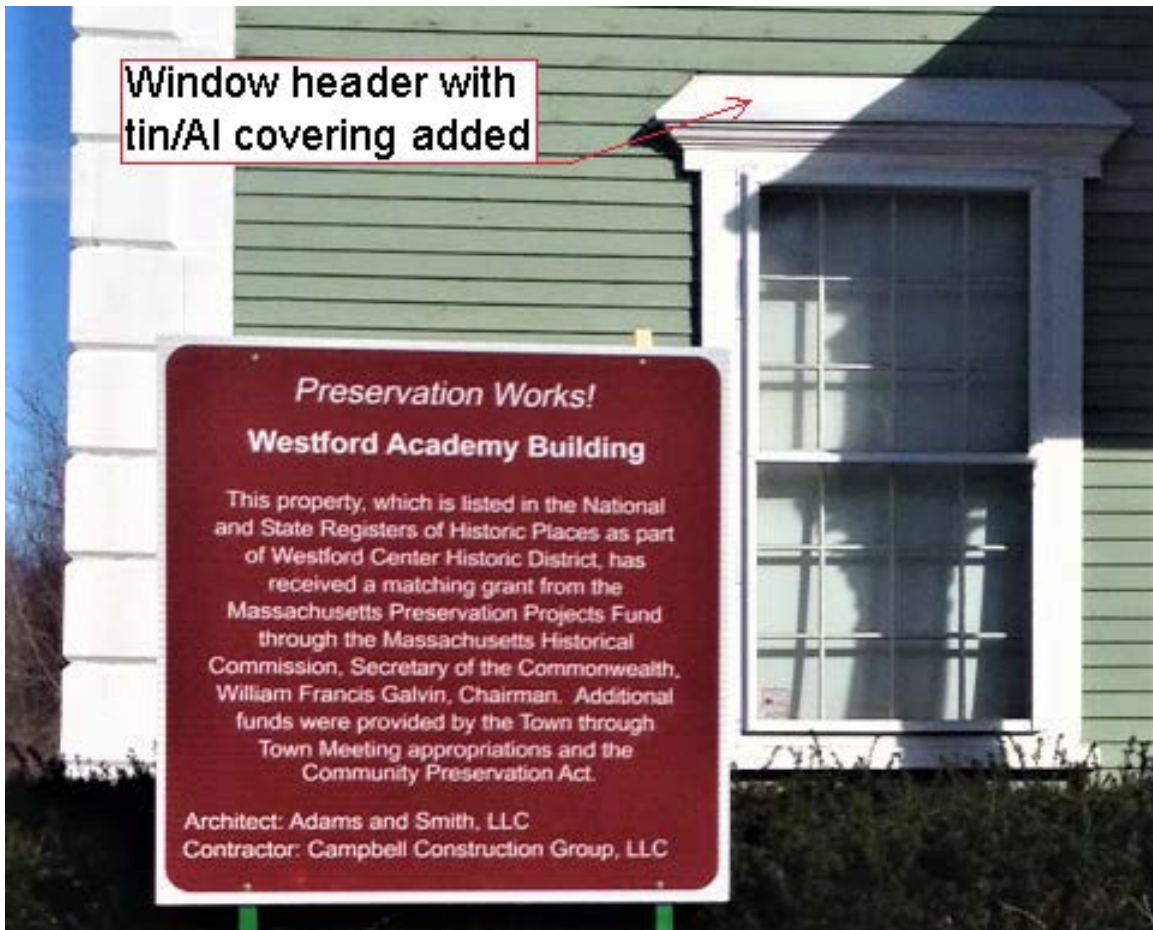
Photo 4. Front view (south facing) of window with aluminum covering on header preserving window frame.
