Community Preservation Funding Application — Fiscal Year 2026

Project Name: First Parish Church United Meetinghouse Historic Preservation

PROJECT:
FIRST PARISH CHURCH UNITED
CONDITIONS ASSESSMENT
#2411-R

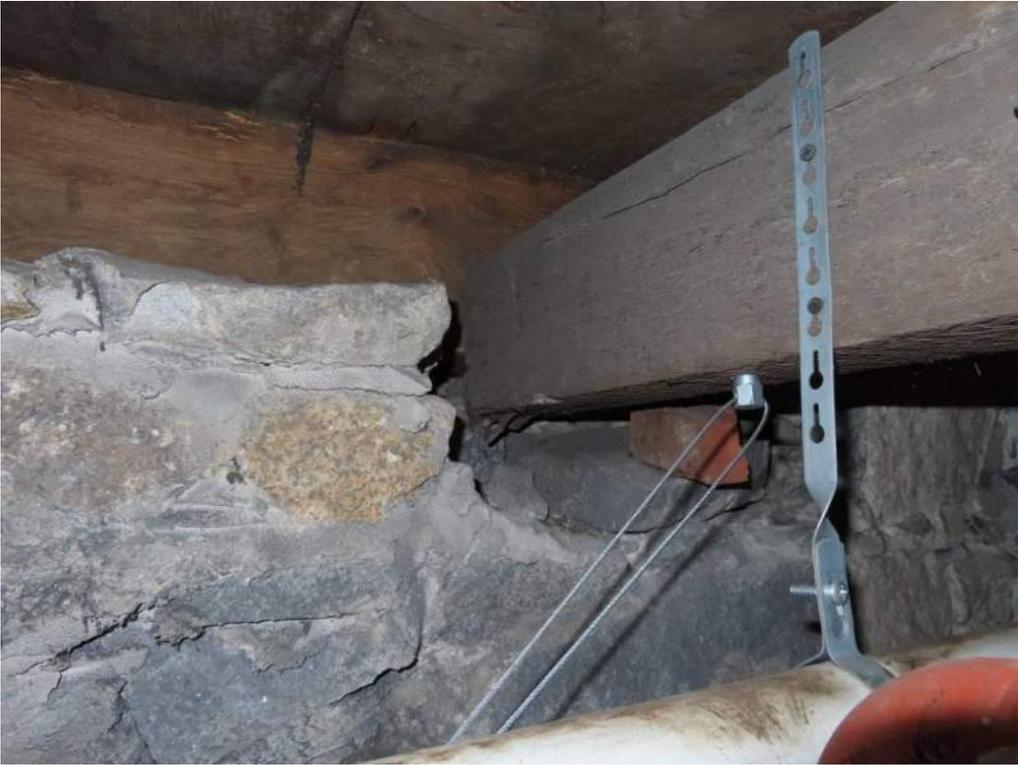
Photo 24
Poorly supported beam end on brick wedge

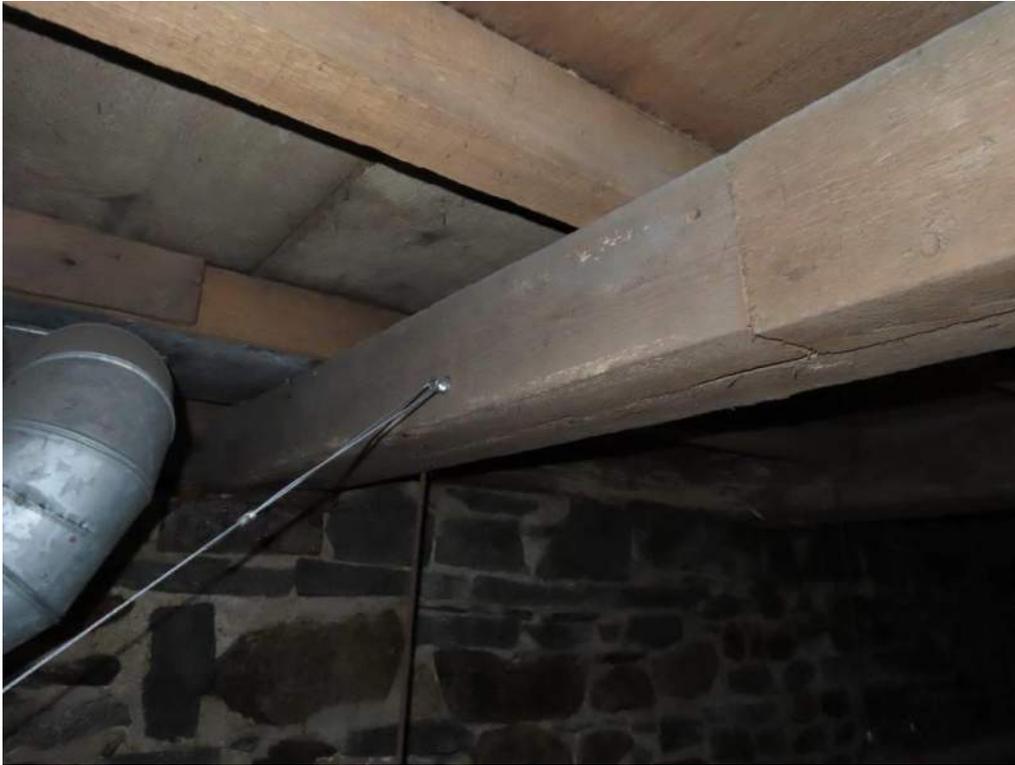
Photo 33
Spliced beam along span

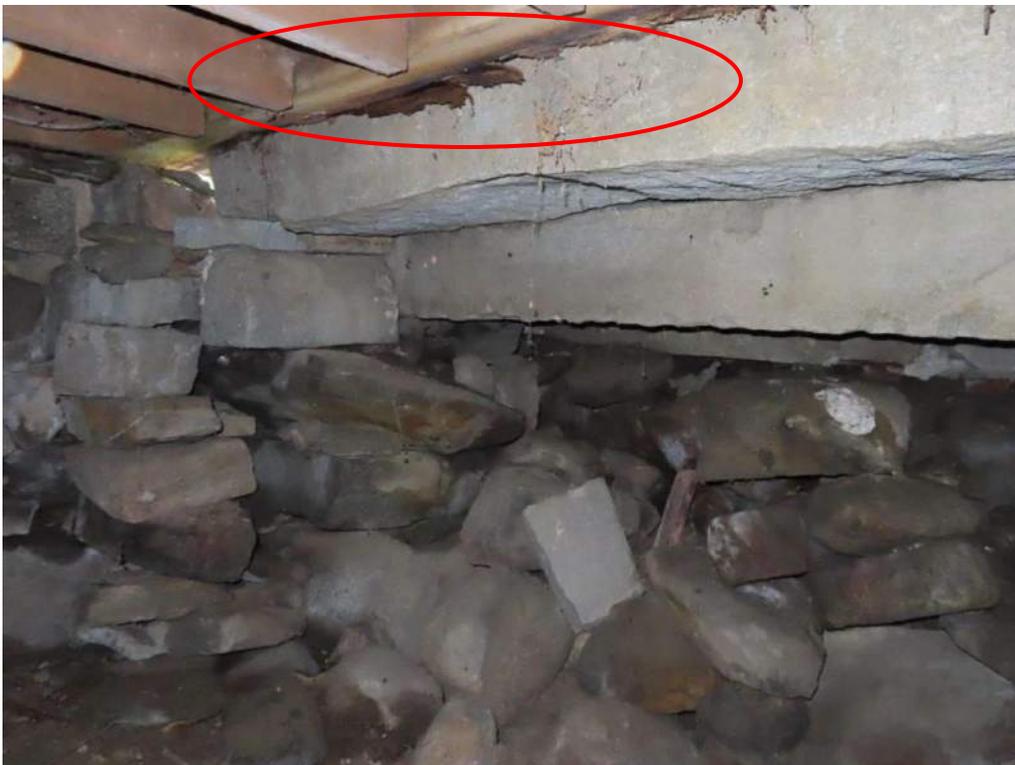
Photo 34
Rotted sill and eroding rubble stair support system

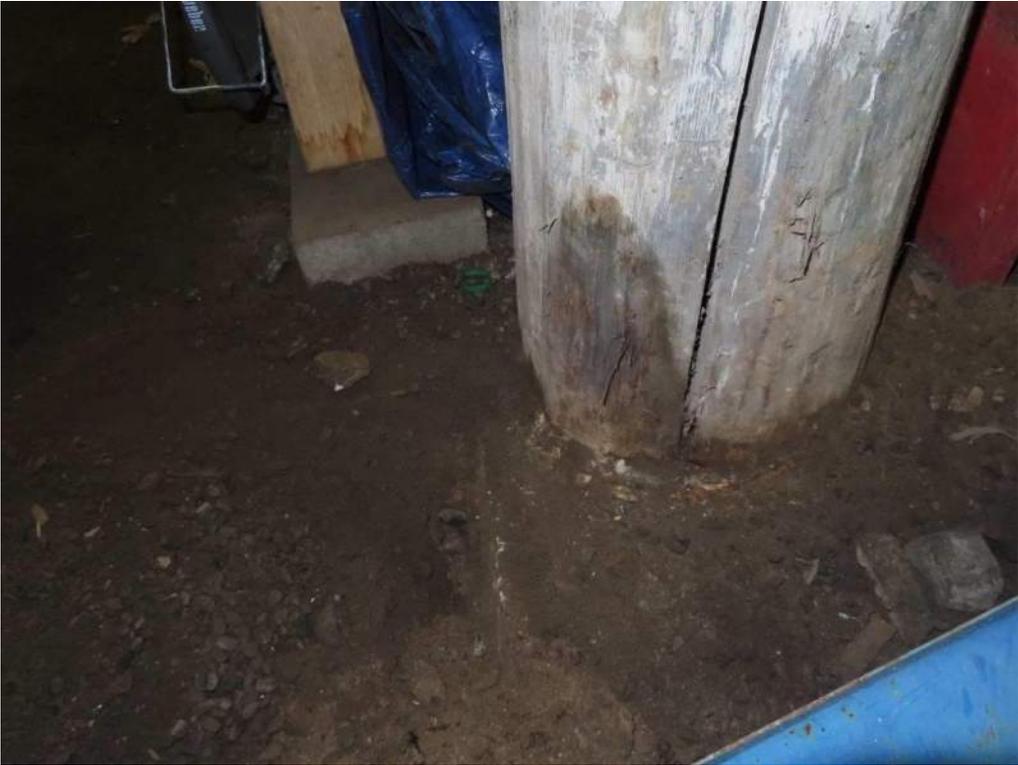
Photo 19
Punky post end on granite stone footing

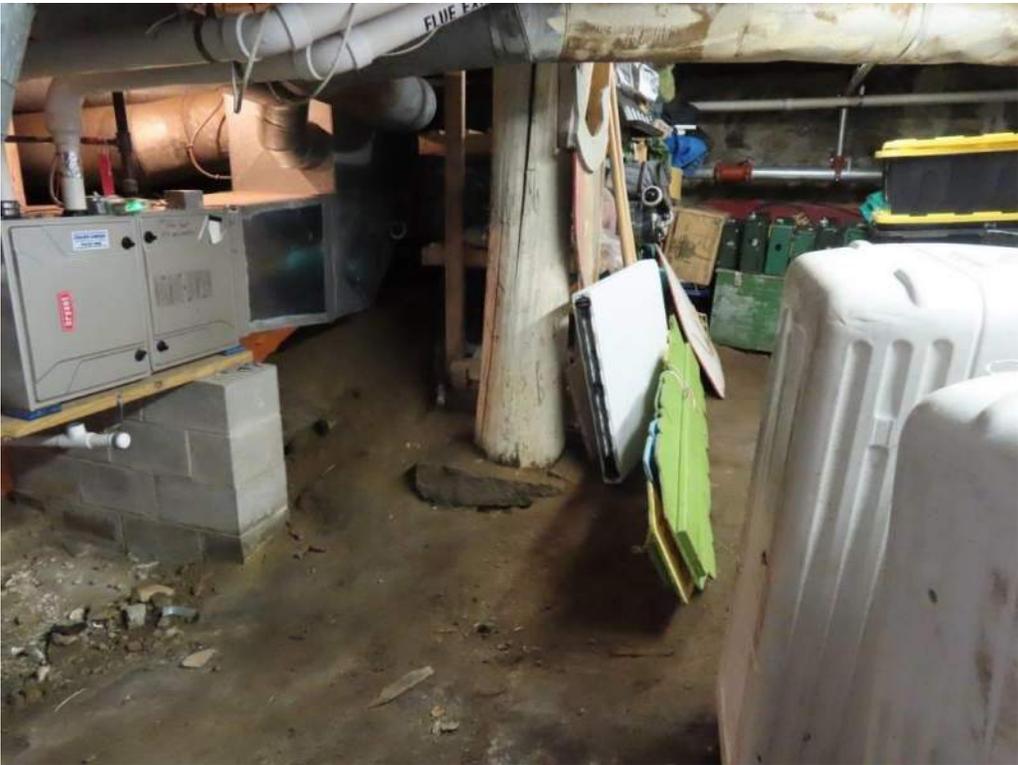
Photo 20
Undermined stone footing

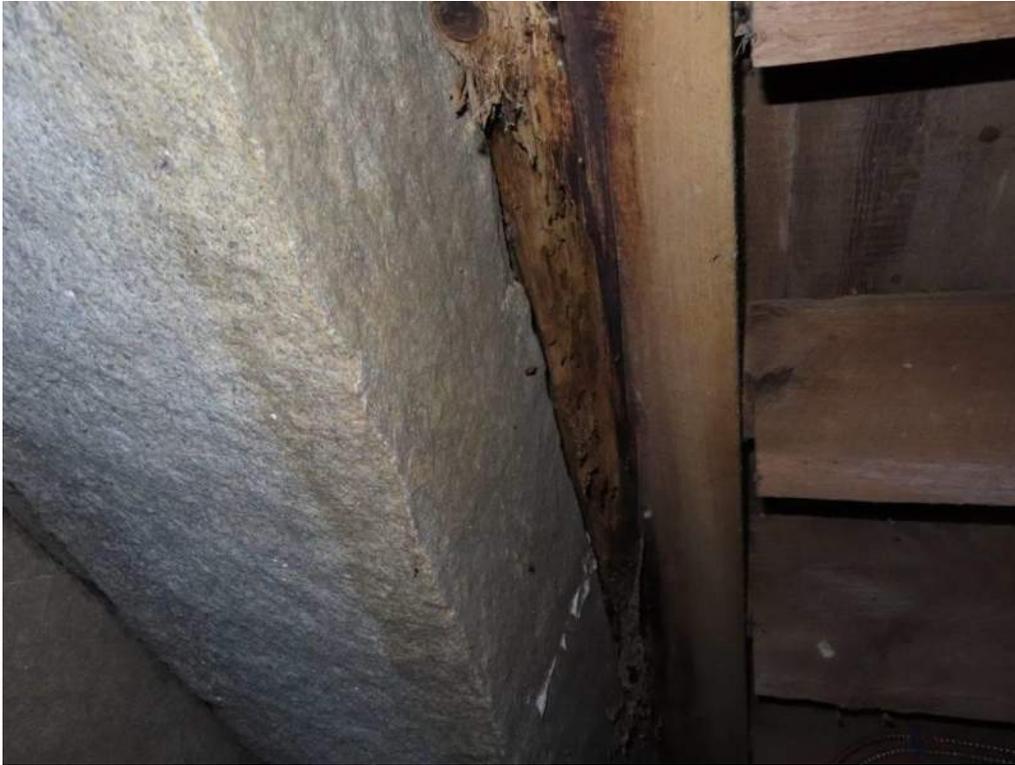
Photo 35
Rotted sill at south elevation

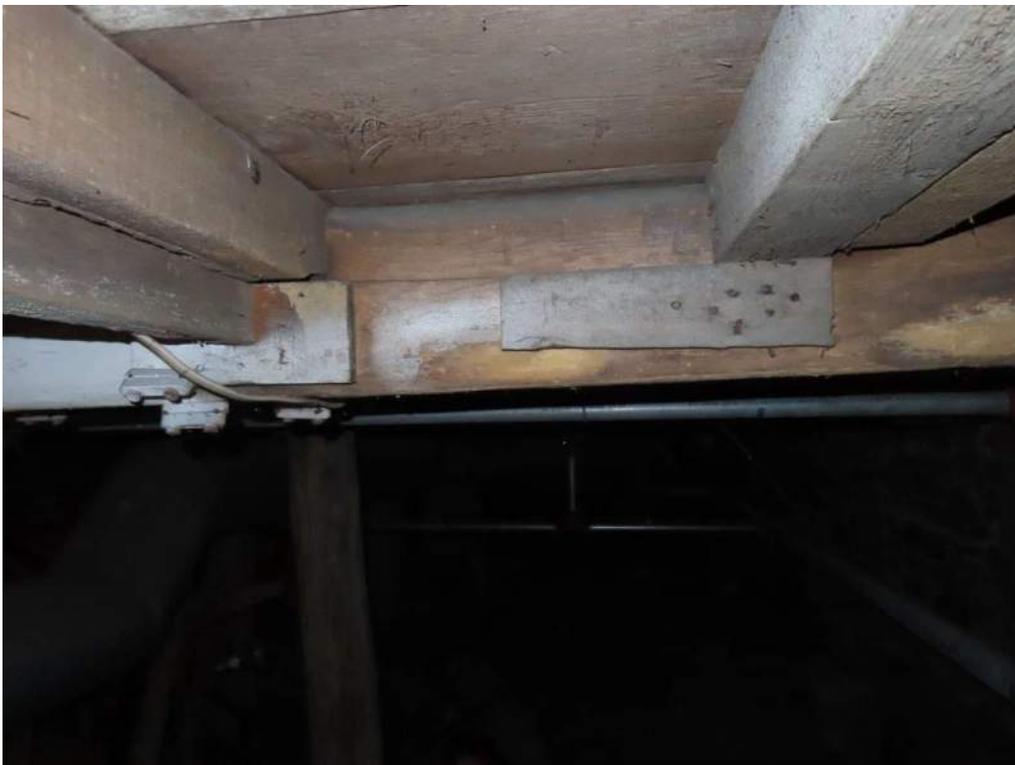
Photo 36
Poorly supported sisters

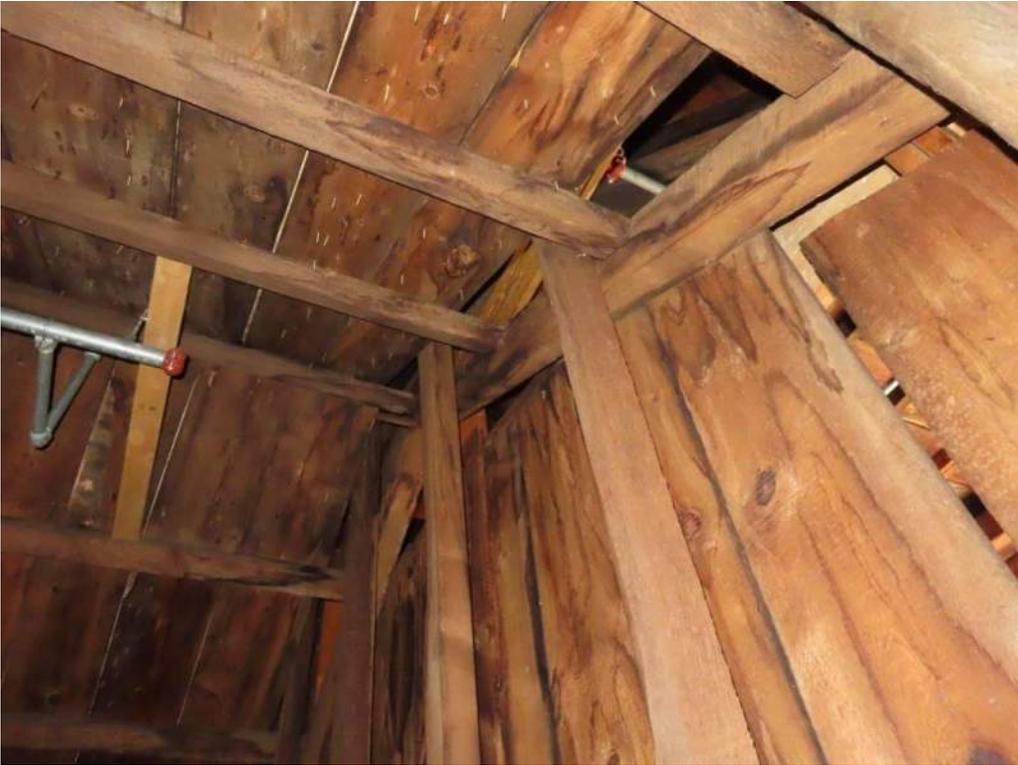
Photo 17
Purlins notched on their tension face

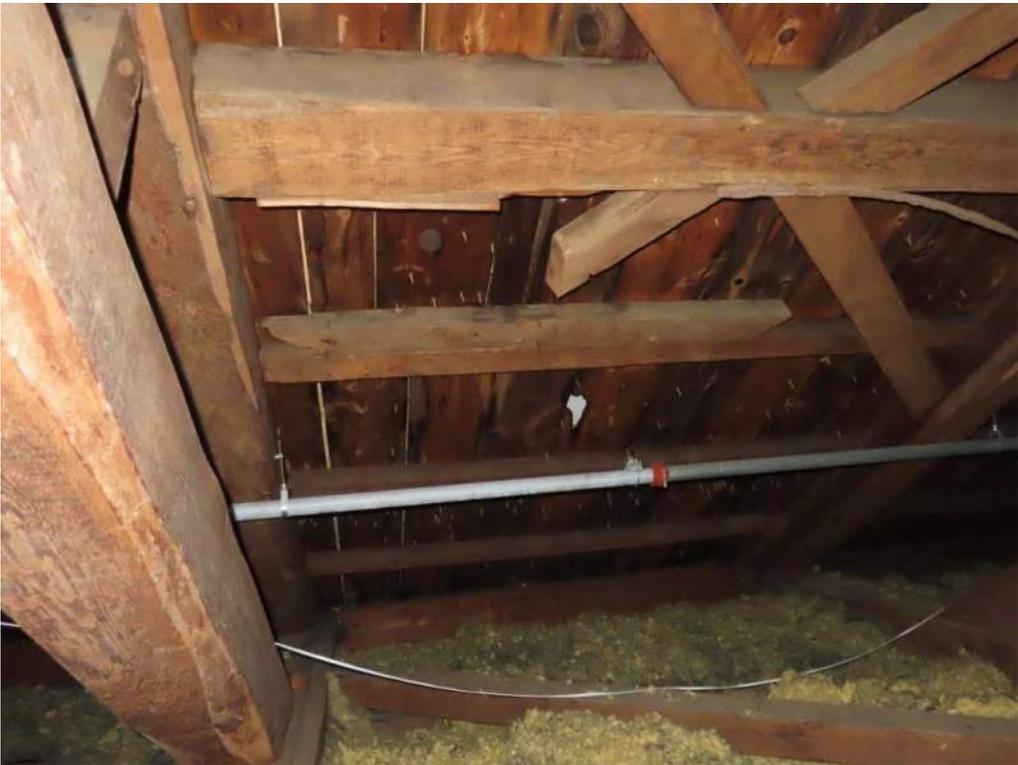
Photo 18
Cut diagonal brace

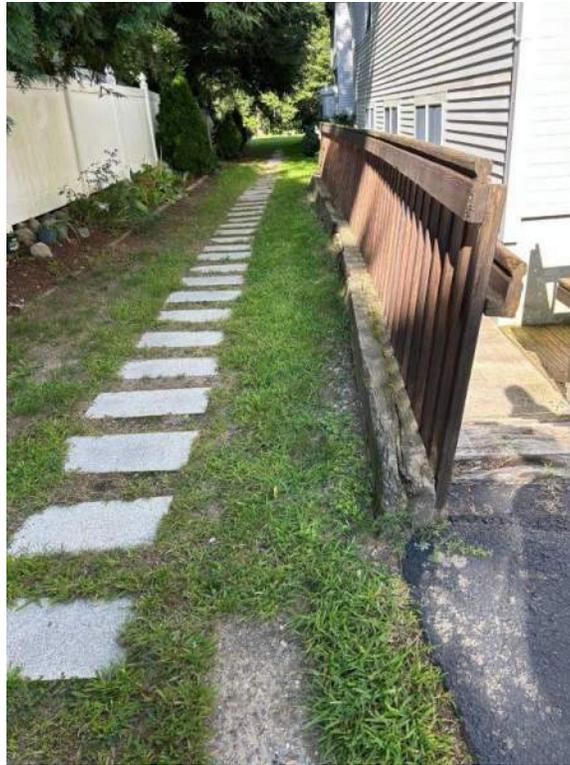
Photo 37
Outward leaning railing and retaining wall

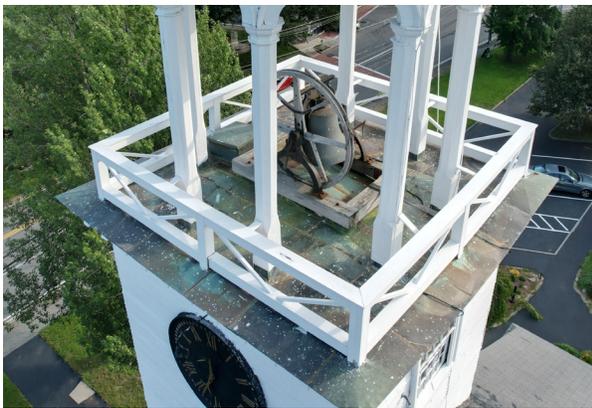
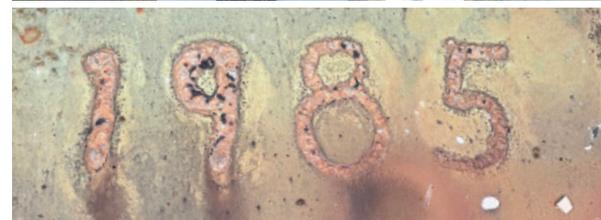
Image 08: View of the flat seam copper cladding at the bell deck, installed in 1985, as indicated by the solder mark.

The bell deck, located at the top of the clock tower, is clad in flat seam copper panels. This particular roof was installed in 1985, though it is unknown what the original deck material was [Image 08].

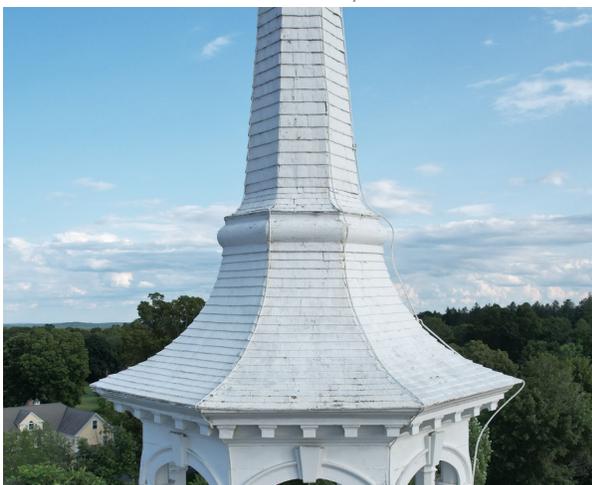
Image 09: View of the painted wood shingles at the spire roof.

The octagonal spire roof, located at the top of the belfry, is the only roof that is clad in wood shingles. Over the years, this roof has been painted with multiple layers of white paint, in an effort to extend the life of the shingles [Image 09].

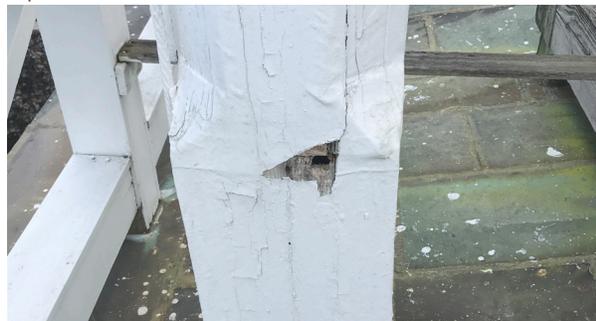
Image 21: Deterioration at the wood surround that covers the lally columns on the north side of the belfry.

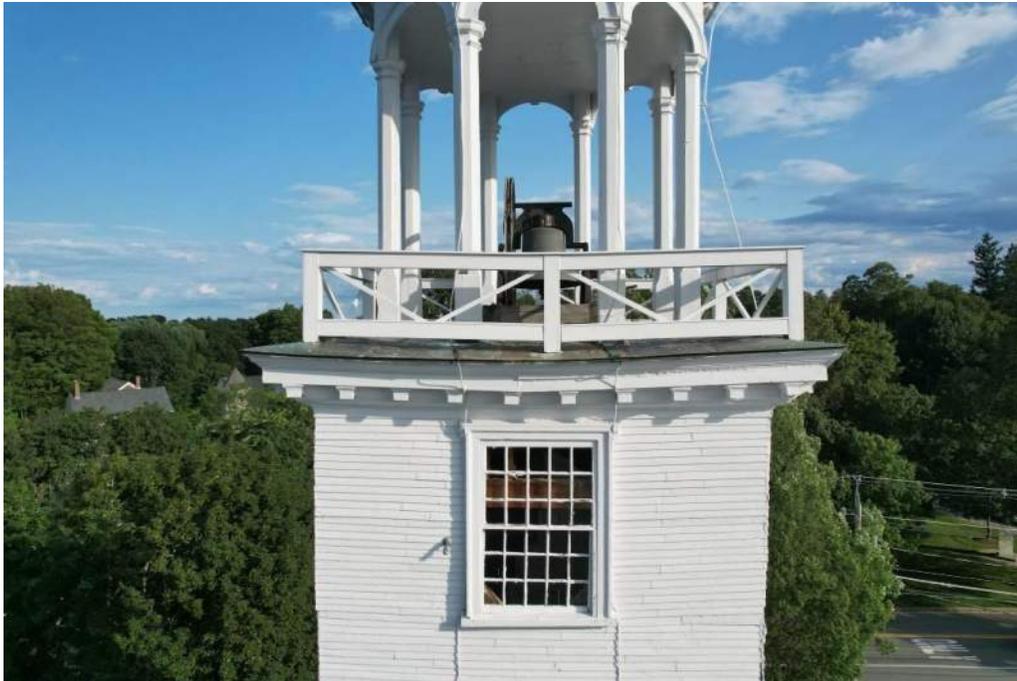
Photo 39
Downward sag at north face cornice
(Photo: Lyman, Scott)

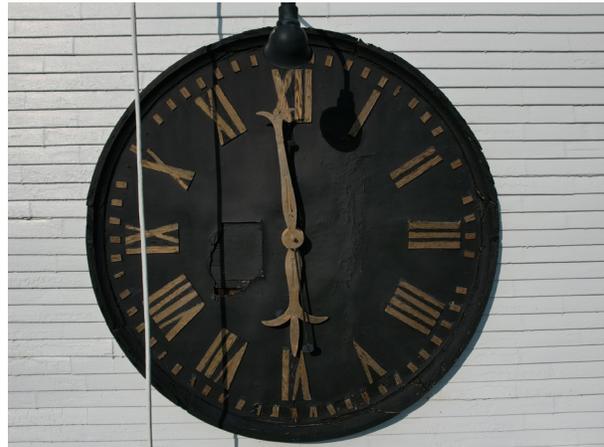
The wood clock faces appear to have been covered by a thick, black canvas material, sometime after their original installation, that has since become warped and deteriorated. The worst of this damage can be seen at the east clock face where the canvas around the access panel has torn, exposing the wood beneath. At the other clock faces, the center seams where two pieces of canvas meet have opened up, allowing water to enter the clock, potentially damaging the wood beneath [Image 32]. As these clocks are not easily accessible and therefore difficult to maintain, these damages must be addressed to prevent any future deterioration.

In addition to the poor condition of the faces and bezels, the numerals and tick marks are weather worn and faded. Made from wood and coated in a gold paint, many of these numbers are cracked, damaged, or altogether missing from the clock face, having been simply face nailed into the wood beyond.

Image 29: View of the west facing tower clock. The design is the same across all three clocks.

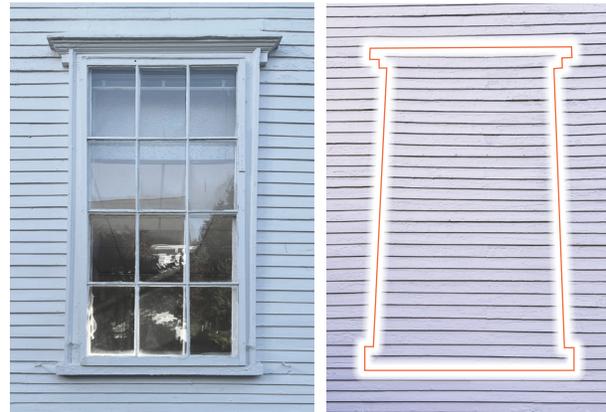
The most common type of window on the First Parish Meetinghouse is the 6 over 6, double hung wood window found on all four elevations of the building [Image 10]. Historic photographs and depictions of the church show that these windows have been in place since at least 1883, though it is likely they are significantly older based on the muntin profiles.

Patching at the clapboard siding shows that the broad sides of the Meetinghouse originally had two rows of windows with seven windows in each row. By 1883, the second, fourth, and sixth windows on each side had been filled in, but the scars show that these windows were the same size as the current 6 over 6 windows [Image 10].

Image 10: Typical 6 over 6 double hung wood window. Scars in the clapboard siding show where previous windows have been

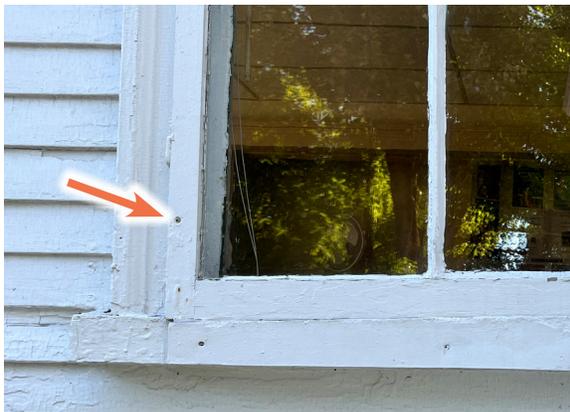
Each of the first floor windows are protected by wooden storm windows, designed to match the 6 over 6 muntin pattern. These storm windows are applied to the front of the window casing and anchored using screws, rendering the windows inoperable **[Image 12]**. Historic photographs, and remaining hardware show that these windows were originally protected with wood shutters, which have since been removed.

Image 12: Close up of a first floor 6 over 6 window showing the screws securing the wood storm window to the casing.

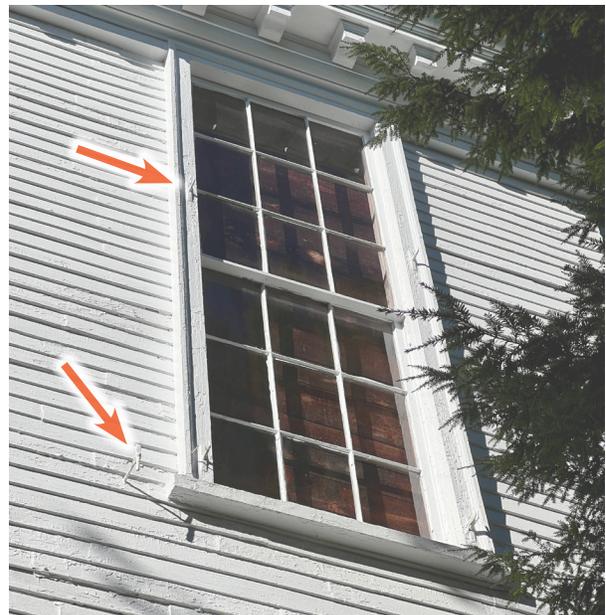
The largest and most prominent windows on the Meetinghouse are located at the second floor. These seven windows, three on the west elevation and four on the east elevation, consist of 9 over 9, double-hung, wood sashes. These windows illuminate the 1846 sanctuary space upstairs and likely date to the 1868 renovation. Unlike the first floor, these monumental windows are not protected by storm windows, however, historic photos of the church show that they were protected by louvered wood shutters in the late 19th century **[Image 13]**.

Image 13: Typical 9 over 9, double hung, sanctuary window and the remaining shutter hardware present around the window casing

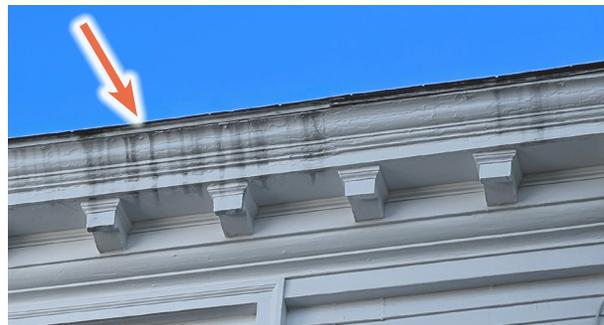
that need to be addressed. As with elsewhere on the building, the paint is cracked and scaly as a result of poor prep work prior to painting and prolonged exposure to the weather. In multiple locations across both the east and west cornices, there is a considerable amount of staining caused by rainwater running off the roof and down the face of the cornice [Image 23]. This staining corresponds to areas where the metal drip edge is twisted or warped, allowing water to sit at the top of the cyma profile. In some instances, this condition has resulted in paint damage and some wood deterioration at the top of the cornice. As the cornice could not be accessed for inspection during the initial assessment, it is unknown how extensive the damage behind the moulding is, though selective repair and replacement may be required.

Image 23: Staining & paint damage at the wood cornice caused by rainwater running down the face of the cornice. Note the warped metal drip edge.

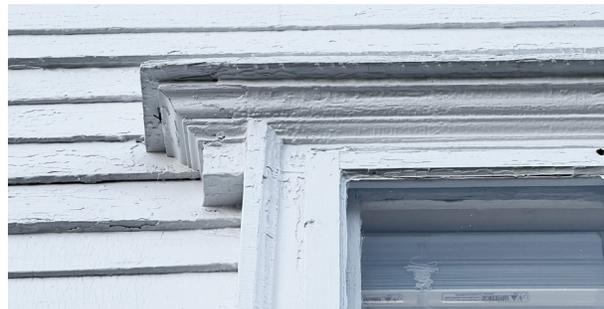
Image 25: View of the original window trim and crossheads. This condition is typical across the Meetinghouse.

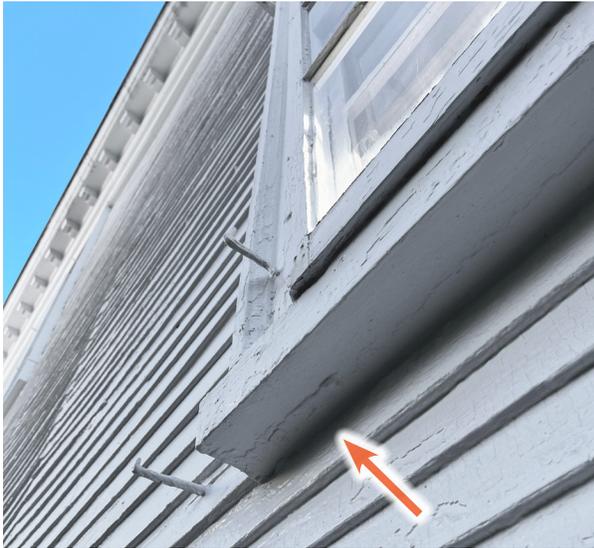
With the exception of the main entrance and a few basement windows, the trim around the windows and doors is believed to be original to the building. Looking at the front and underside of the sills, one can see pins and tenon ends which are indicative of a type of window called a plank frame window, common in late 18th and early 19th century buildings. The same type of pins and tenon ends are also visible when looking up at the enlarged second story windows. These features, along with visible joint seams about 2/3s of the way down the window and the matching trim profiles, imply that the upper windows were extended using material from the windows that were removed [Images 26-27].

Image 26: View of the underside of the plank frame window sill. Note the tenon ends indicative of this type of window construction.

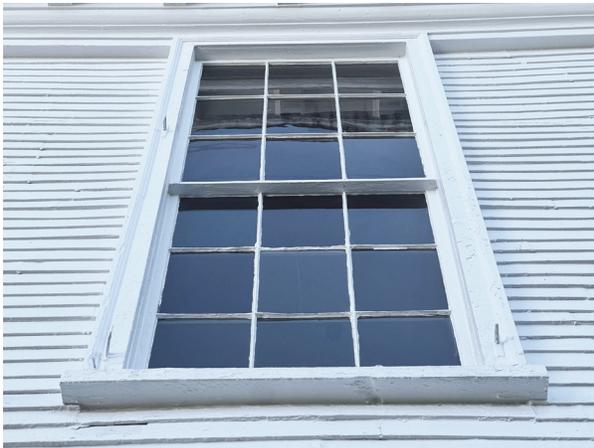
Image 27: View of an enlarged second story window showing the tenon ends and the joint seams 2/3s of the way down the window.

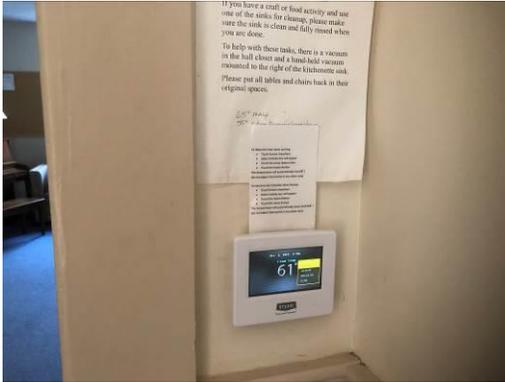
The HVAC system temperature controls are stand-alone electric/electronic programmable type thermostats..

Typical Programmable Thermostat

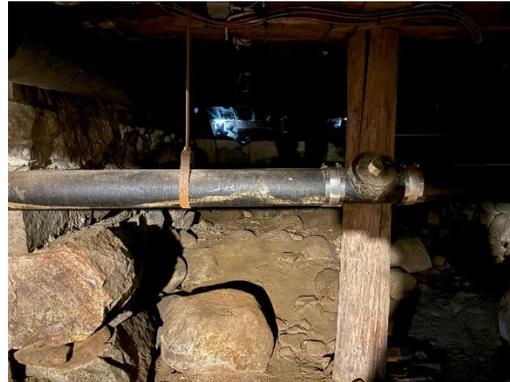
Cast iron is used for sanitary drainage. Where visible, the cast iron pipe appears to be in fair condition. Smaller pipe sizes appear to be copper.

In general, the cast iron drainage piping can be reused even in a major renovation where adequately sized for the intended new use.

Typical cast iron drainage piping

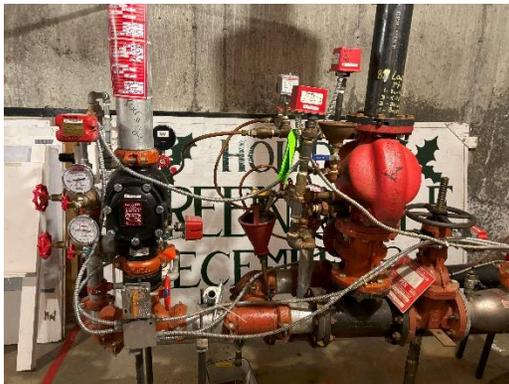
Fire service and dry alarm valves – Fellowship Hall

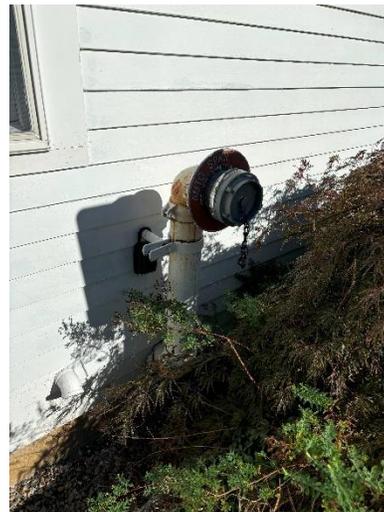
The Fire Department connection is a 4-inch Storz type.

Fire Department connection

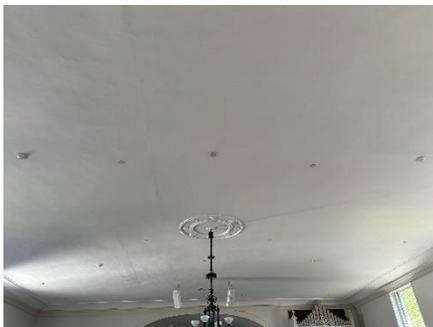
Conceal type sprinklers in Worship space

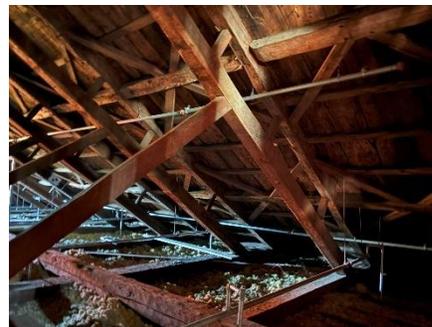
Attic sprinkler piping & heads
