WESTFORD TOWN FARM - ADAPTIVE REUSE CONSIDERATIONS

35 Town Farm Road

Westford MA

22 October 2019

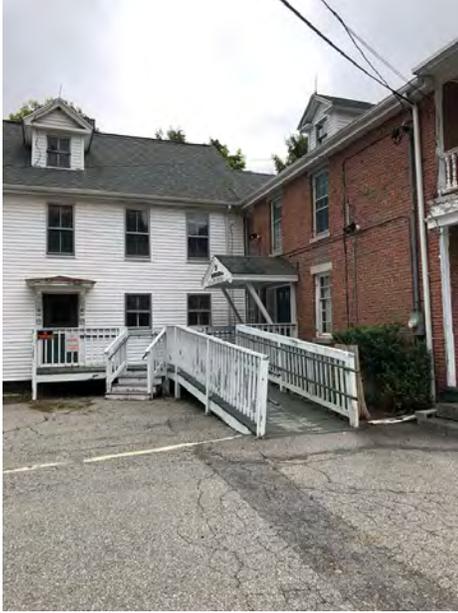
190910-IMG_2950.JPG

Intersection of 1837 Building at Right to 1900 Addition at Left; Wooden Ramp and Stairs

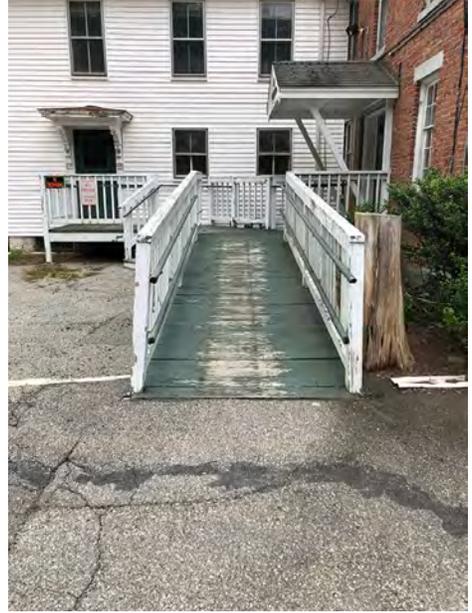
190910-IMG_2955.JPG

Wooden Wheelchair Ramp to Both Entrances

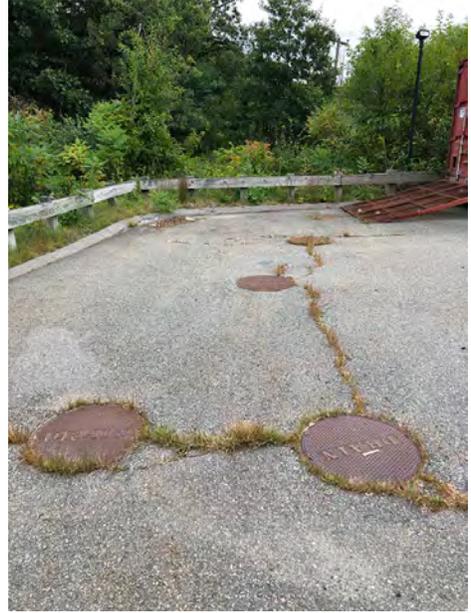
190910-IMG_3032.JPG

Storm Water Manholes at Low East End of Site

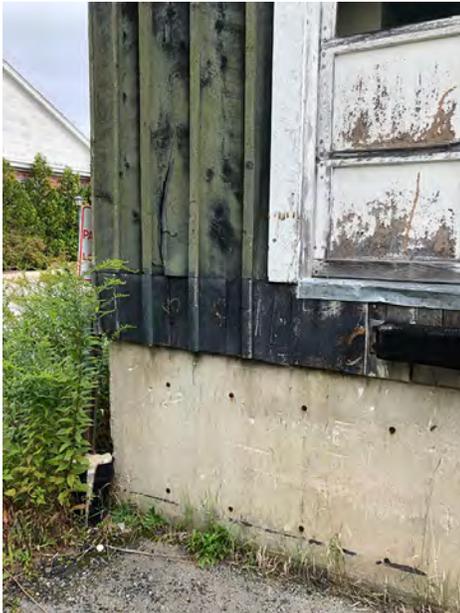
190910-IMG_3051.JPG

Foundation, Siding and Doorway Detail at Northwest Corner of School Storage Barn

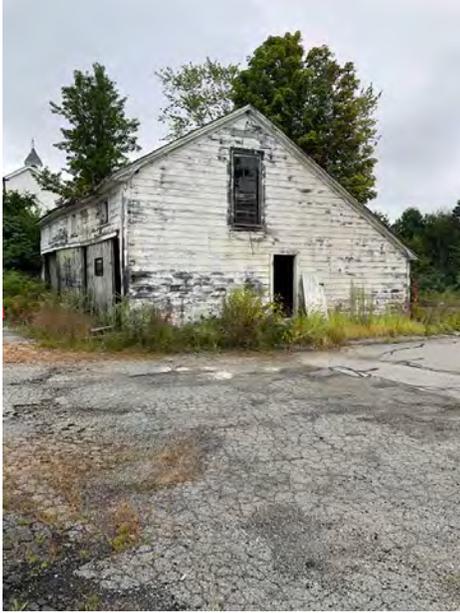
190910-IMG_3016.JPG

*South End of Rogers Fire Station Barn
(Abandoned Building)*

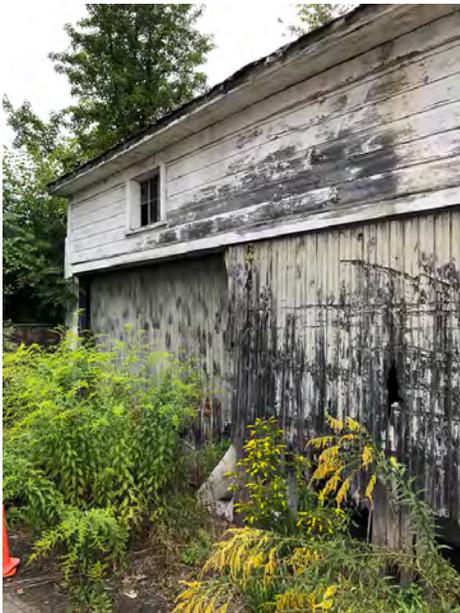
190910-IMG_3002.JPG

*North End of West Facade of
Abandoned Fire Station Storage Barn*

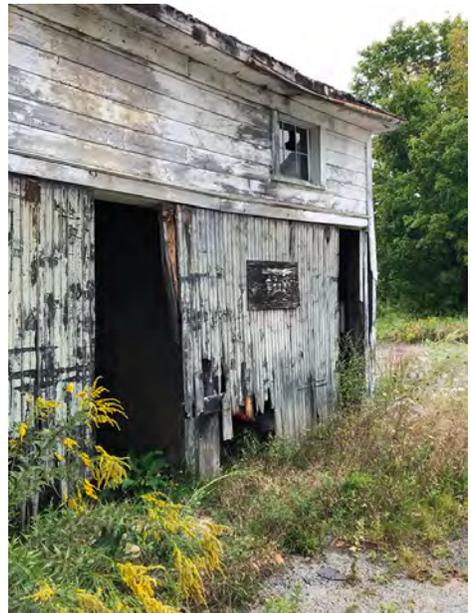
190910-IMG_3004.JPG

*South End of West Facade of
Abandoned Fire Station Storage Barn*

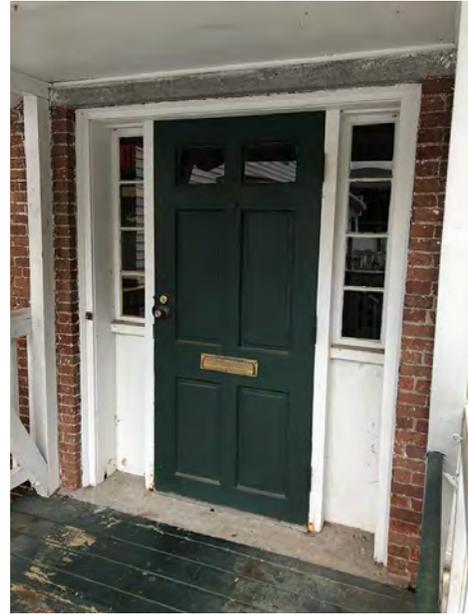
191003-IMG_3901.JPG

6-Panel Door with Sidelights at North Facade; Opening Location is Original but Current Door, Sidelights and Canopy are all Contemporary

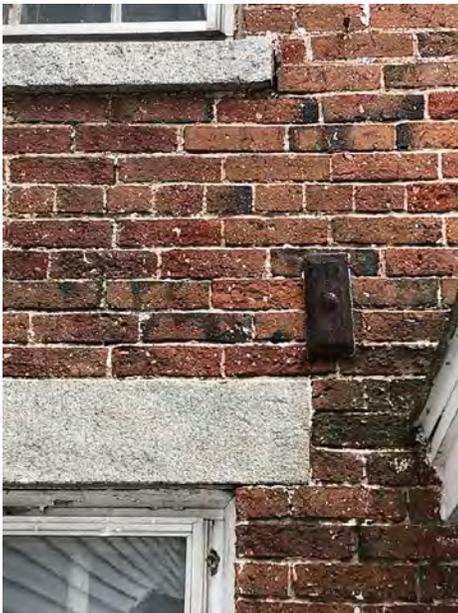
191003-IMG_3928.JPG

Detail of Granite Window Lintels & Sills at North Facade Adjacent to Entrance Canopy; One of a Pair of Iron Anchor Plates with Concealed Tie Rods Thru Brick to Framing

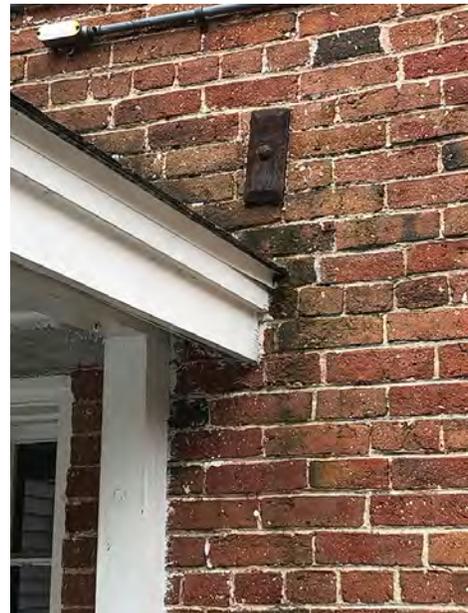
191003-IMG_3935.JPG

Second Iron Anchor Plate Adjacent to Entrance Canopy at North Facade (One Pair per Facade to Floor Framing)

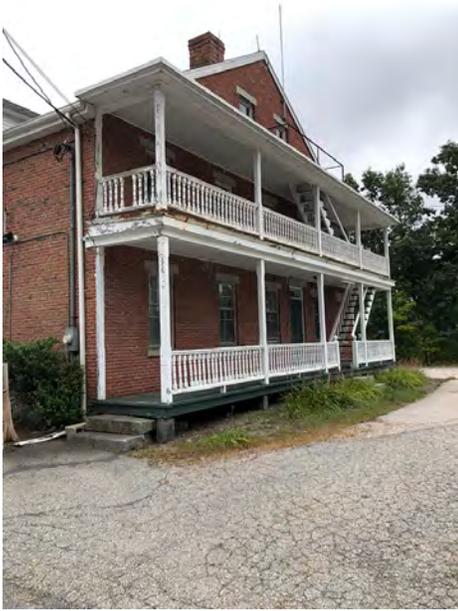
190910-IMG_2952.JPG

Fire Escape Balconies on Town Farm Facade Presumably Installed at Time of North Addition c. 1900

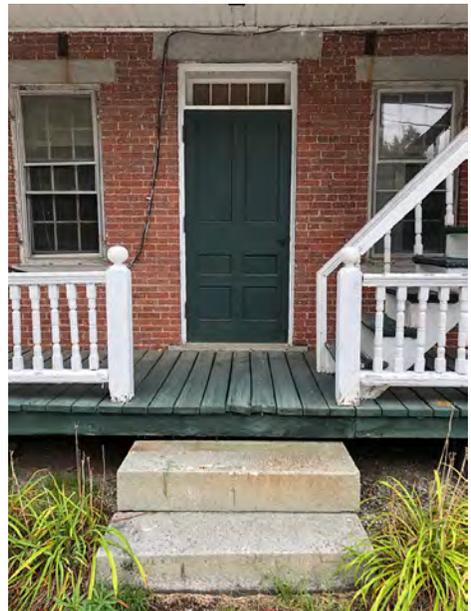
191003-IMG_3898.JPG

Front Entrance Door at Town Farm Facade; Blocked by Shelving at Interior

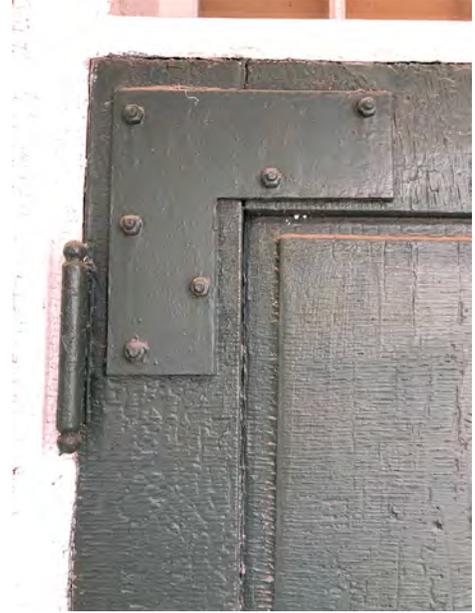
190910-IMG_2983.JPG

Corner Mending Plate to Reinforce Joint Between Hinge Stile and Upper Rail at Front Facade Door

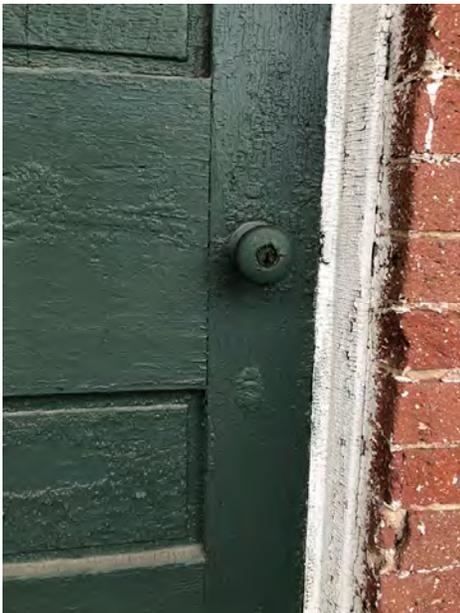
190910-IMG_2985.JPG

Original Woodwork, Multiple Paint Layers and Antique Door Knob Set at Front Facade Door

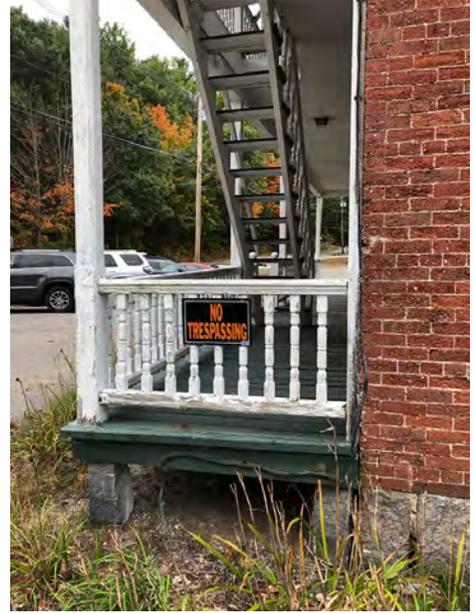
191003-IMG_3897.JPG

*South End of First Floor Fire Escape Balcony;
Railing and Chamfered Corner Post Intact*

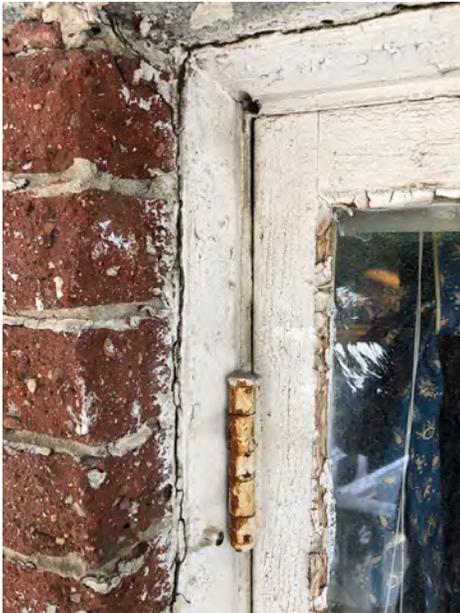
190910-IMG_2978.JPG

*Second Floor Fire Escape Door in Original Window
Opening with Intact Frame and Brick Mouldings;
Door Matches 6-over-9 Window Muntin Pattern*

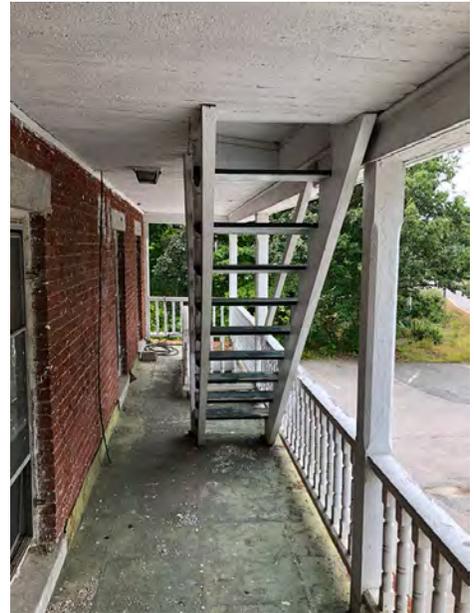
190910-IMG_2980.JPG

*Looking South at Second Floor Fire Escape Balcony;
Stairs Up to Closed Hatch at Third Floor*

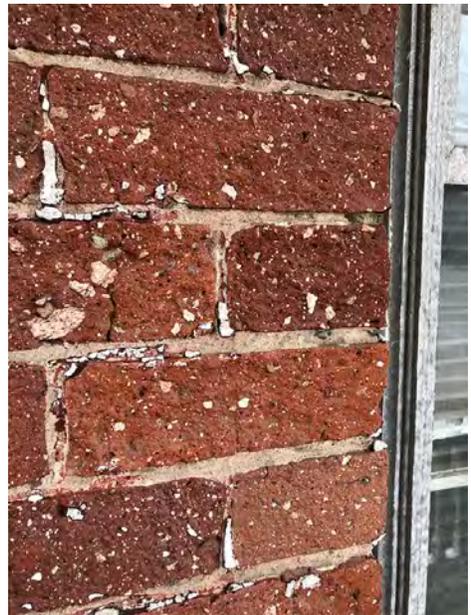
190910-IMG_2960.JPG

Rough Surface of Brick Resulting from Abrasive Sandblasting to Remove Paint; Remnants of Paint Still Embedded in Portions of Brick and Mortar

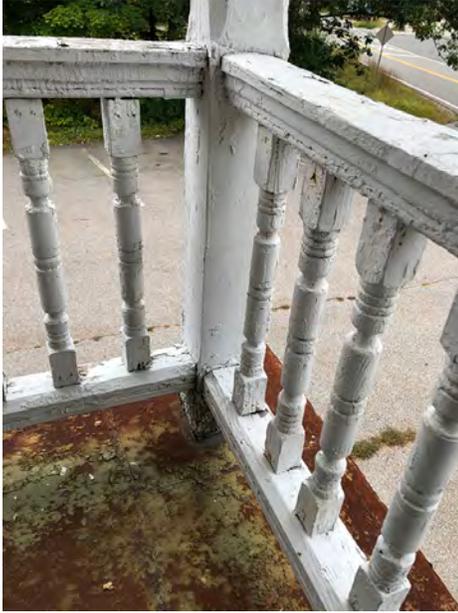
190910-IMG_2970.JPG

Detail at Southwest Corner of Second Floor Fire Balcony; Chamfered Post, Turned Balusters, Moulded Rails

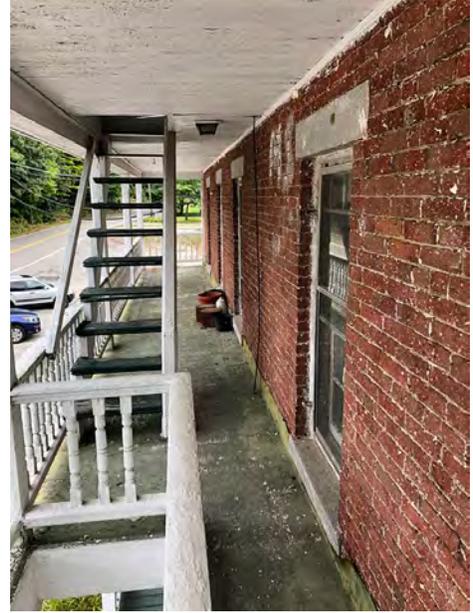
190910-IMG_2972.JPG

Northerly View of Second Floor Fire Escape Balcony; Stairs Up to Third Floor Hatch; Guardrail at Stairs Down to First Floor Balcony and Exit to Grade

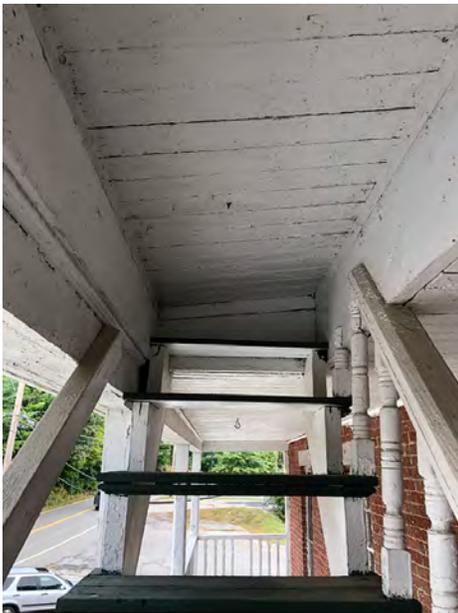
190910-IMG_2974.JPG

Closed Hatch at Roof Over Second Floor Balcony

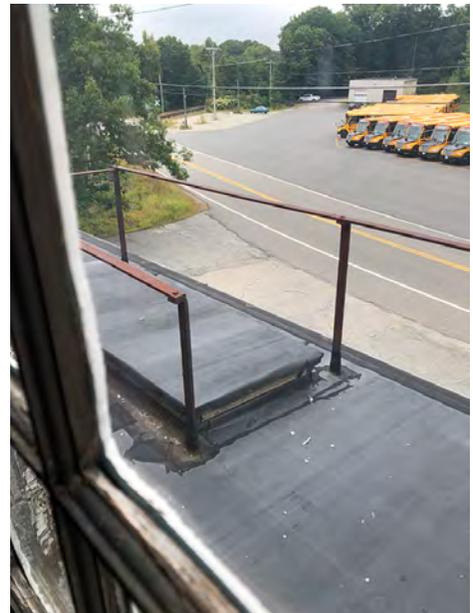
190910-IMG_2881.JPG

EPDM Roofing at Third Floor Exit with Metal Railing to Hatch for Stair Access Below

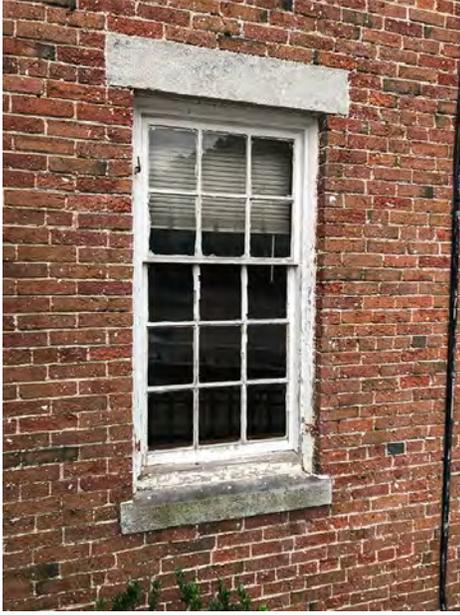
191003-IMG_3900.JPG

Typical 6-over-9 Double Hung Window on South Facade of First Floor

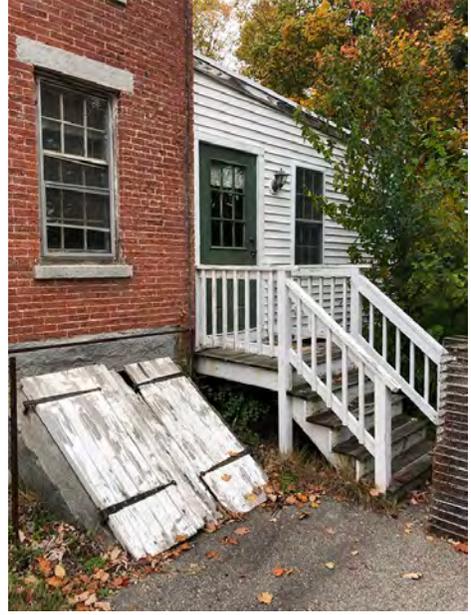
191003-IMG_3931.JPG

Cellar Bulkhead Doors; Contemporary Addition at East Facade of Original Farm Building

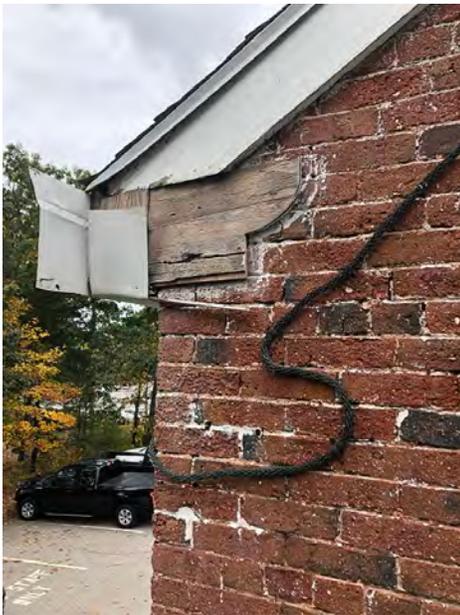
191003-IMG_3912.JPG

Rake and Eave Transition at Southeast Corner; Lightning Arrester Cable Mounted on Brick

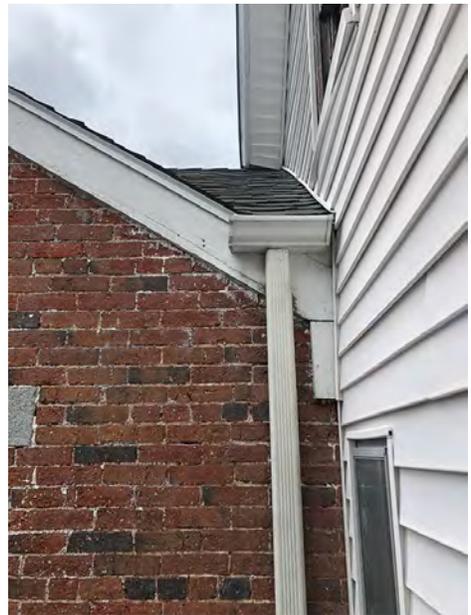
191003-IMG_3913.JPG

Northeast Corner at Intersection with 1900 Addition at Right

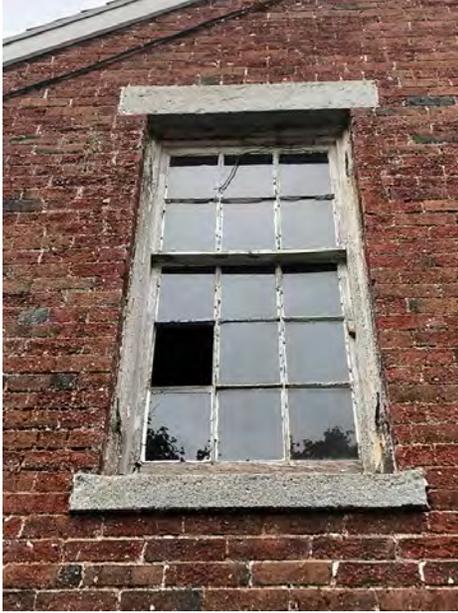
191003-IMG_3906.JPG

*6-over-9 Third Floor Window on East Facade;
Sandblasted Brick, Granite Lintel and Sill*

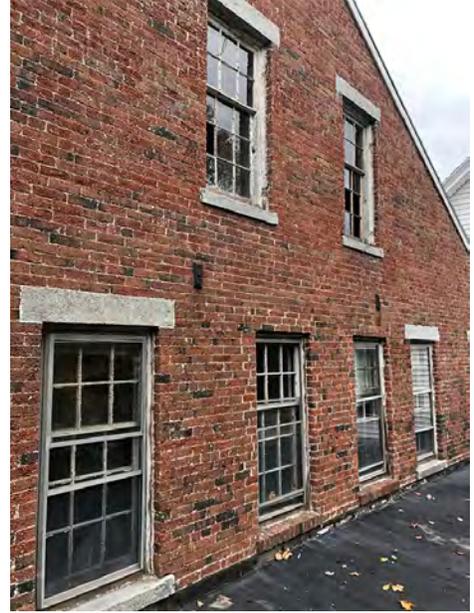
191003-IMG_3907.JPG

*East Facade of Second and Third Floors Above
Low Slope Roof of Contemporary East Addition;
Middle Pair of Windows Not Original (Post 1952)*

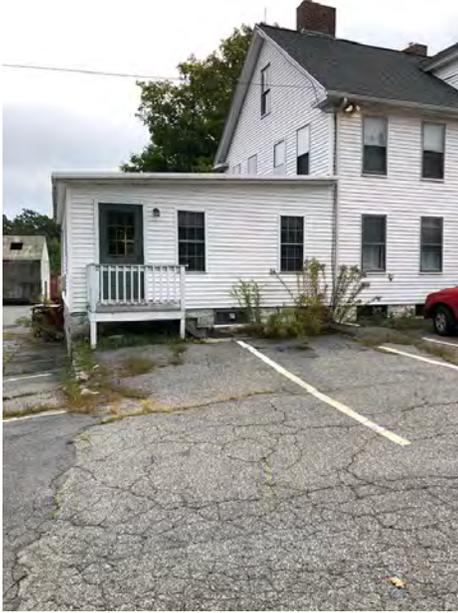
190910-IMG_2989.JPG

One-Story Addition at Side of 1900 North Addition

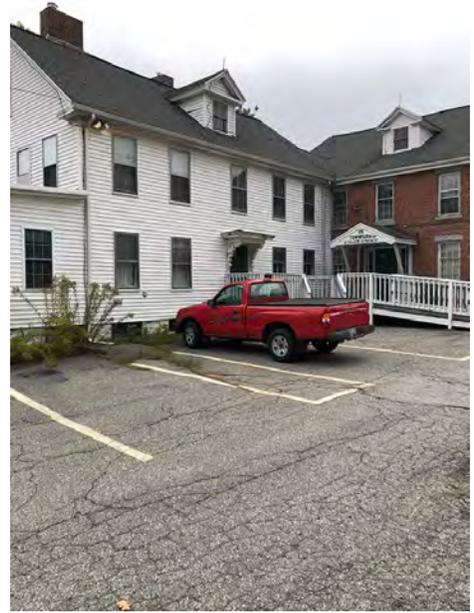
190910-IMG_2991.JPG

1900 Addition Replaced an Earlier Ell in Same Location

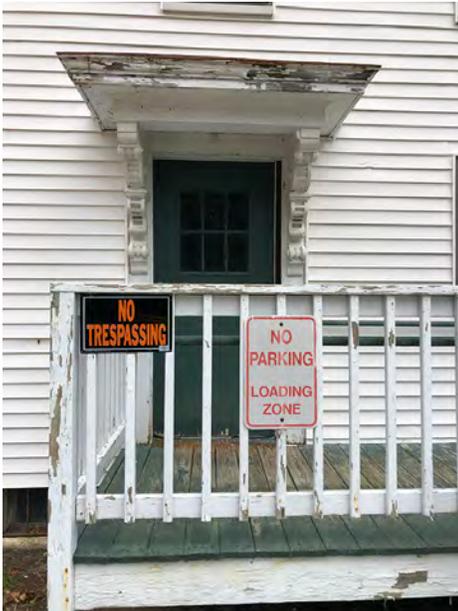
190910-IMG_2947.JPG

Entrance Deck Obscures Originally Intended Steps and Front Door to the Addition

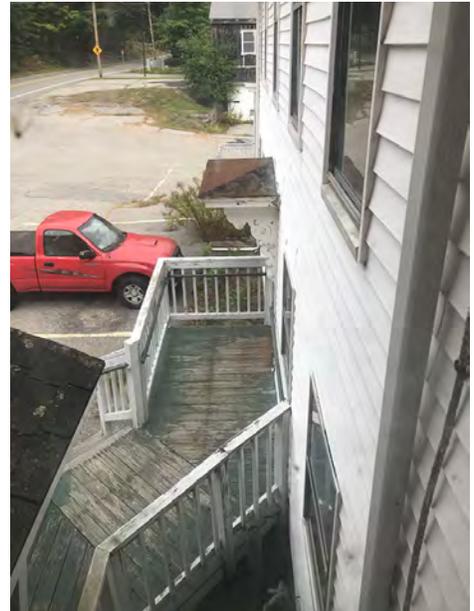
190910-IMG_2860.JPG

Extension of Deck Serving Both Entrances

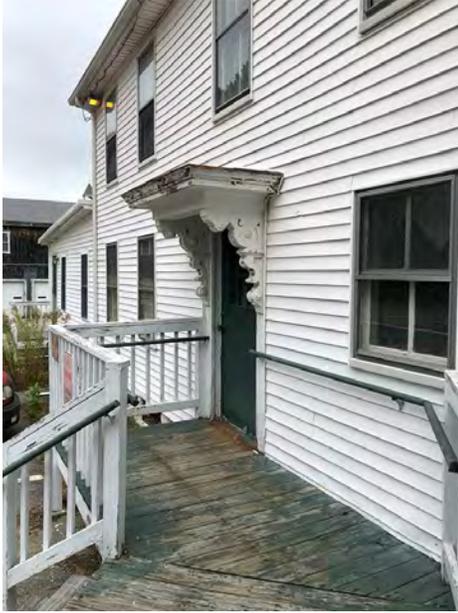
190910-IMG_2944.JPG

Side Approach to Canopied Entrance

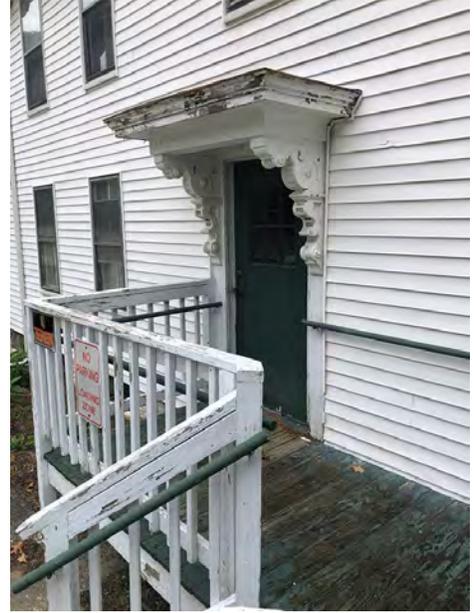
191003-IMG_3902.JPG

Heavily Bracketed Original Canopy Intact

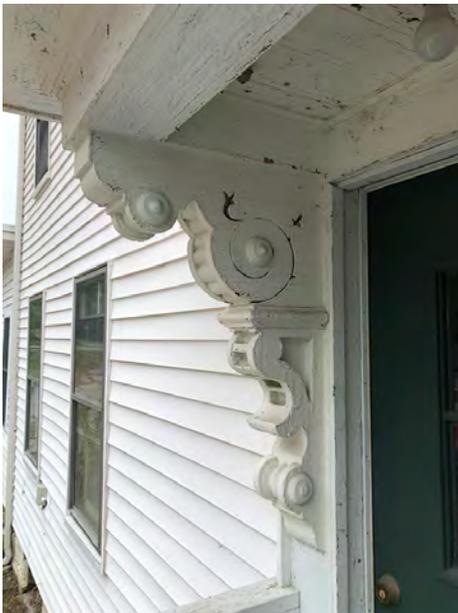
190910-IMG_2945.JPG

Detail of Carved Bracket and Canopy Ceiling

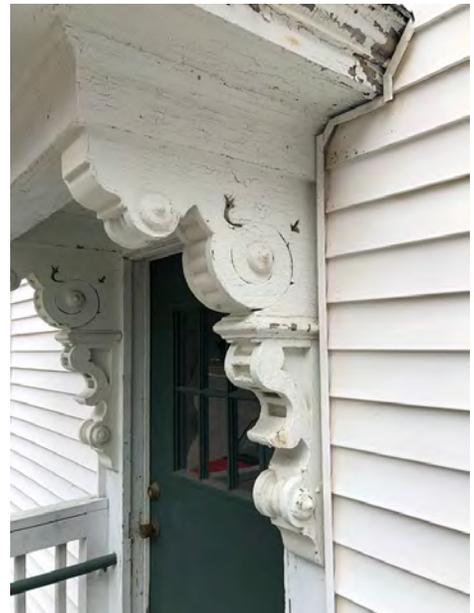
190910-IMG_2946.JPG

Bracket Retains Its Original Character and Integrity

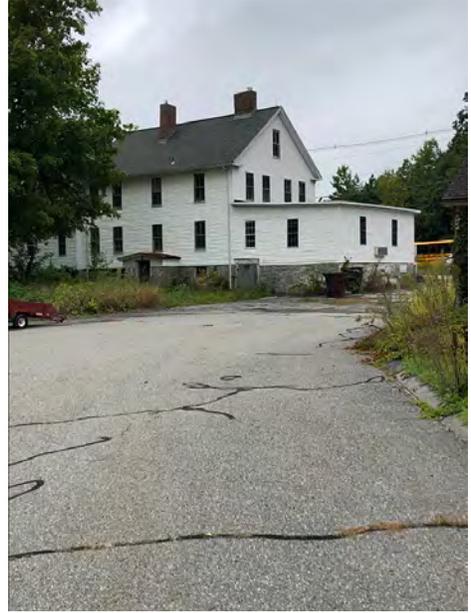
190910-IMG_3034.JPG

View to Southwest from Rear Lot Area

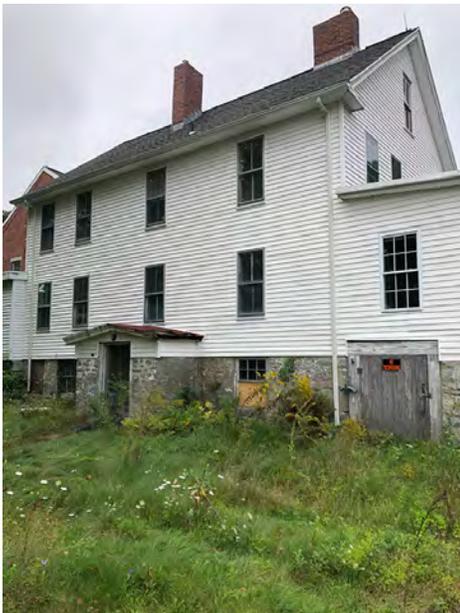
190910-IMG_3010.JPG

Rear Access to Basement at Left and to Crawl Space Under Addition at Right

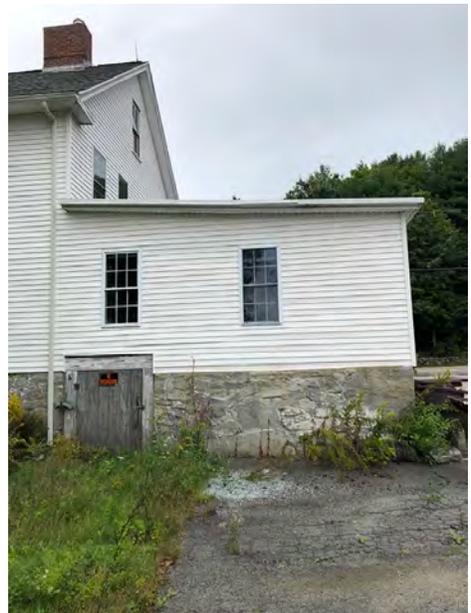
190910-IMG_3008.JPG

One-Story Portion of Addition on c. 1840 Older Stone Foundation of Previous Ell

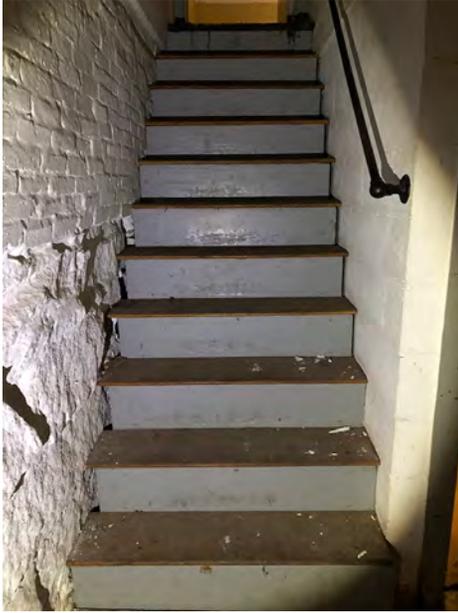
190910-IMG_2922.JPG

Basement Stairs to First Floor

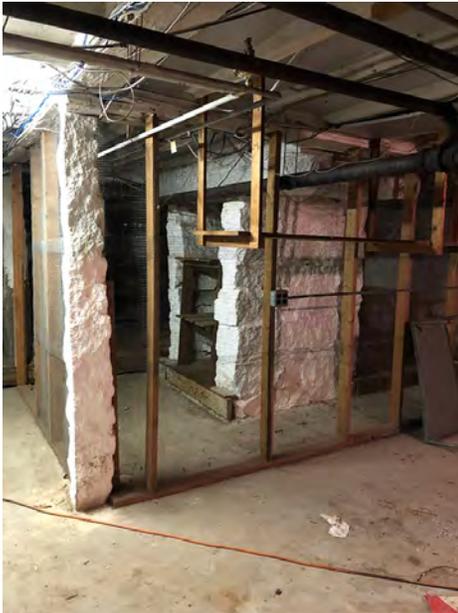
190910-IMG_2928.JPG

Storage Cage Enclosures in Southwest Corner

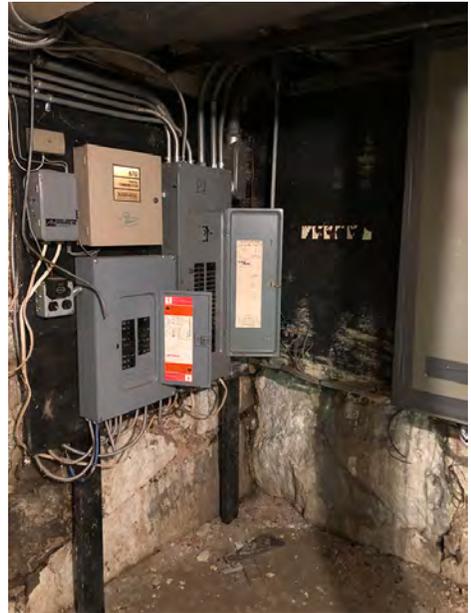
190910-IMG_2925.JPG

Electrical Panels in Northwest Corner

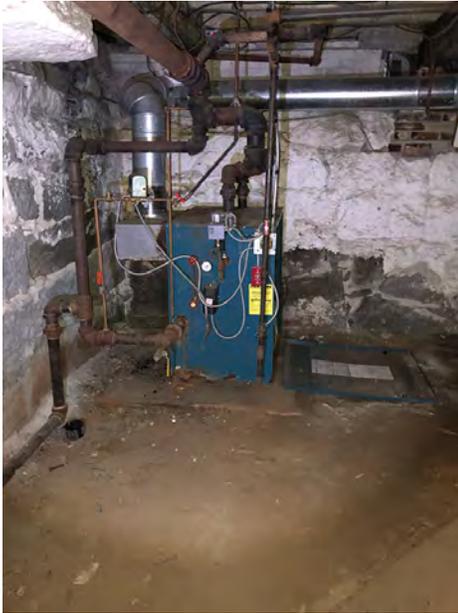
190910-IMG_2930.JPG

Cast Iron Gas-Fired Two-Pipe Steam Boiler

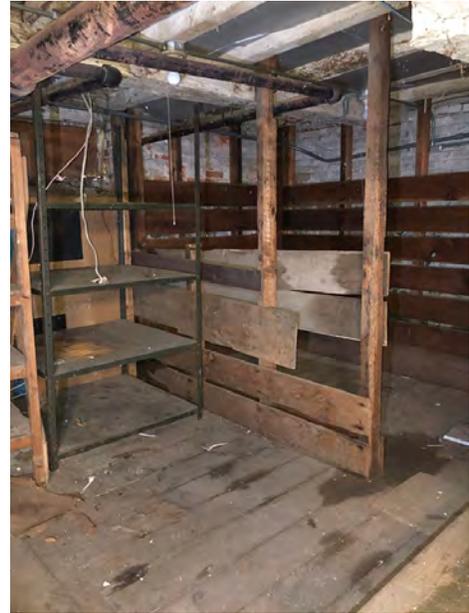
190910-IMG_2929.JPG

Wooden Platforms and Storage Area Dividers

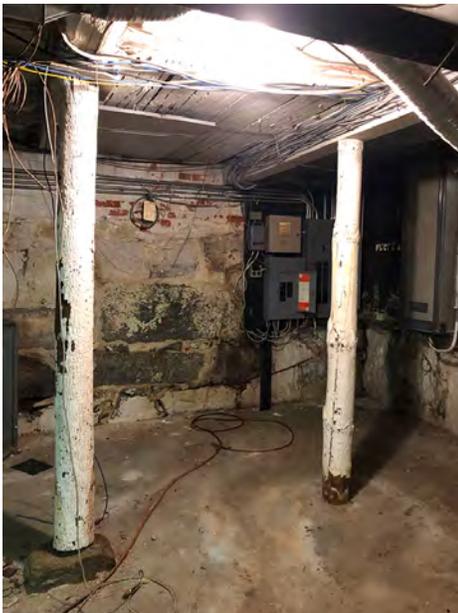
190910-IMG_2935.JPG

Pair of Log Posts with One on Stone Plinth

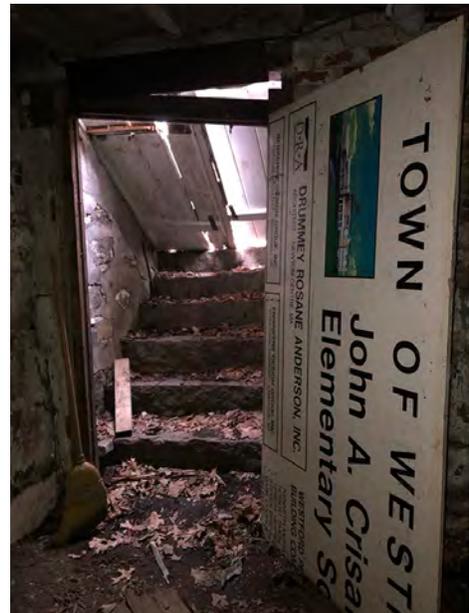
191003-IMG_3933.JPG

Bulkhead Door and Steps with Former Crisafulli School Sign as Inner Door

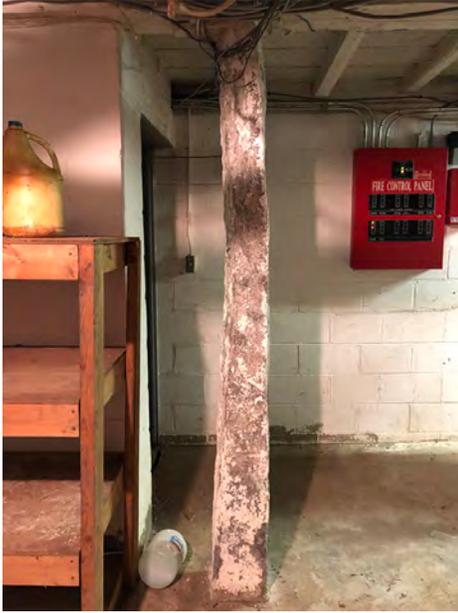
190910-IMG_2936.JPG

One of Several Painted Granite Posts

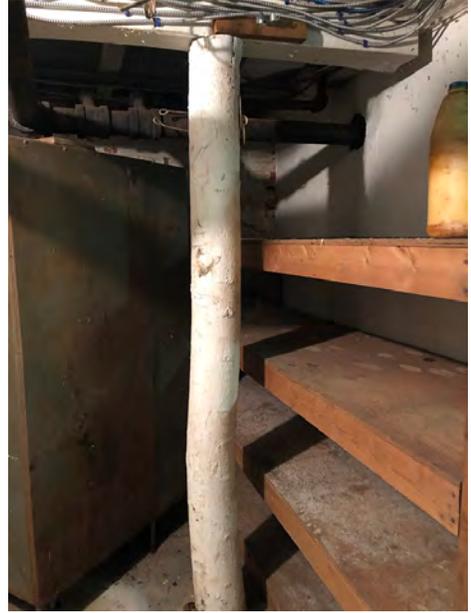
190910-IMG_2937.JPG

One of Several Painted Log Posts

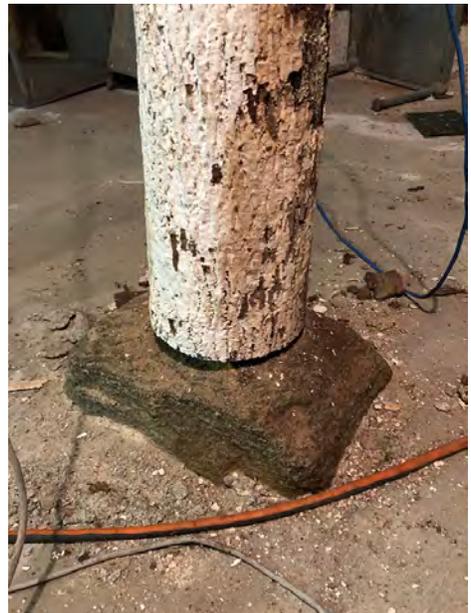
190910-IMG_2939.JPG

Base of Painted Log Post on Stone Plinth

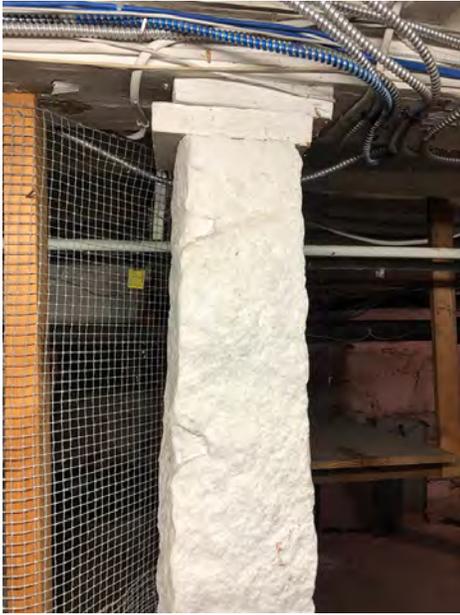
190910-IMG_2941.JPG

Stacked Wood Capitals of Painted Granite Post

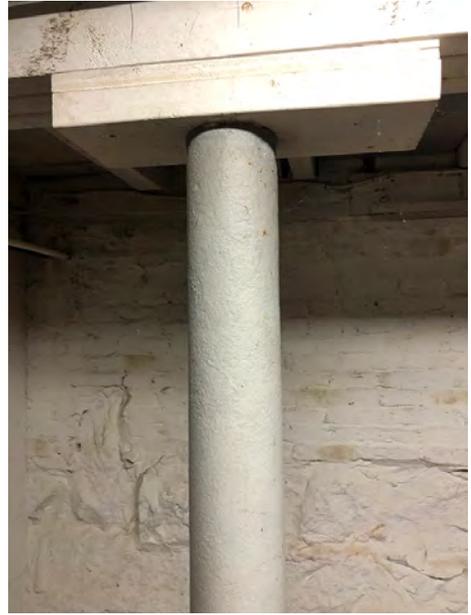
190910-IMG_2940.JPG

Wood Capital of Painted Steel Column

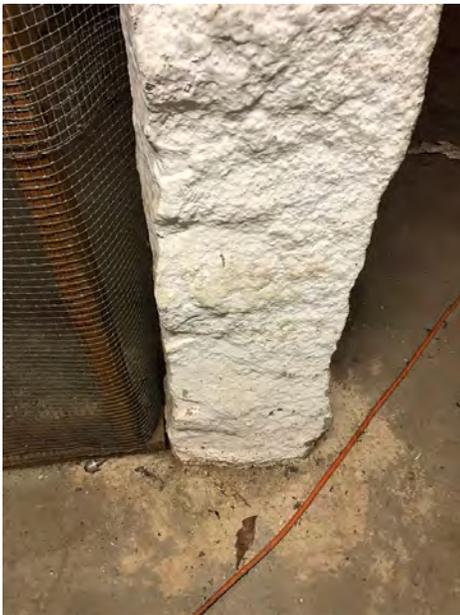
190910-IMG_2942.JPG

Base of Painted Granite Post

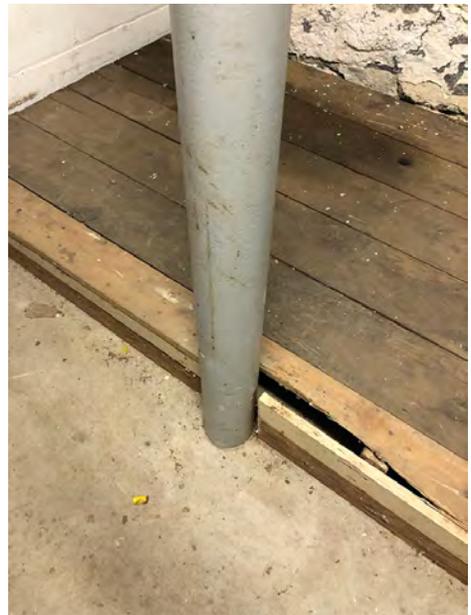
190910-IMG_2943.JPG

Base of Painted Steel Column

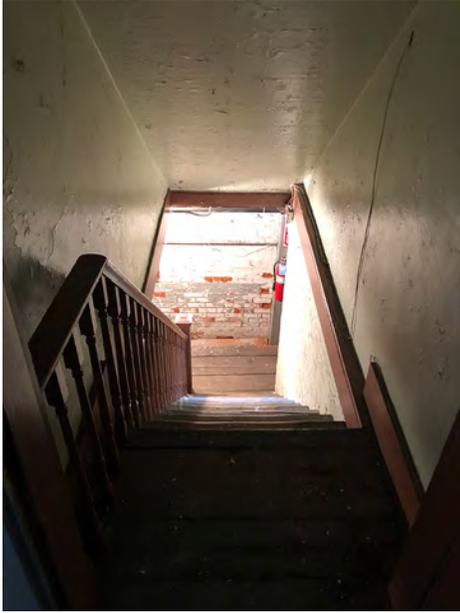
190910-IMG_2805.JPG

Stairs Down to Basement from First Floor

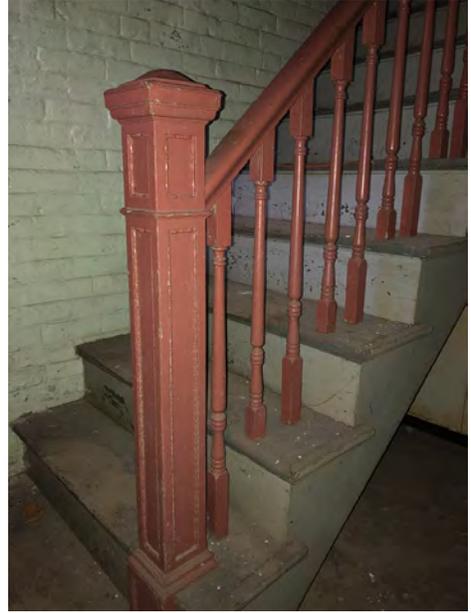
191003-IMG_3927.JPG

Newel Post and Balustrade at Basement

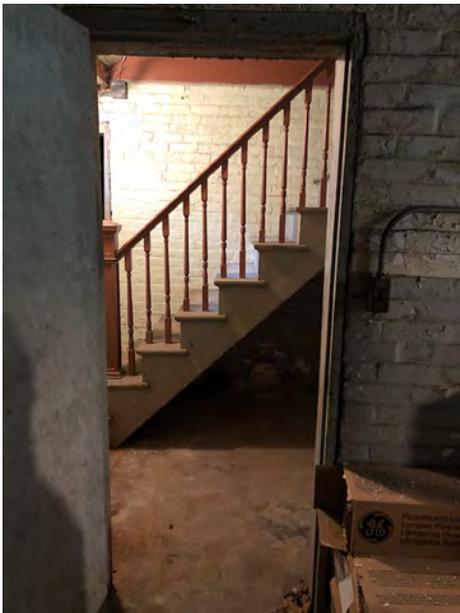
190910-IMG_2796.JPG

Looking North to Basement Stairway

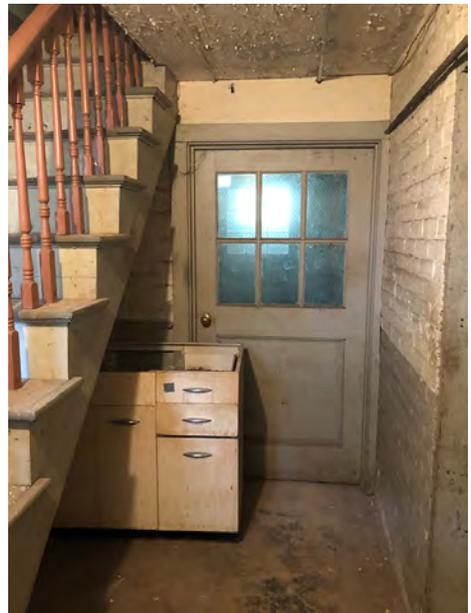
190910-IMG_2791.JPG

Looking East at Door Leading to Jail Cells

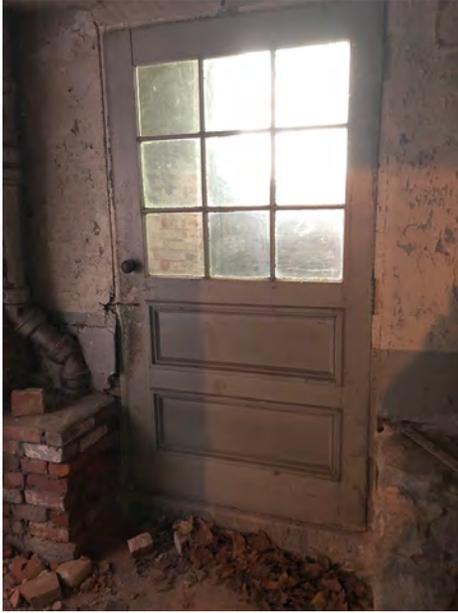
190910-IMG_2804.JPG

Exterior Bulkhead Door from Jail Cells

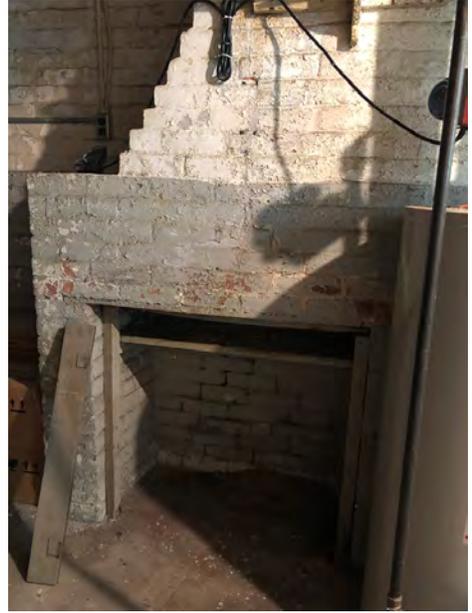
190910-IMG_2797.JPG

Brick Fireplace in South Room of Basement

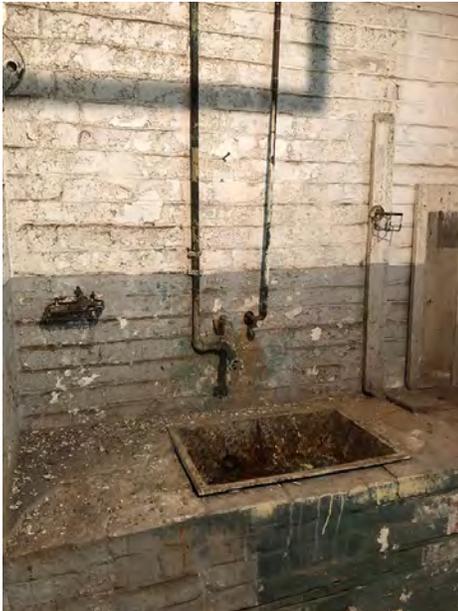
190910-IMG_2793.JPG

Sink Area and Brick Counter Adjacent to Fireplace

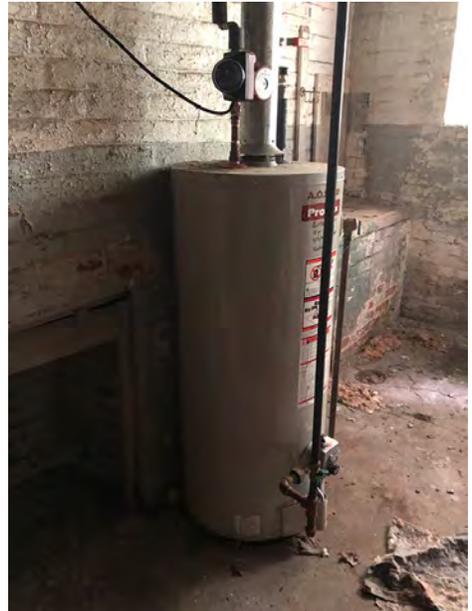
190910-IMG_2792.JPG

*Gas Fired Domestic Hot Water Heater
Between Fireplace and Sink Area*

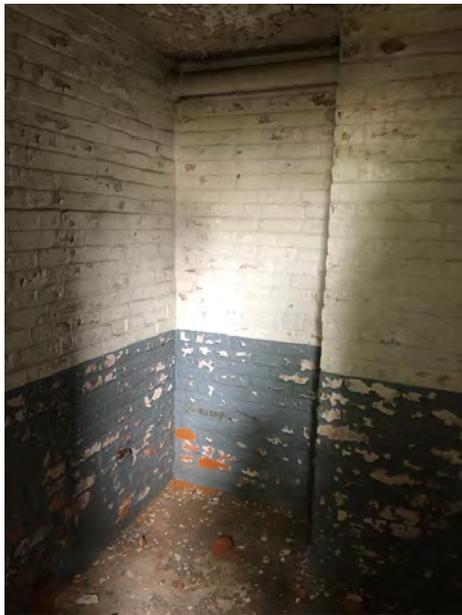
190910-IMG_2802.JPG

One of Two Jail Cells

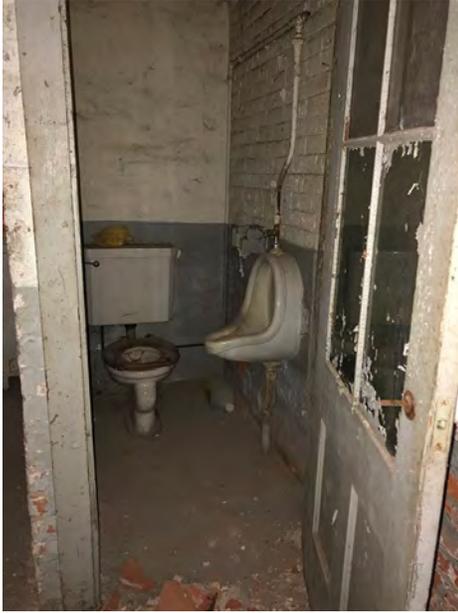
190910-IMG_2798.JPG

Toilet and Urinal Adjacent to Jail Cells

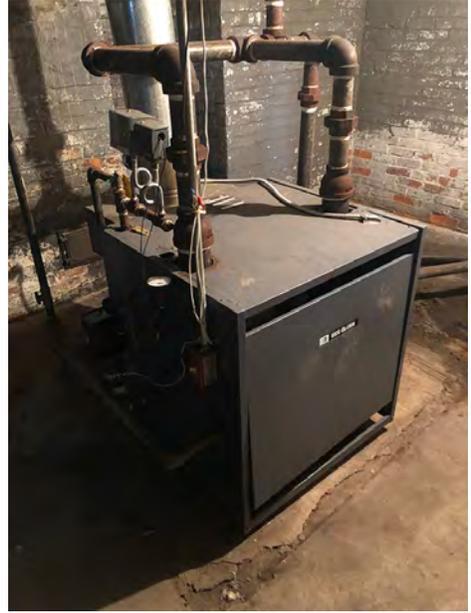
190910-IMG_2786.JPG

Gas-Fired Steam Boiler

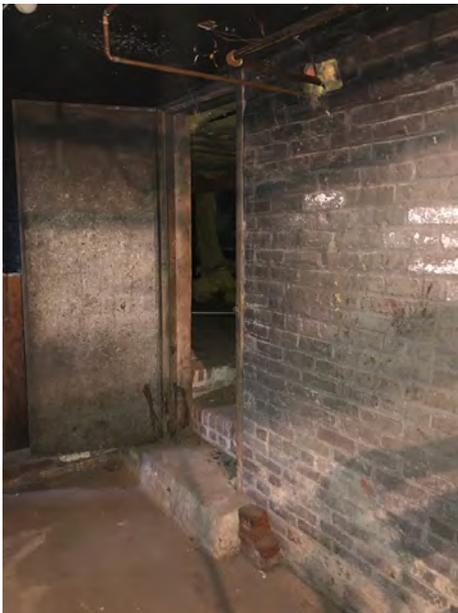
190910-IMG_2787.JPG

*Door and Steps to Crawl Space
Below One-Story Addition to North*

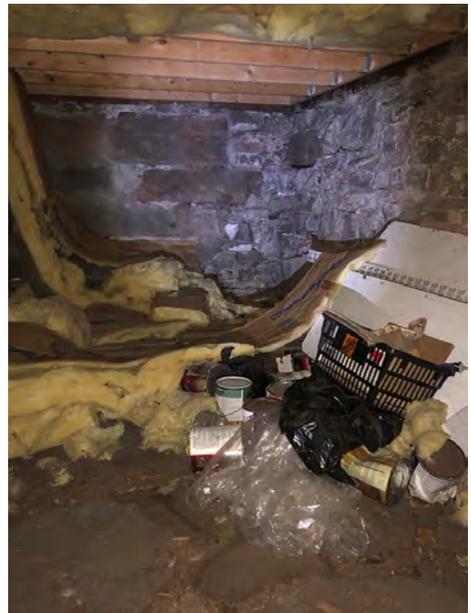
190910-IMG_2782.JPG

*Older Stone Foundation and Contemporary
Lumber Framing at North Addition*

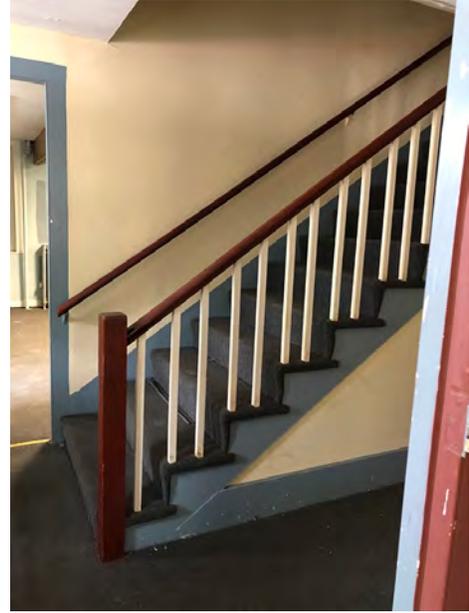
190910-IMG_2886.JPG

Central Stairway with Carpeted Wood Treads & Risers; Simple Square Newel Post and Balusters

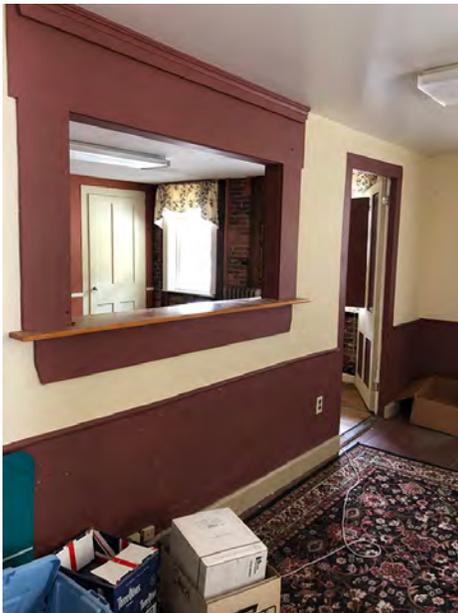
190910-IMG_2888.JPG

Northwest Corner of First Floor Most Recently Served as Office Reception Area

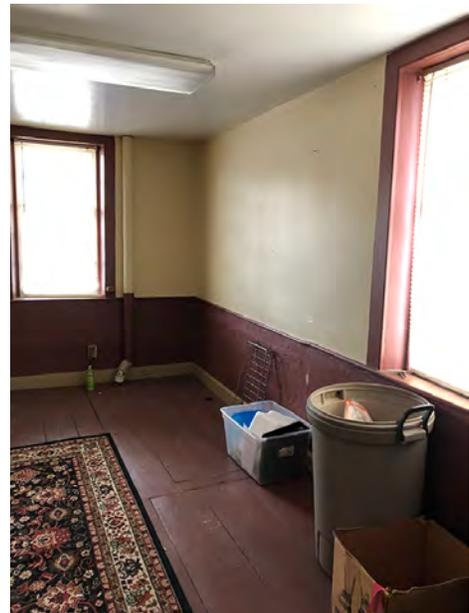
190910-IMG_2889.JPG

Northwest Corner of First Floor; Painted Wood Plank Flooring

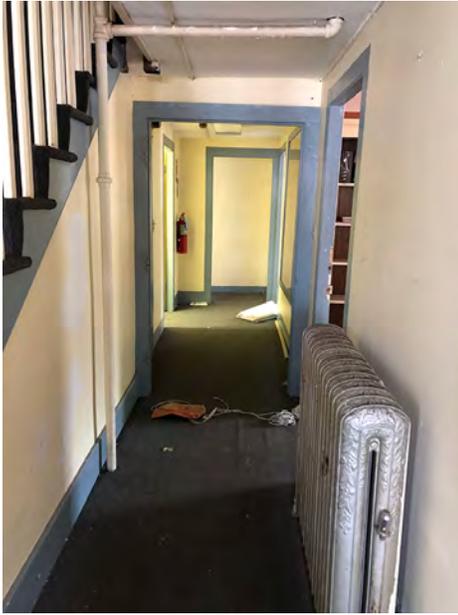
190910-IMG_2890.JPG

Looking South in Central Stair Hallway Toward Restroom

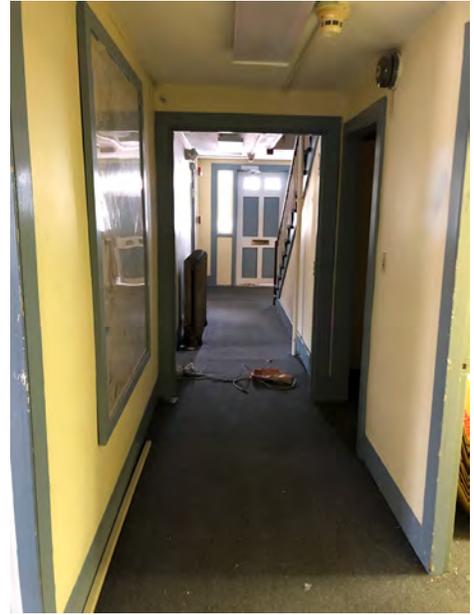
190910-IMG_2904.JPG

Looking North in Central Hallway Toward Entrance

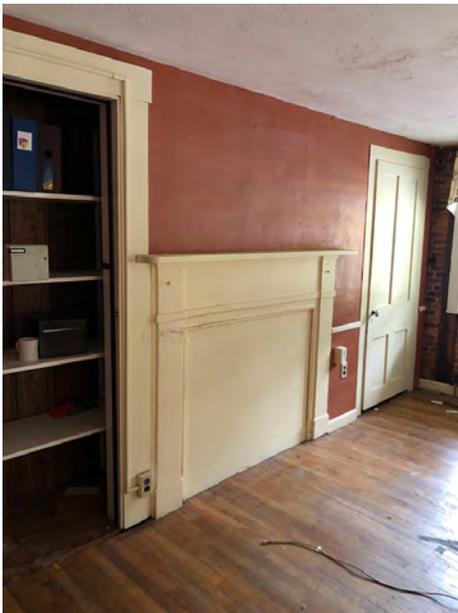
190910-IMG_2895.JPG

*Middle Room Adjacent to Reception Area
with Blocked Fireplace at Intact Painted Mantle*

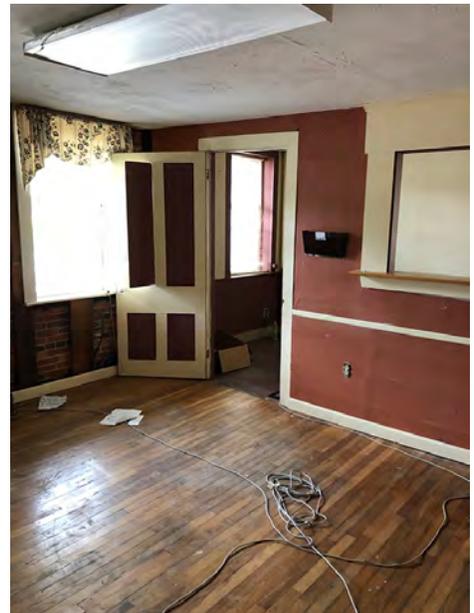
190910-IMG_2896.JPG

*Middle Room with Wood Strip Flooring
Added to Cover Plank Flooring*

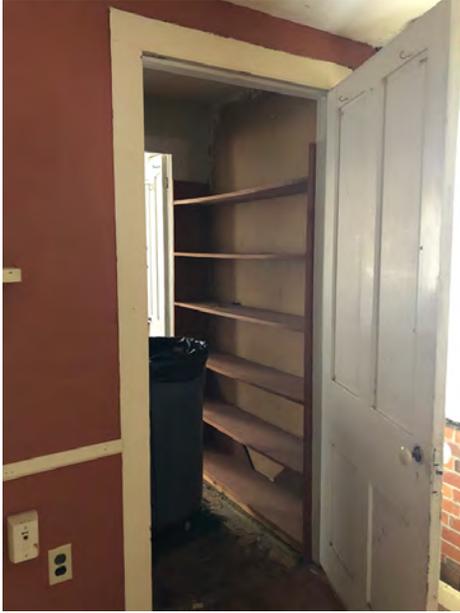
191003-IMG_3920.JPG

*Former Front Facade Doorway
Concealed by Shelving in Former Foyer*

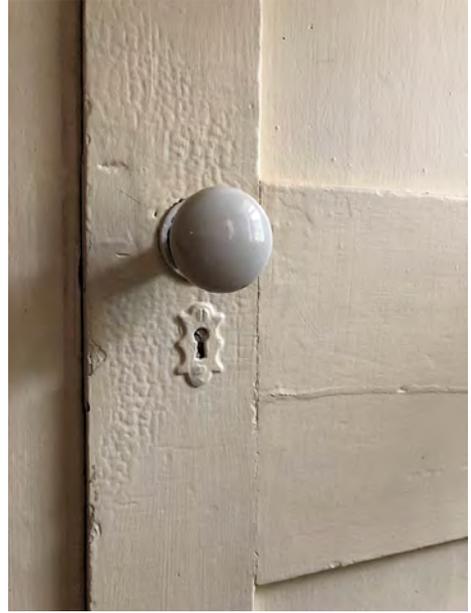
191003-IMG_3919.JPG

Historic Knob and Mortise Lockset
