WESTFORD TOWN FARM - ADAPTIVE REUSE CONSIDERATIONS

35 Town Farm Road

Westford MA

22 October 2019

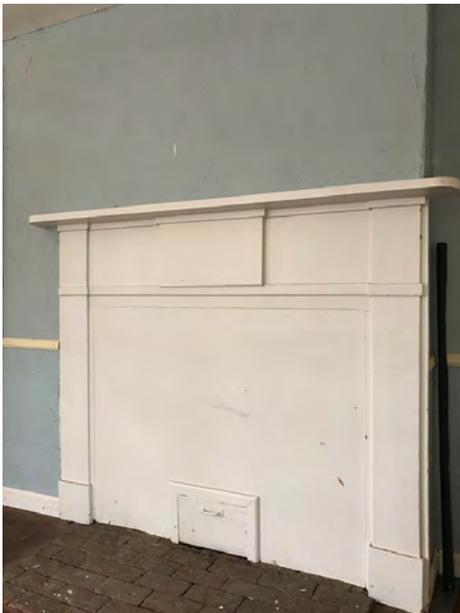
191003-IMG_3921.JPG

Blocked Fireplace with Intact Mantle in Southwest Room

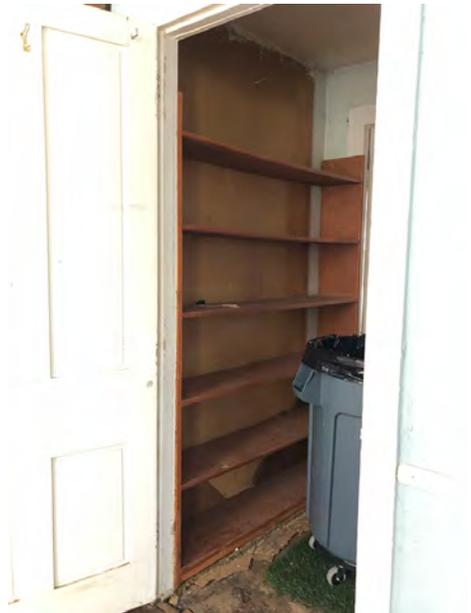
191003-IMG_3922.JPG

*Former Front Facade Doorway
Concealed by Shelving in Former Foyer*

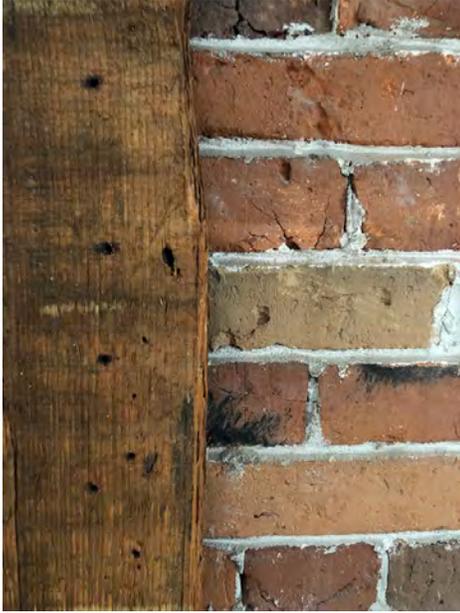
190910-IMG_2897.JPG

Lath & Plaster Removed at Interior Surface of Exterior Wall Showing Hewn Strapping on Brick

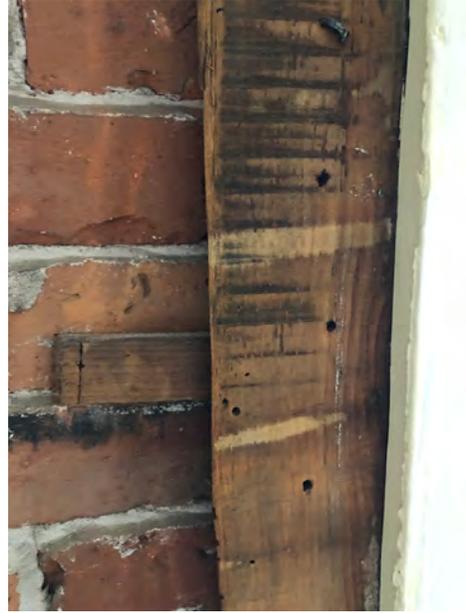
190910-IMG_2898.JPG

Lath & Plaster Removed at Interior Surface of Exterior Wall Showing Hewn Strapping on Brick

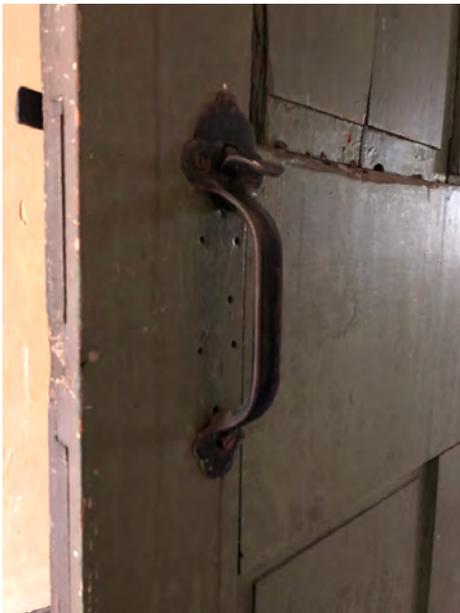
191003-IMG_3917.JPG

Thumb Latch and Door Pull Hardware

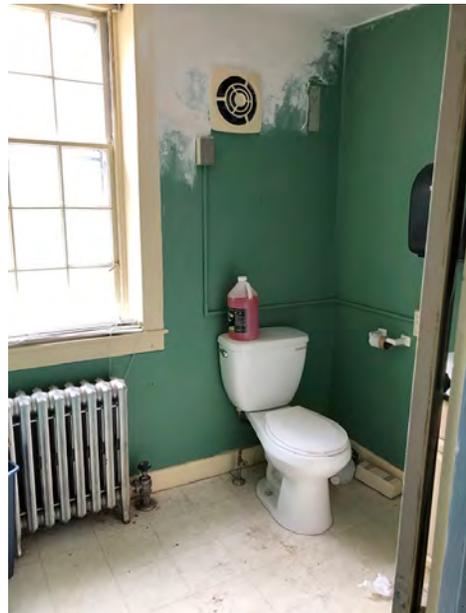
190910-IMG_2903.JPG

Restroom at South Wall Off Central Hallway

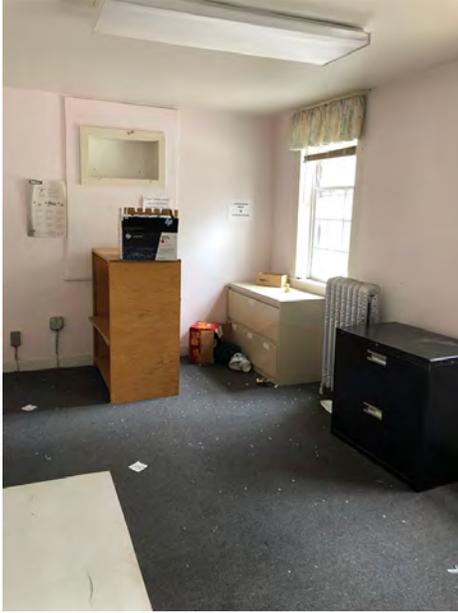
190910-IMG_2902.JPG

*Office in Southwest Corner of Original Brick Building;
Window in East Wall (at Left) Concealed by Addition*

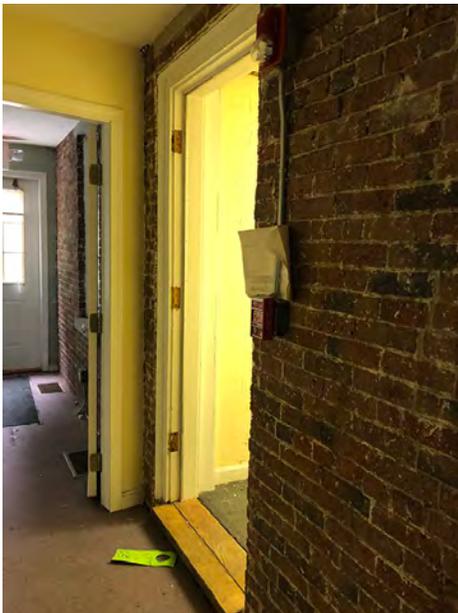
190910-IMG_2907.JPG

*Door from Transverse Hallway into East Addition;
South Door to Exterior Beyond at Left*

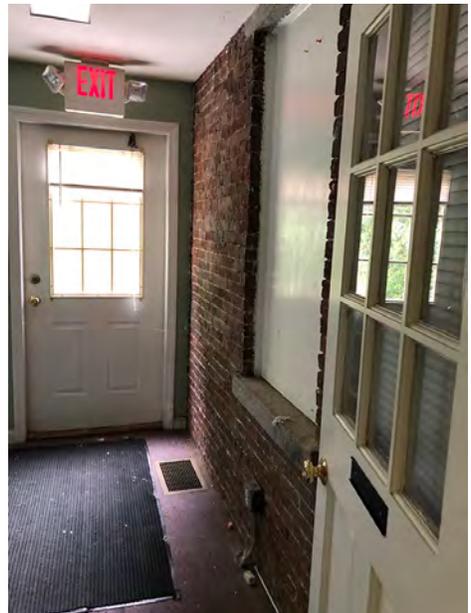
190910-IMG_2908.JPG

*Door to Exterior Adjacent to SE Corner of Brick Building;
Infilled Original Window Opening in East Facade*

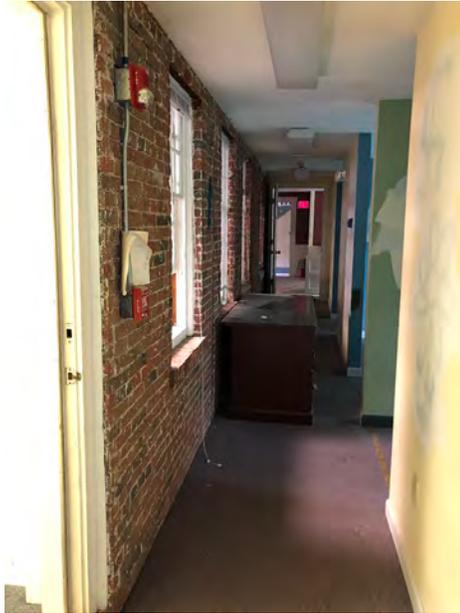
190910-IMG_2910.JPG

Looking North in Corridor Adjacent to East Facade; Original Brick Building at Left & East Addition at Right

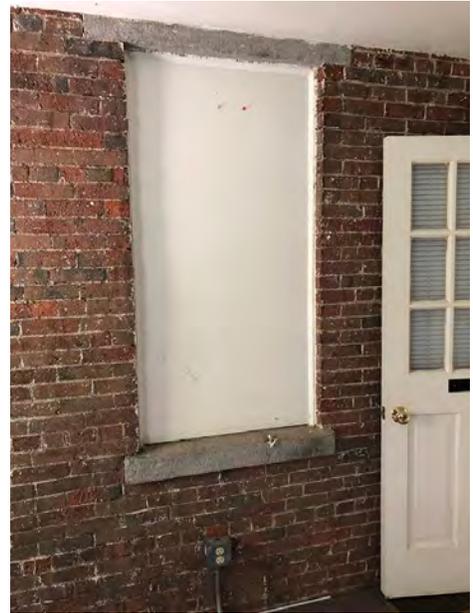
190910-IMG_2912.JPG

East Window Infill Near SE Corner; East Addition Built After Paint was Sandblasted from Exterior Facades

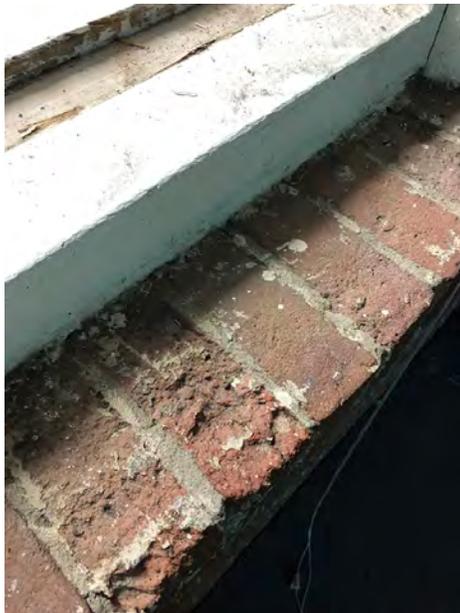
190910-IMG_2914.JPG

Non-Original Brick Window Sill at First Floor Similar to Two Openings at Second Floor of East Facade (page B.17)

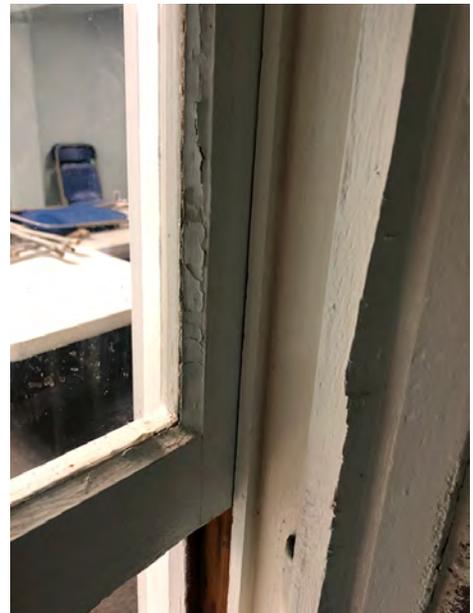
190910-IMG_2913.JPG

East Facade Window Added to Match Original Units

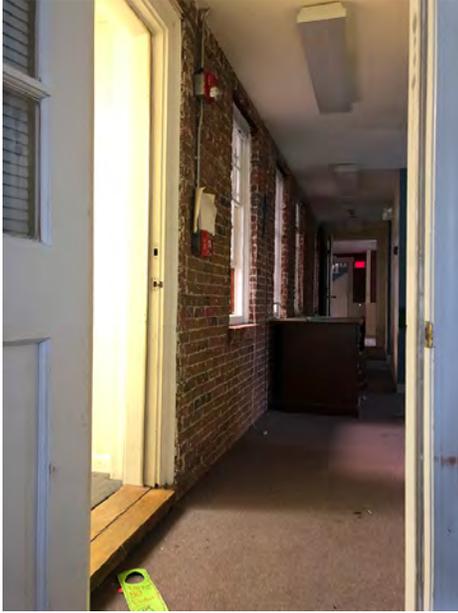
191003-IMG_3924.JPG

*Hallway Adjacent to First Floor East Facade;
Wooden Porch at This Location Photographed in 1952*

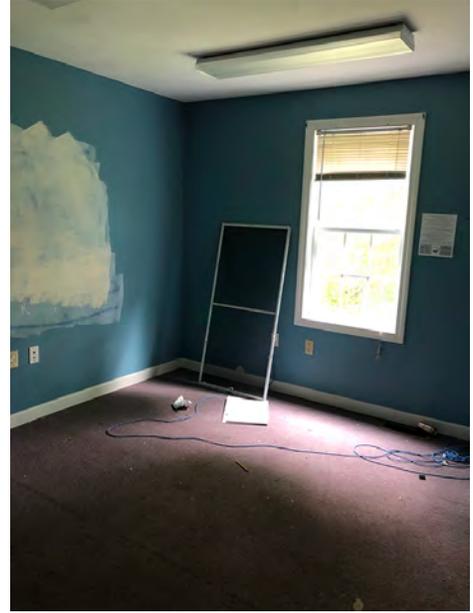
190910-IMG_2916.JPG

One of the Four Offices in East Addition

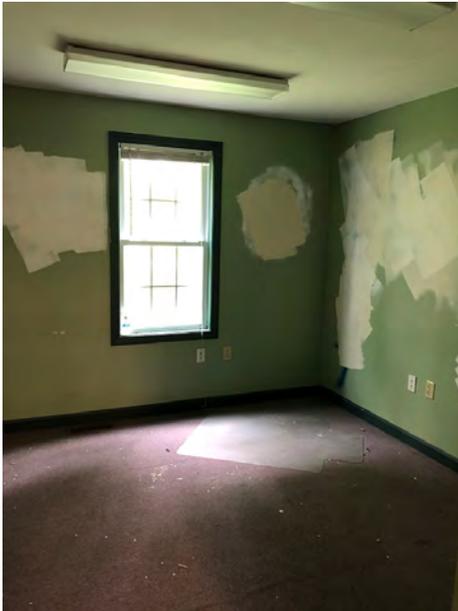
190910-IMG_2915.JPG

Another of the Four Offices in East Addition

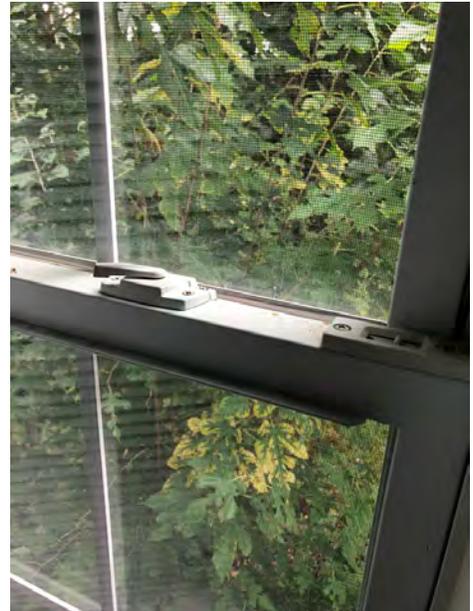
190910-IMG_2911.JPG

*Vinyl Windows in East Facade of East Addition
With 6-over-6 Simulated Divided Light*

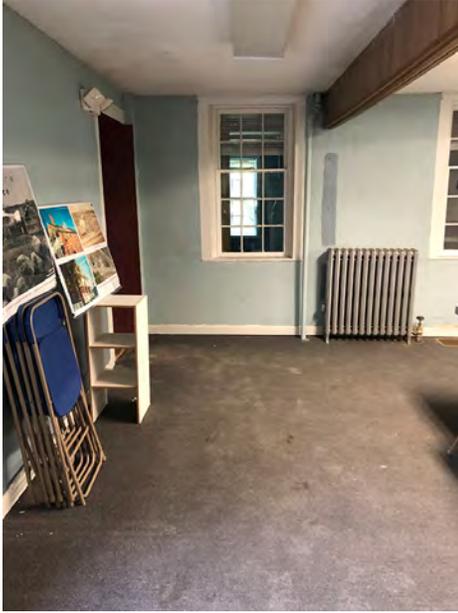
190910-IMG_2891.JPG

*Meeting Room in NE Corner of Brick Building;
6-over-9 Original Windows of East Facade*

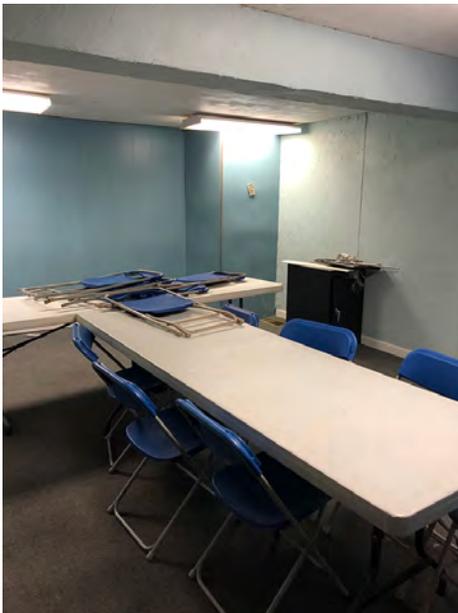
190910-IMG_2894.JPG

*Looking Southwest in First Floor Meeting Room;
Ceiling Soffit in Middle of Room at Former Partition*

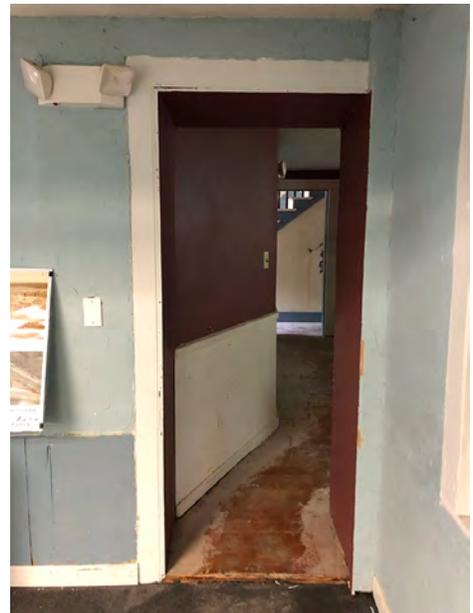
190910-IMG_2893.JPG

Awkward Passage from Meeting Room to North Addition

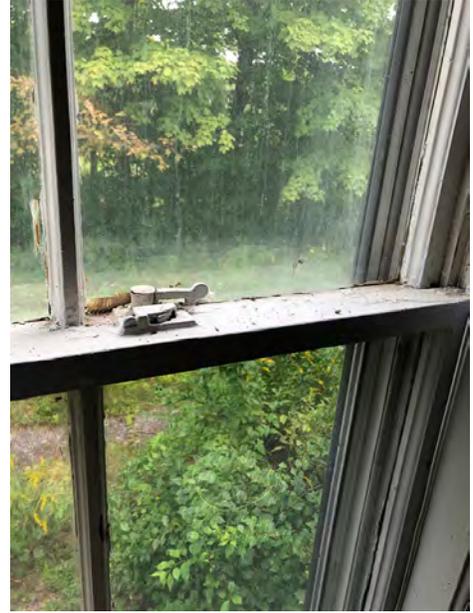
190910-IMG_2919.JPG

Original 2-over-2 with Sash Lock and Added Triple Track Exterior Storm

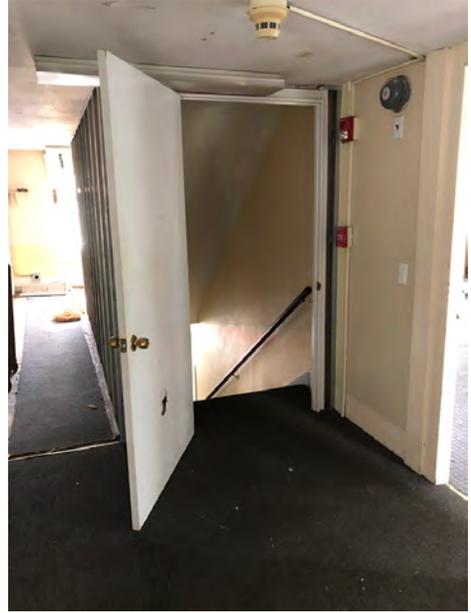
190910-IMG_2869.JPG

*Door at Stair Landing Swinging into Hallway;
Insufficient Landing Between Top Riser and Door*

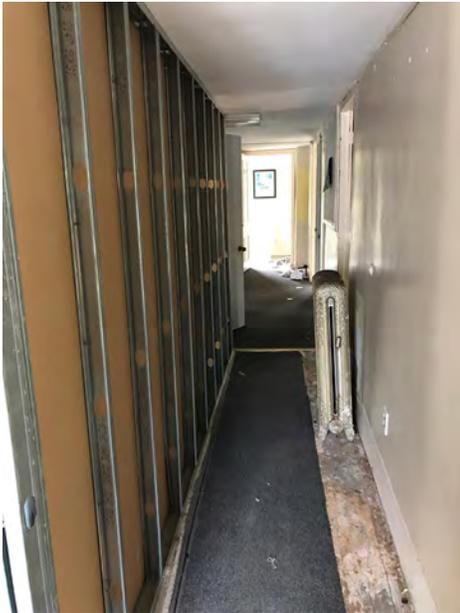
190910-IMG_2861.JPG

*Looking South in Central Hallway with Added
Metal Stud Partition Partially Enclosing Stairway*

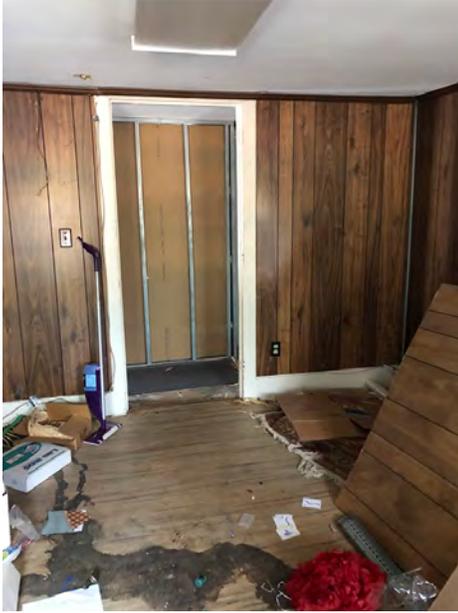
190910-IMG_2865.JPG

Masonite Paneling at Wall Surfaces in West Room

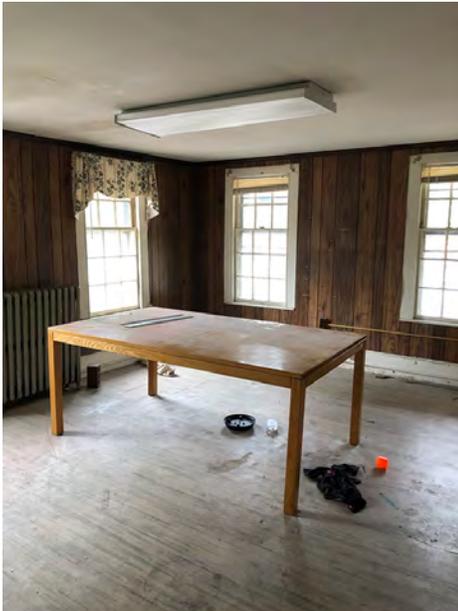
190910-IMG_2866.JPG

Southwest Room with Masonite Paneling Over Plaster

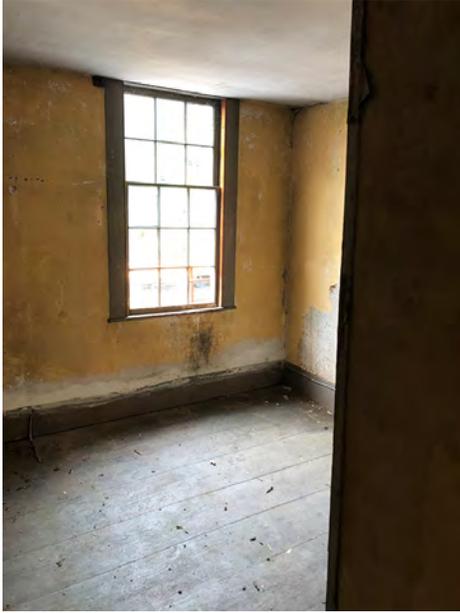
190910-IMG_2879.JPG

Flat Plaster Walls and Wood Baseboard Trim

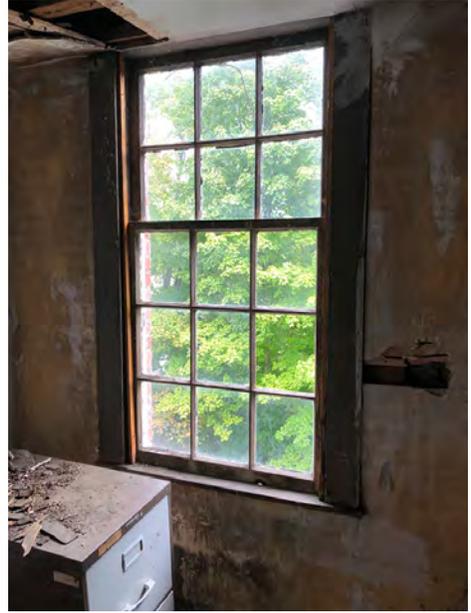
190910-IMG_2876.JPG

*Typical 6-over-9 Double Hung Window;
Head Aligned with Finished Ceiling*

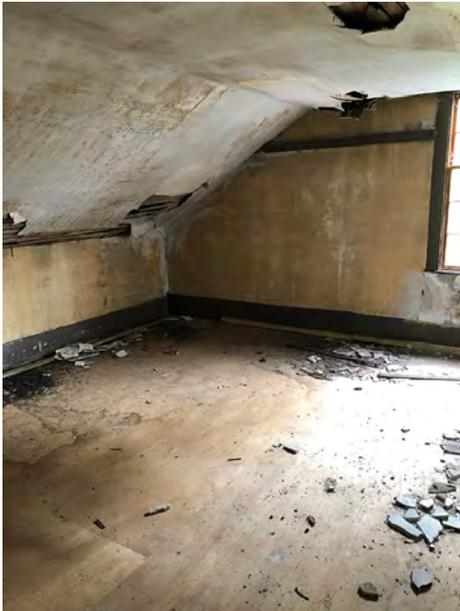
190910-IMG_2874.JPG

*Northeast Bedroom at Third Floor;
Plywood Floor Surface (Carpet Underlayment)*

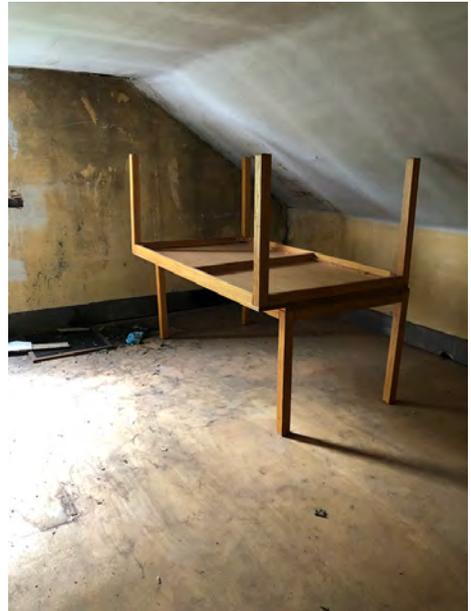
190910-IMG_2875.JPG

*Southeast Bedroom at Third Floor;
Plywood Floor Surface (Carpet Underlayment)*

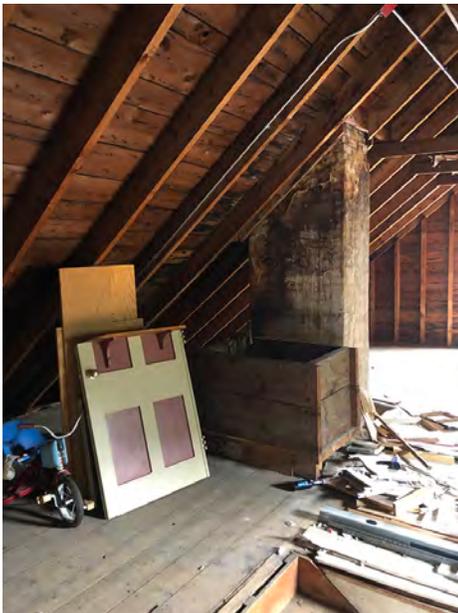
190910-IMG_2857.JPG

*Attic View Toward Chimney and Water Storage Box;
Lower Half of Dutch Door Stored Next to Tricycle*

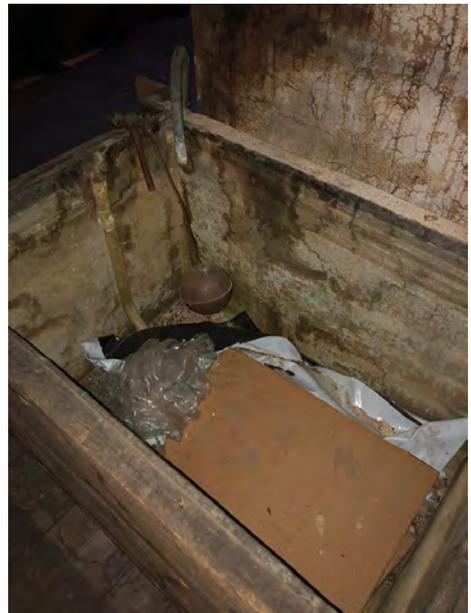
191003-IMG_3903.JPG

*Metal Lined Water Storage Tank with Float
for Automatic Water Fill Shut Off*

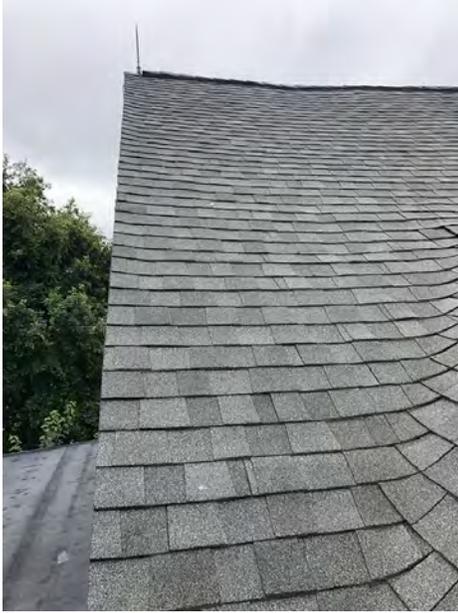
190910-IMG_2852.JPG

*North Slope of Eastern Gable Rake with
Lightning Arrestor at Ridge*

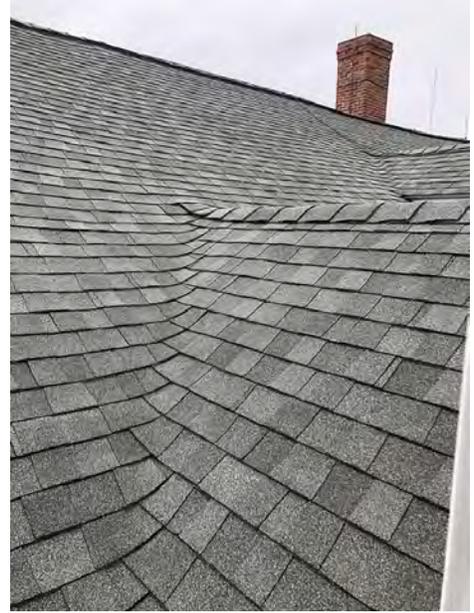
190910-IMG_2848.JPG

*GAF Timberline 40-Year Shingles Installed in 2007;
Closed Valleys; Brick Chimney Beyond Ridge*

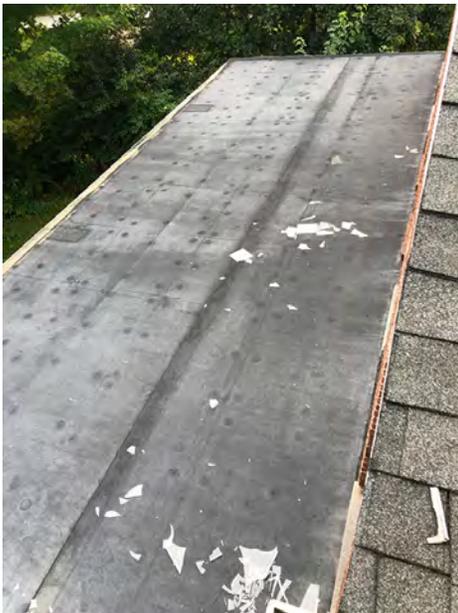
190910-IMG_2853.JPG

*EPDM Roofing Membrane at Low Slope Locations:
East Addition + Upper Fire Escape*

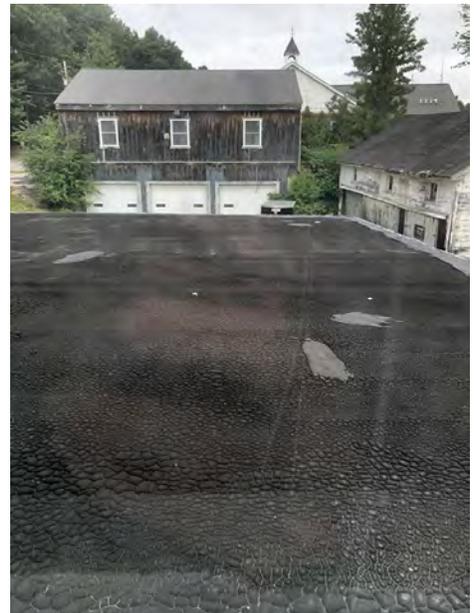
190910-IMG_2826.JPG

*EPDM Membrane Roofing at Shed Roof of
One-Story Portion of Addition*

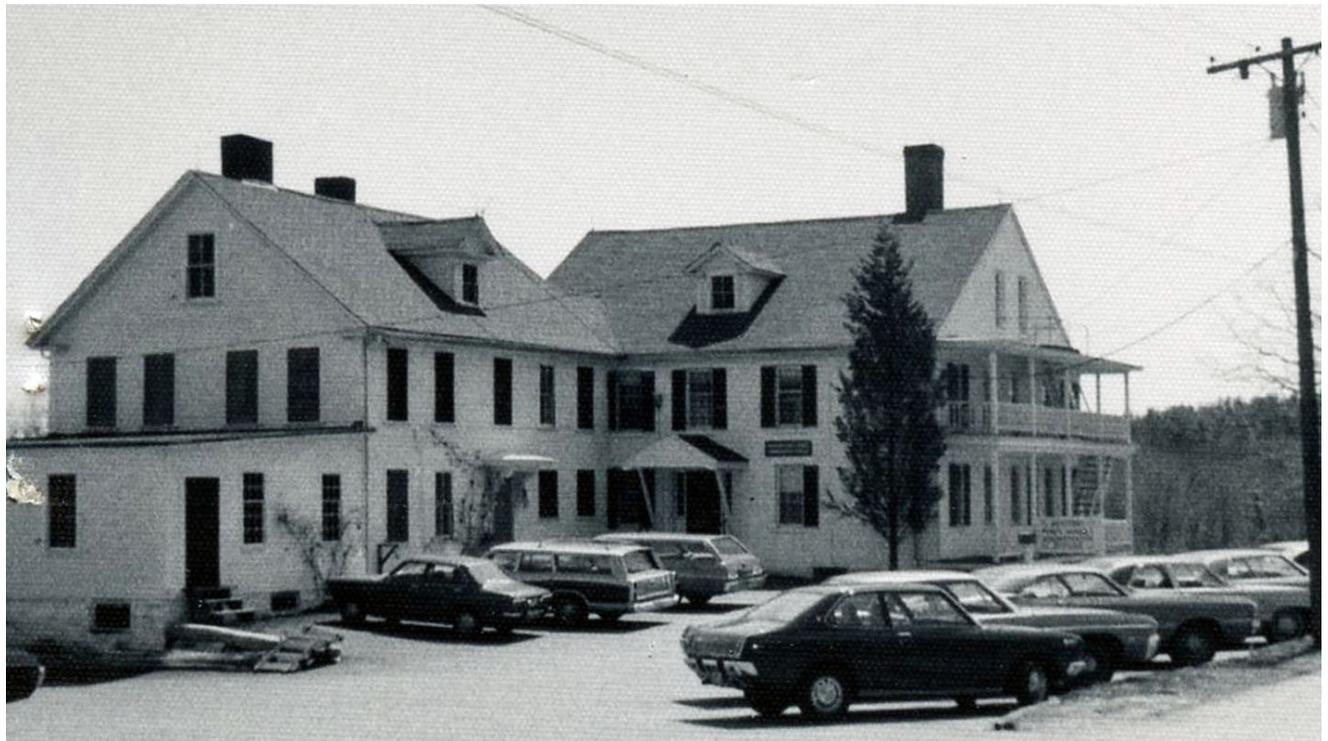
Early 1970's Photograph from Northwest; Rear Chimney in 1837 Portion of the Building Removed; Complex Appears to be Painted White Prior to Sandblasting the Brick Portions

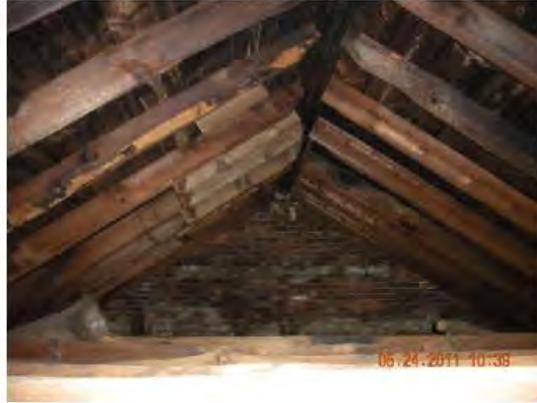
Figure 1 - *Farmhouse* - Main Roof Framing & Ridge Board

- The gable roof structure of the *Farmhouse* was observed to be framed with rough hewn timber rafters that appear to be framed into the sides of a rough hewn timber ridge board by means of mortise and tenon joints – refer to **Appendix A – Figure 1**. IREI anticipates that the bottom ends of these gable roof rafters bear on and are supported by the top of the brick masonry sidewall bearing walls along the left and right sidewalls of the *Farmhouse*. However, the bottom ends of these rafters could not be directly viewed because of the interior timber framed knee walls at the Third Floor level. IREI did observe a significant amount of damage and water staining to the interior plates finish at the underside of both the sloped and flat portion of the Third Floor level ceilings – refer to **Appendix A – Figure 2** and **Figure 3**. The observed plaster damage is significant and indicates apparent substantial amount of water leaking through the roof shingles. IREI is not sure whether the leak is currently leaking or whether this water damage occurred at some time in the past. IREI's concern is that there could be a significant potential of structural damage to the timber roof framing elements in these areas from long term water leakage and decay. IREI recommends that the *Town* have all of the existing damaged plaster finishes removed from all the walls and ceiling surfaces (both flat and sloped portions of the ceilings) at the Third Floor level so that the underlying timber roof structure can be closely reviewed and inspected for timber damage and determine whether the roof framing must be repaired and reinforced.

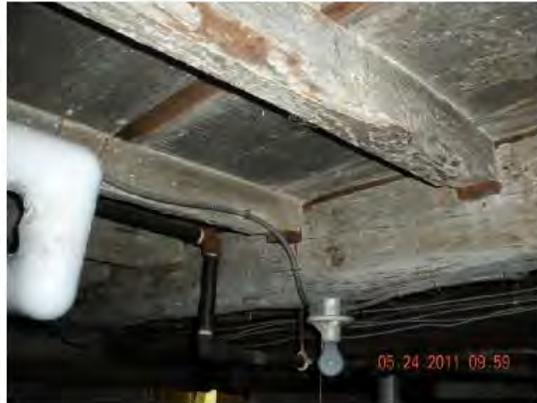
Figure 9 - *Farmhouse* - Excessive Deflection in Timber 1st Floor Beam

- At the right rear portion of the First Floor framing IREI observed that the timber floor beam has excessive deflection at the mid-portion of the beam length. The beam deflection was significant enough that someone had installed wood shims (approximately ¼ inch thick shims) in the bottom of the mortise cuts in the sides of the beams (see **Appendix A - Figure 9**) that support the tenoned ends of the flush framed floor joists to fill the gap caused by the beam deflection. As noted above this beam is structurally deficient. **IREI strongly recommends that the Town install continuous temporary shoring lines parallel and below this damaged floor beam and the tenoned ends of the floor joists on each side of the beam immediately. This temporary shoring line must support the bottom of the failed floor beams itself as well as supporting the tenoned ends of the floor joists on each side of the floor beams to eliminate the loading on the tenoned ends. It is IREI's professional opinion that this line of temporary shoring should be installed immediately to prevent a complete structural failure and collapse of the floor system. This temporary shoring should remain in place until these insufficient floor joist connections and damaged floor beam have been repaired, corrected, or replaced.**

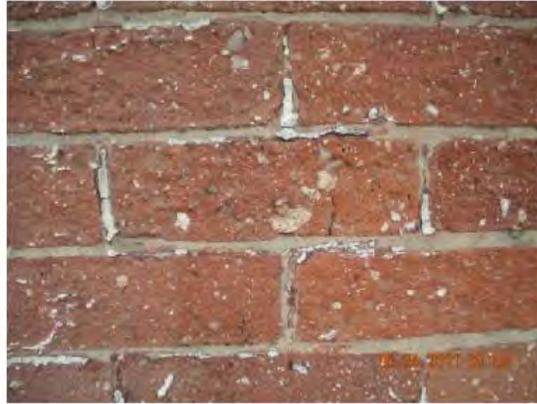
Figure 11 - *Farmhouse* - Sandblasted Brick Surface

- IREI observed that it appears that the exterior faces of the brick surfaces of the *Farmhouse* exterior walls have been sandblasted at sometime in the past (refer to **Appendix A – Figure 11**). In general, it appears that this sandblasting has removed the protective finish surface on the brick that prevents moisture from migrating into the exposed interior portion of the brick. IREI recommends that the *Town* retain a qualified Architect or masonry/restoration specialist as soon as possible to visit the *Farmhouse*, view the sandblasted brick surfaces, and provide the *Town* with their professional recommendations for the repairing the mortar joints (i.e. tuckpointing) in the brick and options for applying some type of suitable masonry sealer material to seal the exterior of the brick to reduce moisture penetrating the brick. Sealing the exterior face of the brick appears to be in need to be applied to minimize the potential for additional and future damage due to ice riving from freeze-thaw cycles of water in any open or cracked mortar joints and the brick elements themselves. This is preventative maintenance which is money well spent by the *Town* to reduce the potential for future significant structural damage to these exterior brick walls.
